City of Kingston Mentone Office

Roof Refurbishment

STAGE 1 – Roof restoration / preventative protection for asset protection

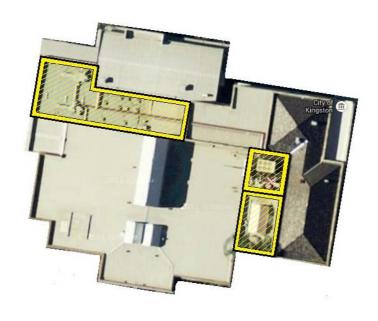
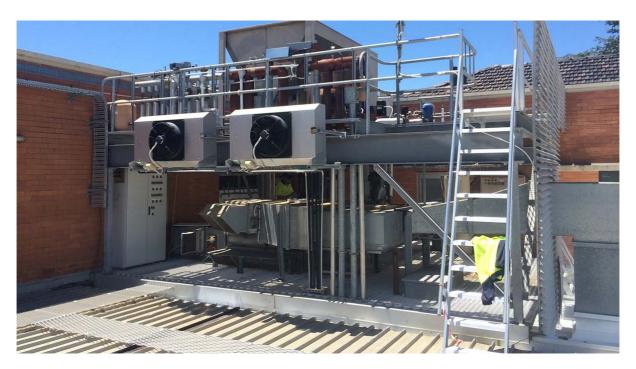
Below are photos of the plant room, or gantry.

You can see that it is the epicentre for the buildings air conditioning system.

The roof below it all – was in need of restoration (as you will see later in the report)

You can see from above that there is a huge investment in air conditioning assets, that are permanently fixed to a small roofing area.

If the roof below this area were the completely corrode through – the cost of replacement would be simply frightening... & also result in major disruption to the office use itself.

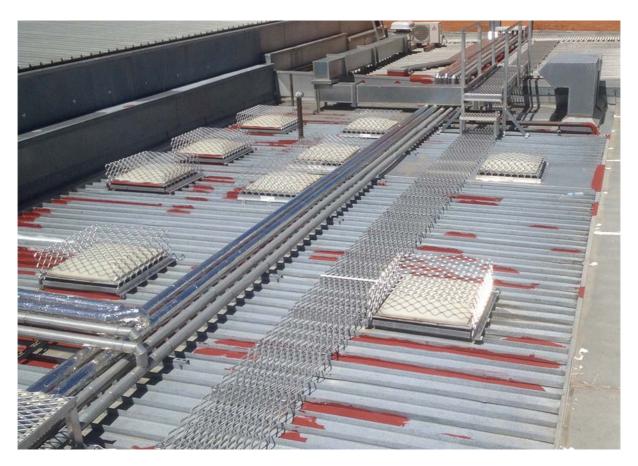
Below are a series of photos from the meeting room roof area.

Purpose of the photos is to demonstrate how many permanent fixtures rely on the roof being in a stable and structurally sound condition.

If the above roof were to rust/corrode through, the cost of roof replacement would 'blow out' to an unnecessarily huge price tag – due to the painstaking (and specialised) efforts required to uninstall & reinstall the MANY & various permanent fixtures on the roof!

With appropriate knowledge, products, processes & maintenance – the roof lifespan will live far beyond - what was looking to be a far too premature end.

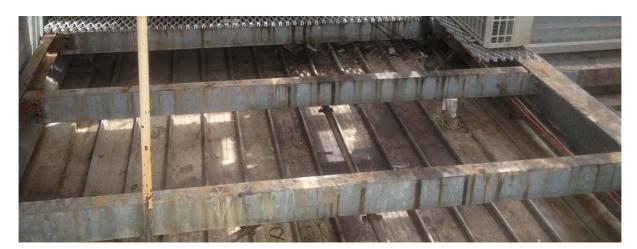
You can see from the below photo how the roof was covered heavily in dirt and oil & grease – which is a certain precursor for corrosion:

Works first started on the plant room/gantry area. Walkways were cut, removed and the below area was cleaned.

A de-greasing wash was required to remove significant amounts of oily residue.

The cleaning process was quite arduous & time consuming.

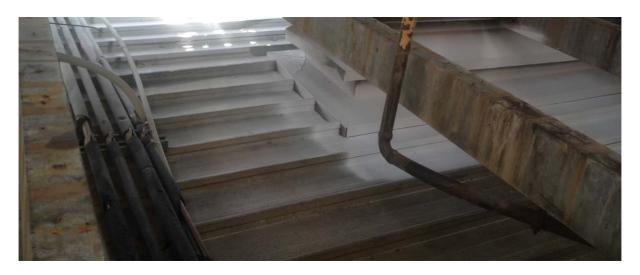
You can see from the below mid progress photo below – that following both the degreaser and high pressure water that the roof condition came up better than expected therefore, didn't require full rust conversion:

Following the degreasing & power washing, we applied a heavy duty 2 part, water based etch primer to ensure maximum product 'contact'.

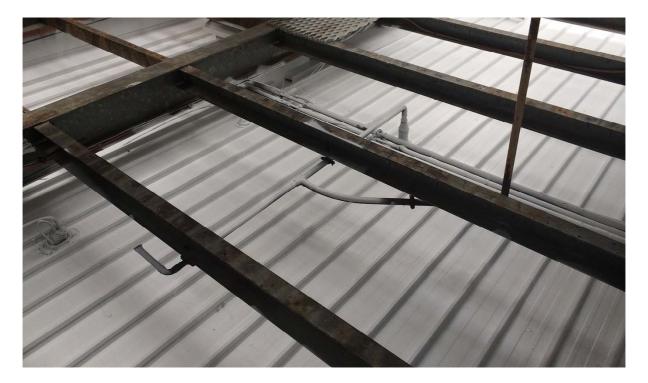
Below is a wide angle photo of the finished plant/gantry area.

The coating was applied extremely thick to ensure maximum protection of the aging metal:

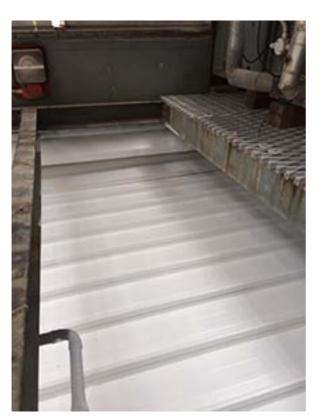
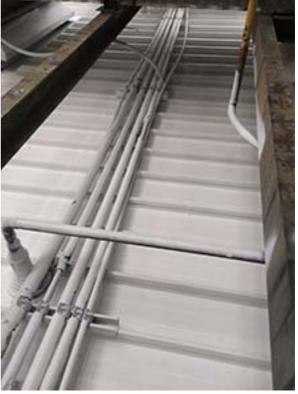
The above & below photos demonstrate the comprehensiveness of the coverage. When coating a roof with a relatively steep pitch – each coat is applied focusing on a particular direction, meaning there may be areas of "shadow". However on the subsequent coats, the angle of approach is reversed and any shadows are well sealed.

Last point to mention on the plant/gantry areas is that in total – 3 coats were applied and the result is a well sealed, thick coverage of ceramic coating has left a 'protective blanket' that will ensure the underlying metal remains free of corrosive elements exposure.

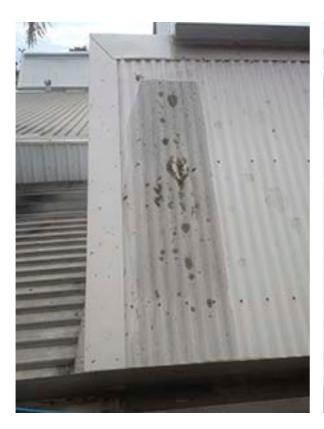
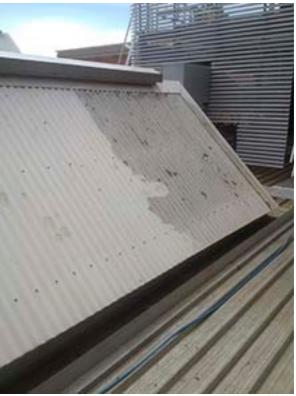
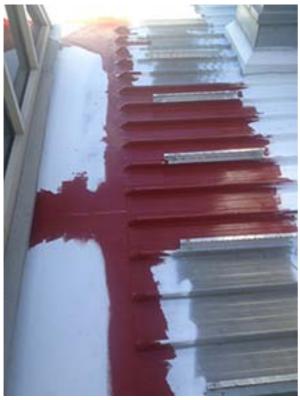
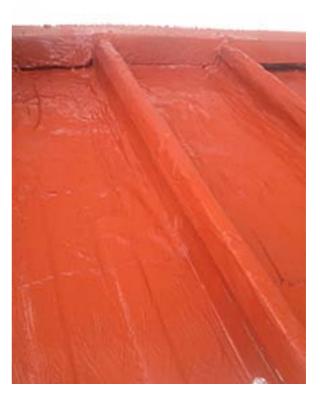
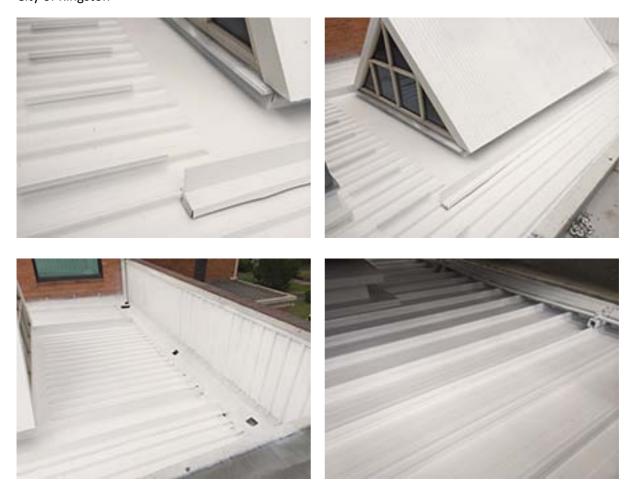
Below photos show the preparations for the plant/gantry area landing. The roof had areas of corrosion that were treated.

You can see from the below photos the area was effected by mould & grime. The mould inhibitors in the Thermoshield coating will greatly aid the prevention of this.

The landing area was more effected by rust than the plant/gantry area – but we are very pleased with the results.

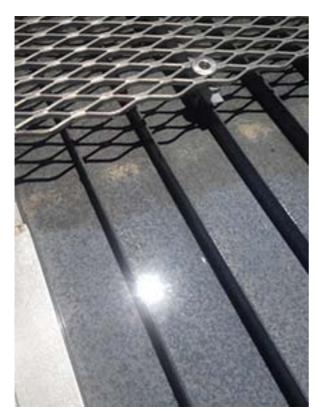
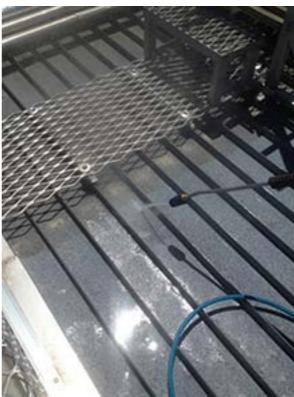
As always, the roof comprehensively power washed –Below two photo show the difference between cleaned & uncleaned. There is a clear 'line' of clean steel and steel heavily covered in grime & mould:

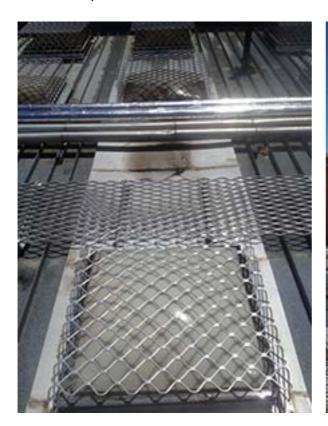
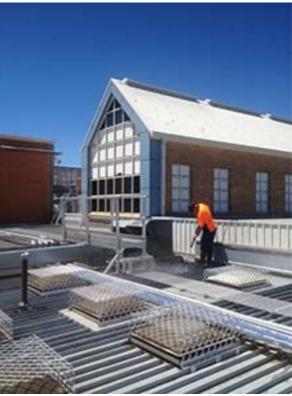
Below two photos show the massive difference between a cleaned & an uncleaned skylight:

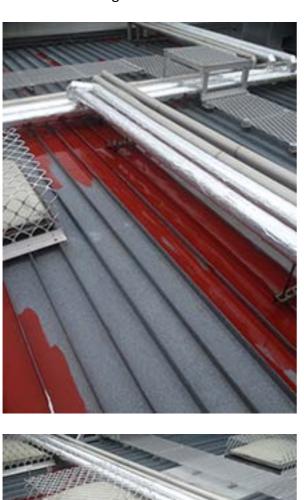
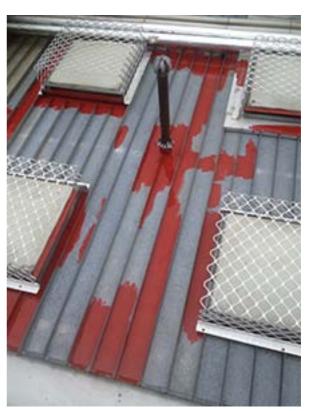
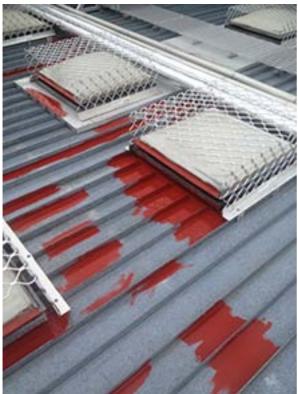
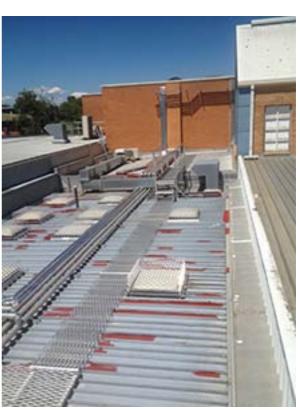
Below are additional photos showing the cleanliness of the roof sheeting which ensures maximum coating contact — also shown is the care taken to apply rust conversion by hand:

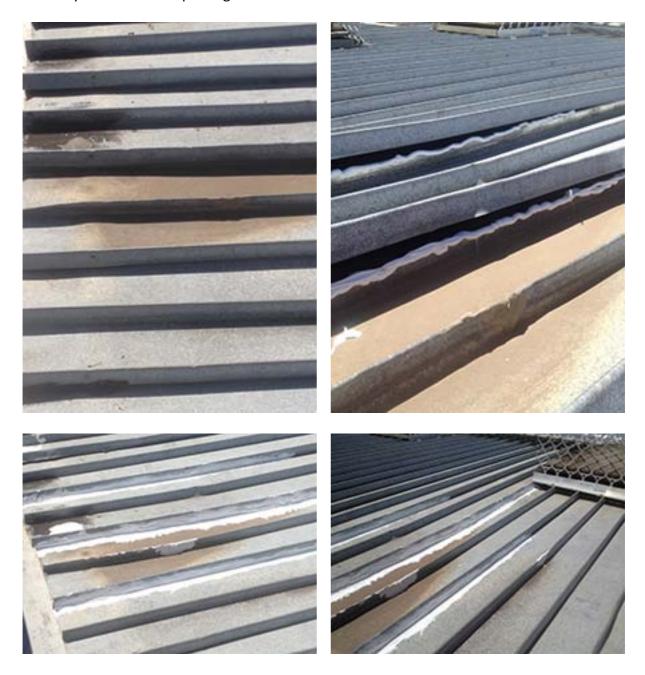
Below is an area of 'gal' kliplok that had come loose & quite spongy. This would cause quite significant waterproofing issues is left untreated.

You can see that the loose sheets were lifted, sealed with (paintable) silicone then re-set correctly to avoid water pooling:

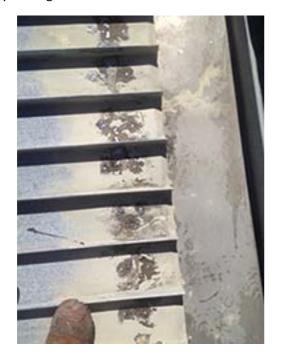
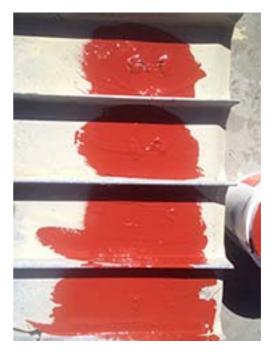
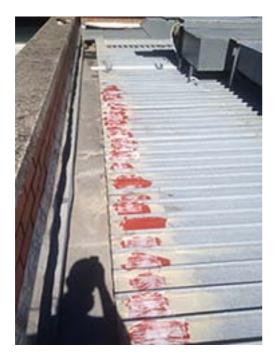
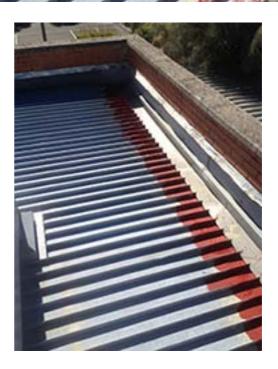
Along the sheet ends nearing the box gutter, significant care was taken to convert rust then provide a waterproofing layer of protection. Over page shows the stages of steps taken to treat the affected areas.

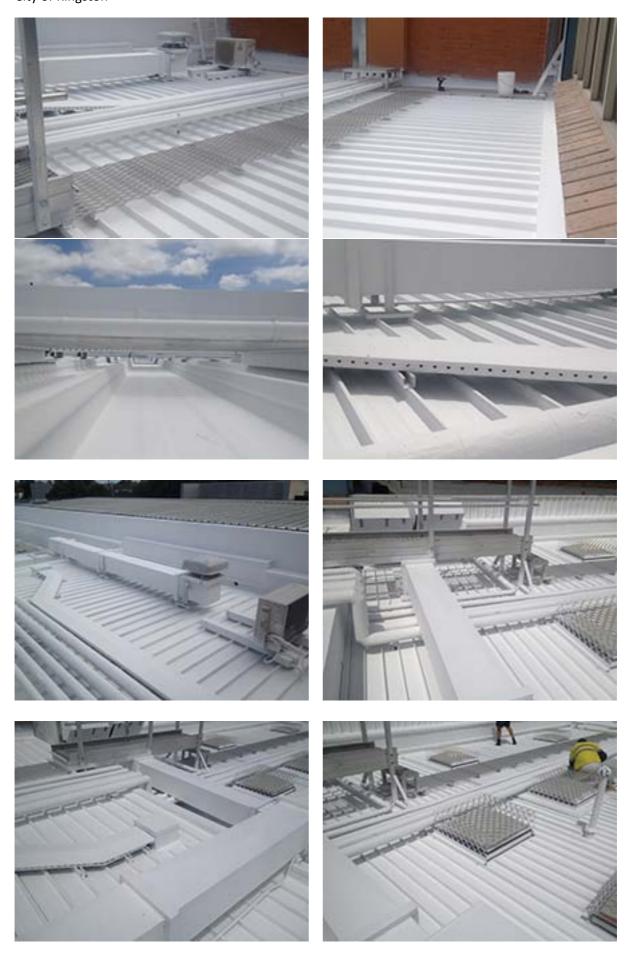
Below are the finished shots from a great project we are well proud of:

The coating process resulted in two very thick coats, which has resulted in a thick 'blanket' the encase the metal beneath. This will result in long term roof protection underneath the many & various assets permanently fixed to it.

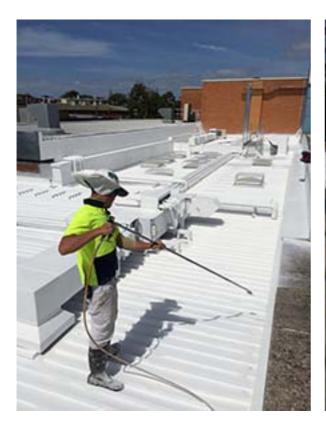
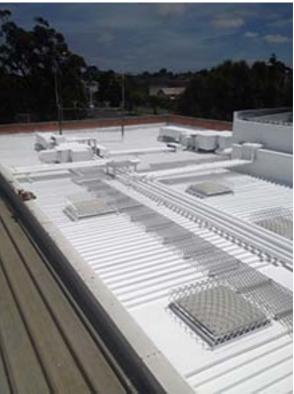
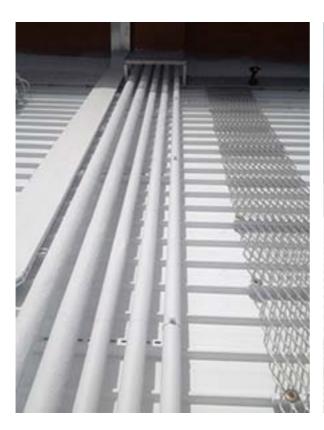
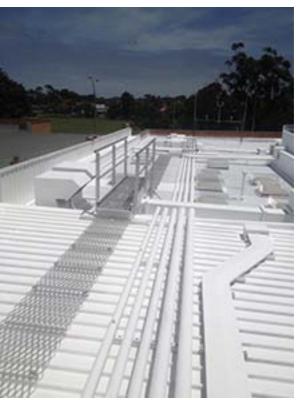
Below is a photo of the last coat being applied – along with additional finished shots:

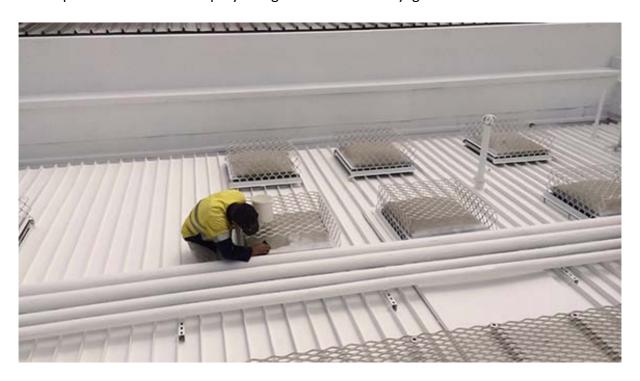
Below photos show are overspray being cleaned off the skylights:

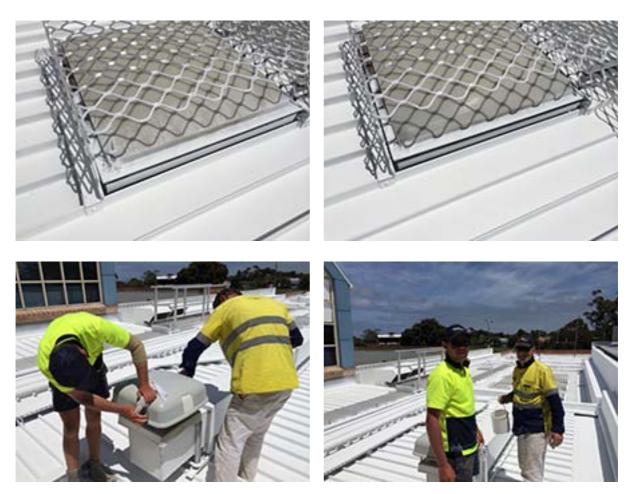
Below photos further show care taken to clean overspray – where necessary:

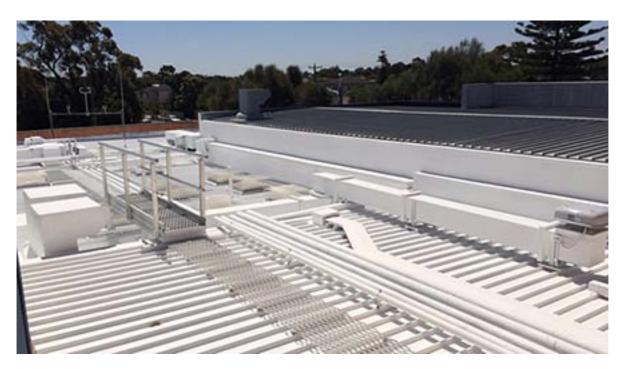
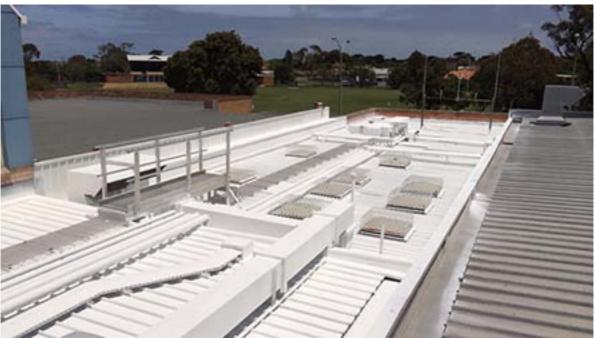
Last are two wider angle photos of the completed – stage 1 Upon completion – we couldn't be more pleased knowing the roof has been comprehensively sealed for protection. We hope Kingston are also well pleased!
