# THERMO SHIELD®

Rio Tinto ammonium nitrate  
storage facility corrosion control

## **AMMONIUM NITRATE FACILITY BEFORE REFURBISHMENT – SITE INSPECTION**

## 6 MONTH INSPECTION OUTCOMES

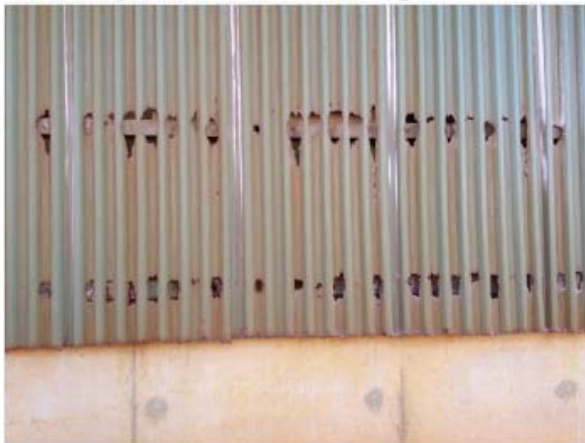
\*Closer inspection of external cladding

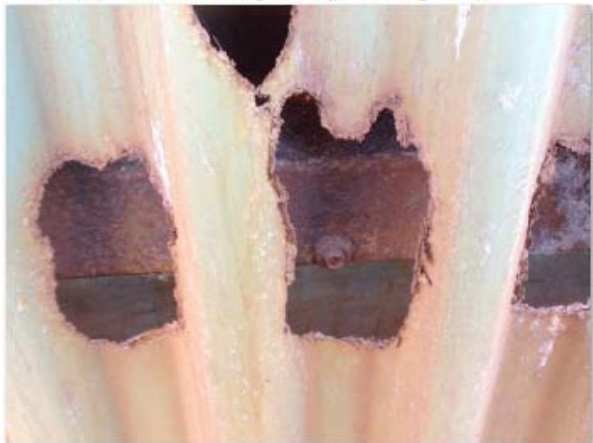
\*Sheets corroded through - major falling hazard

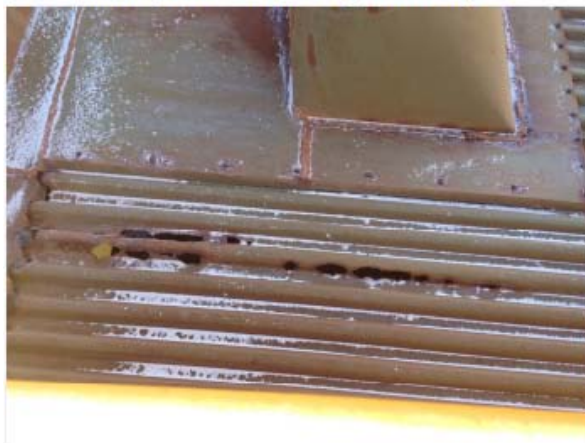
\*Roof sheeting corroded in corrugation 'troughs'

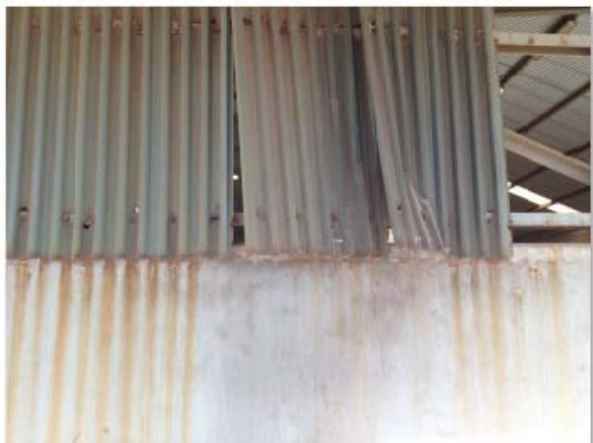
\*Internal wall sheeting - imminent risk of falling

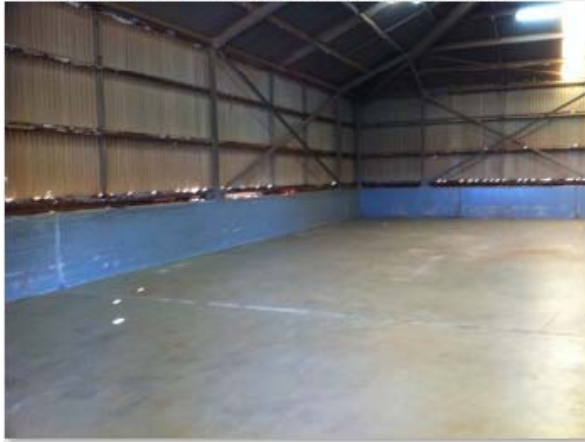
\*Each storage bay - severely corroded framework

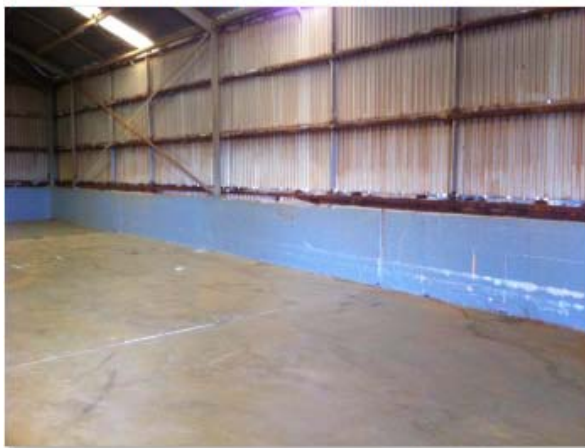
\*All bays of both sheds under identical duress

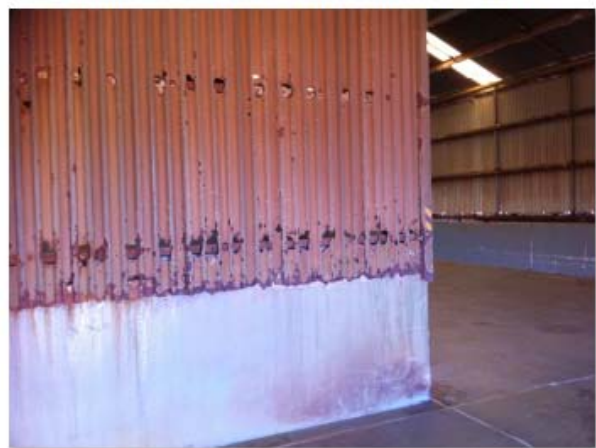
\*Replaced sheets in bay 1 - with 'protective' coating

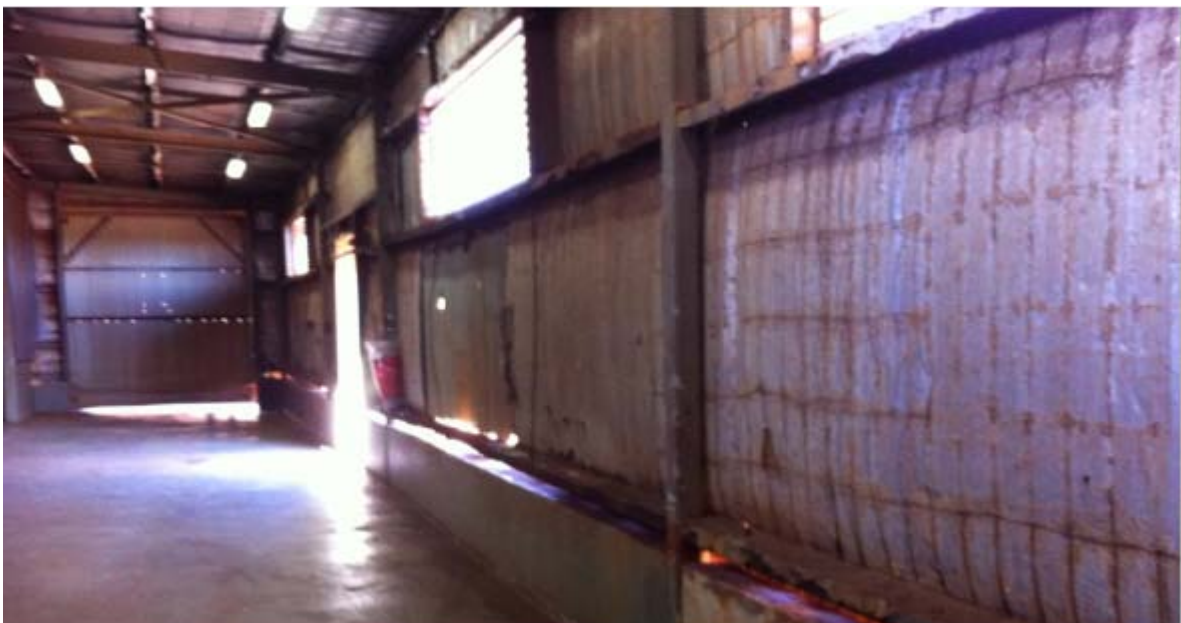
The below shot shows that the front apron of the sheds, which aren't in direct contact with the ammonium nitrate are equally as corroded simply through vapour exposure:

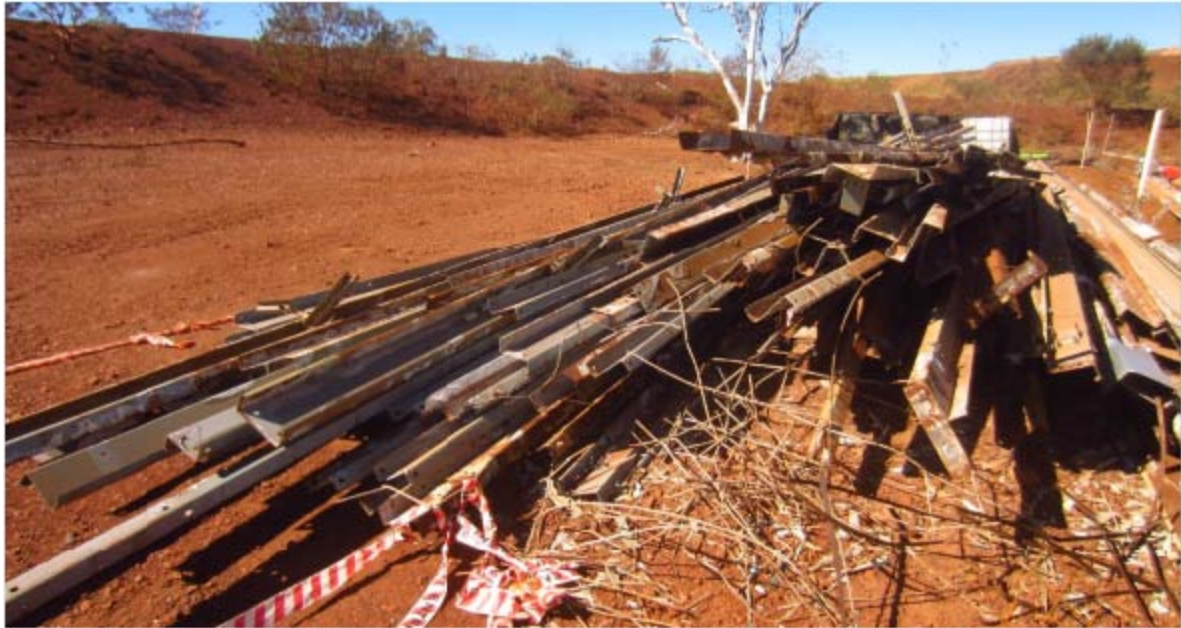
Finally, we'll demonstrate the extent of structural framework corrosion by more closely examining the below pile of discarded purlins:

You can see on closer inspection that all purlins were unable to remain protected by the coating and the structural integrity of the storage sheds was severely compromised:

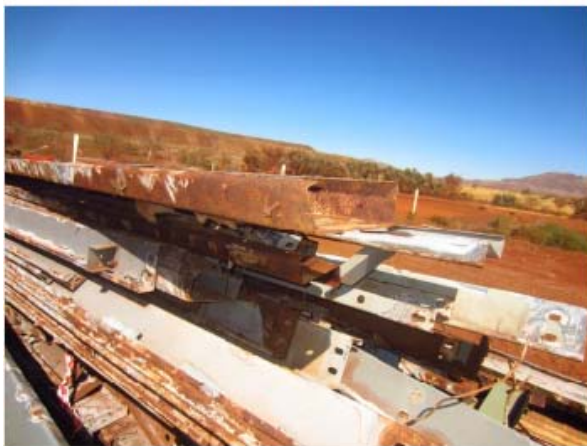
\*When coating is 'flaked' off - reveals extent of corrosion    \*Protective coating inflexible & unable to adhere

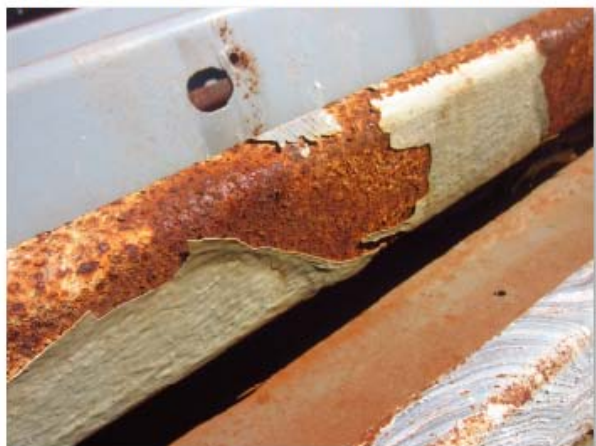
\*Engineers deemed purlins contained hairline cracks

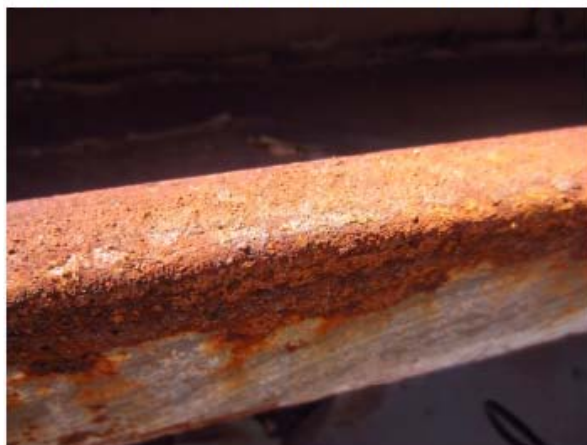
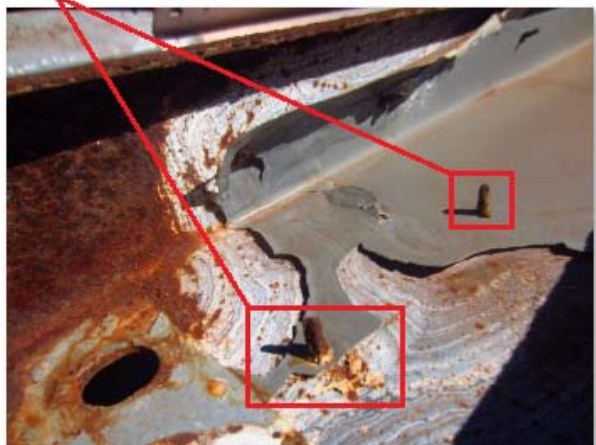
\*Tech screws provided entry points for corrosion

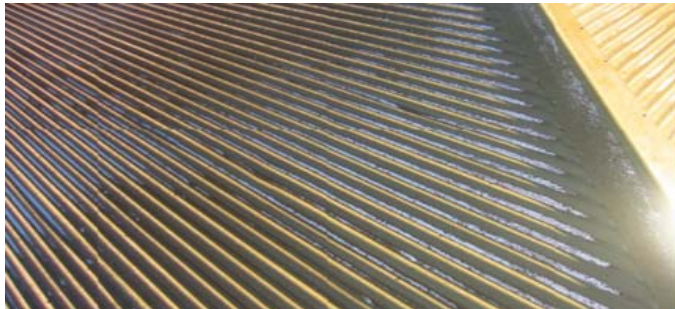
3 months of 'caked on' ammonium nitrate as a result of spillage upon delivery

AN heaped to as much as 2 inches at various points

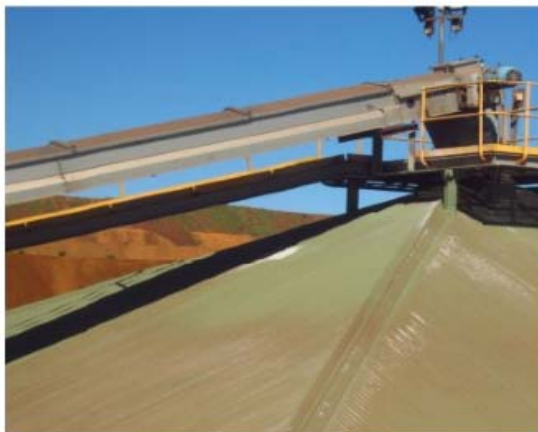
3 inch thick AN build up removed in seconds

Hosed area in isolation as a basis for comparison

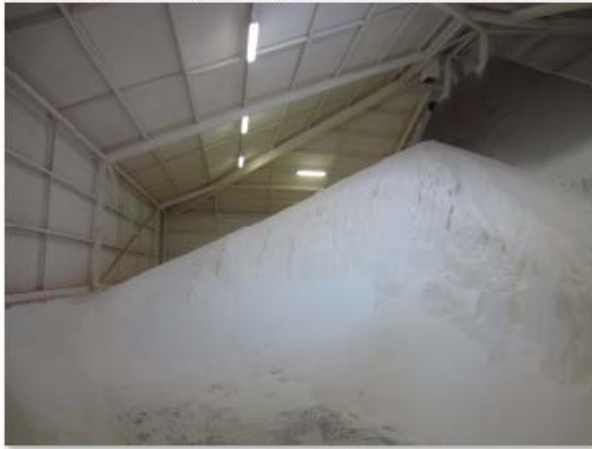
\* Shed 1 (west bay) - no signs of corrosion

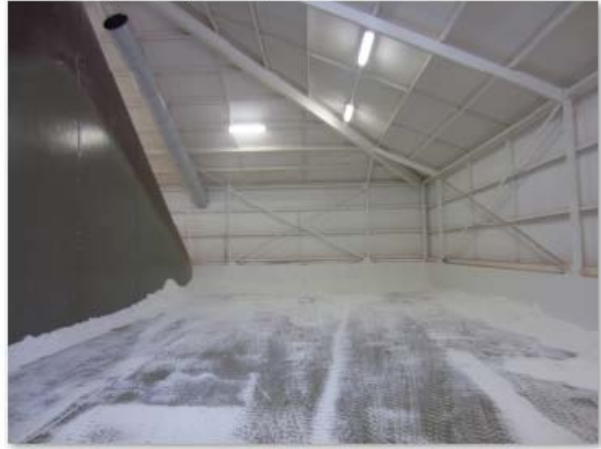
\* Shed 1 (east bay) - no signs of corrosion

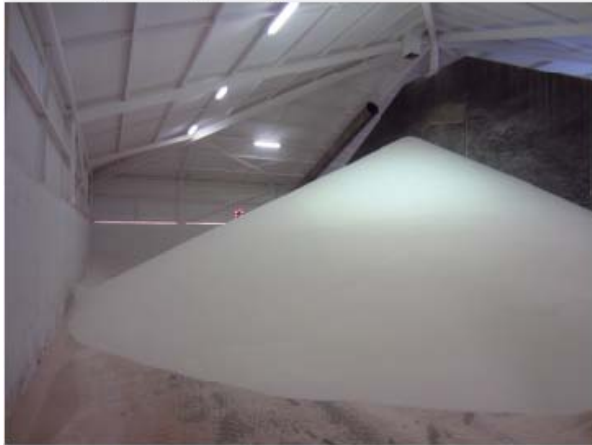
\* Shed 2 (west bay) - no signs of corrosion

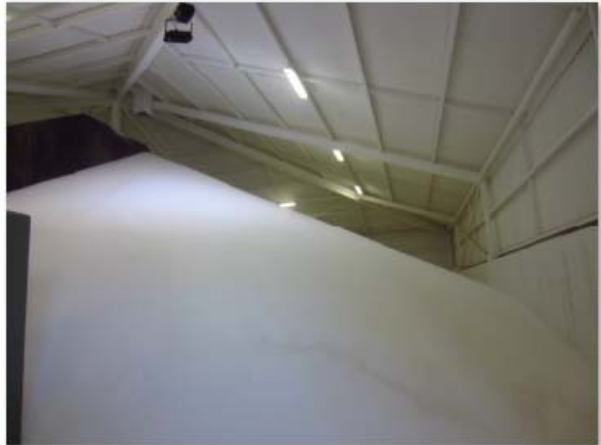
\* Shed 2 (east bay) - no signs of corrosion

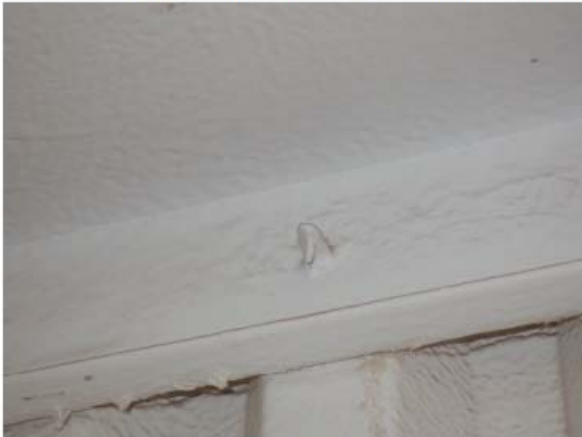
\* All tech screws were hand painted in addition to spray

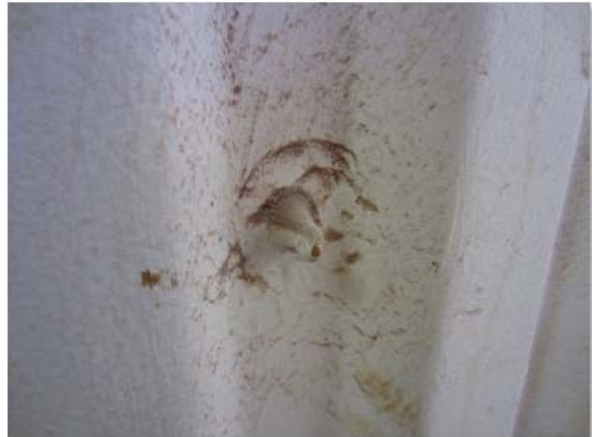
\* Ceramic coating 'heaped' 360° around penetrations

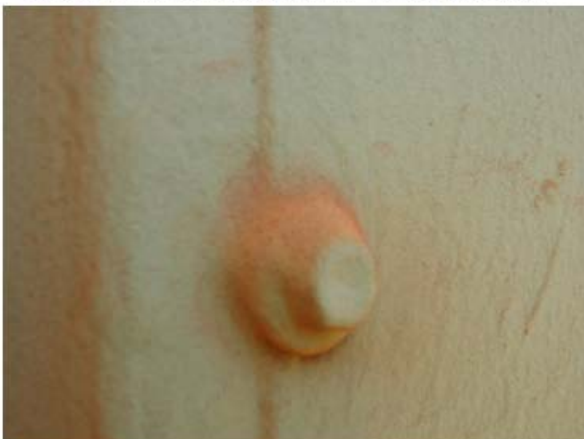
\* External tech screws fully 'sealed' - showing no wear

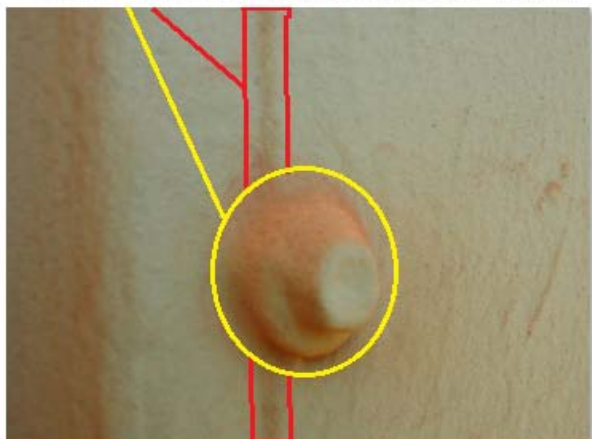
\* Same shot - sheet joins (red) also fully sealed - no wear

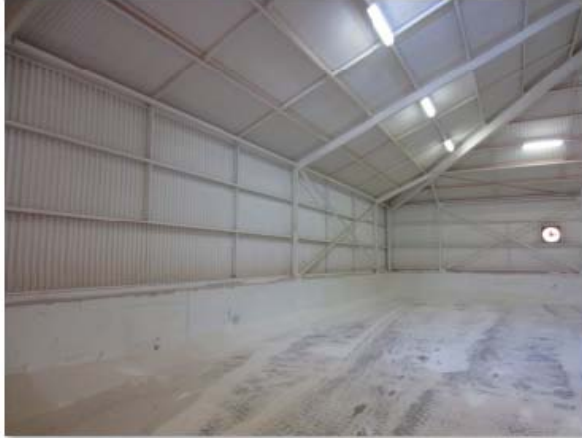
\* Bay 2, shed 1 - no signs of corrosion or product failure

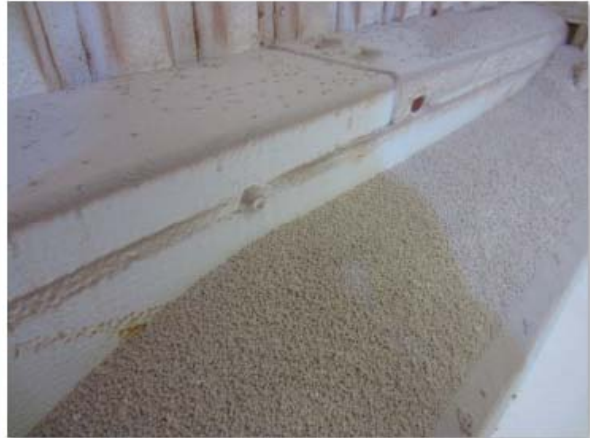
\* Bay 2 - sheet joins & screws sealed. Piled AN 'harmless'

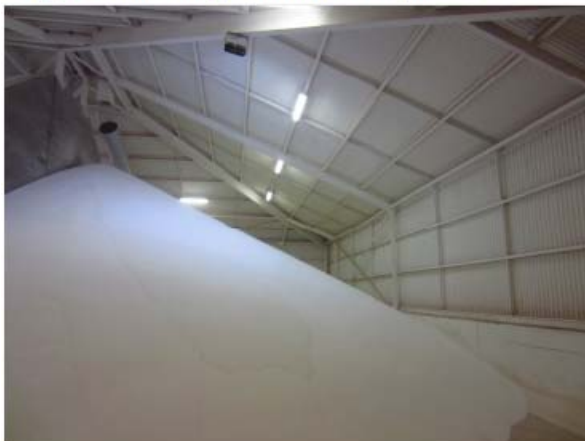
\* Bay 1, shed 1 - no signs of corrosion or product failure

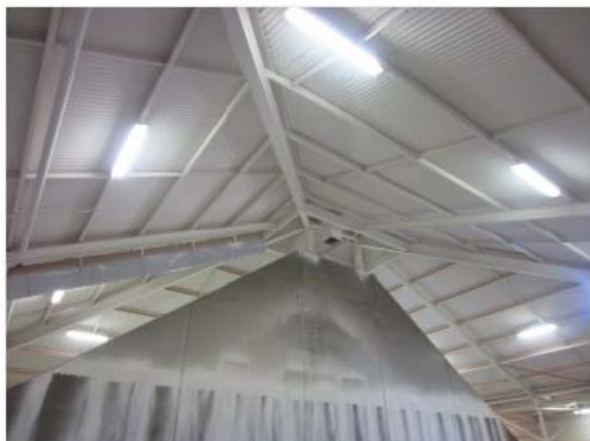
\* Shed 1 - no causes for concern to internal roof area

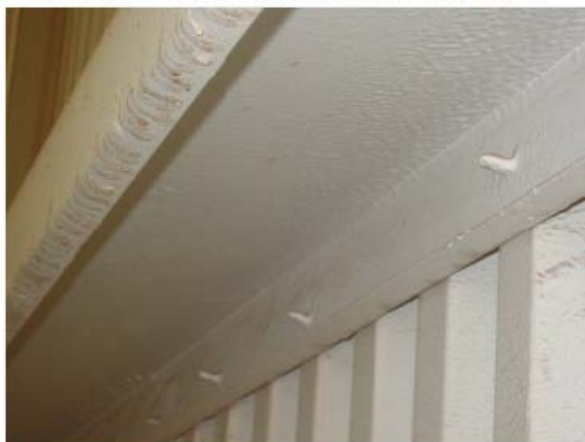
\* Bay 4, shed 2 - penetrations in purlins heavily sealed

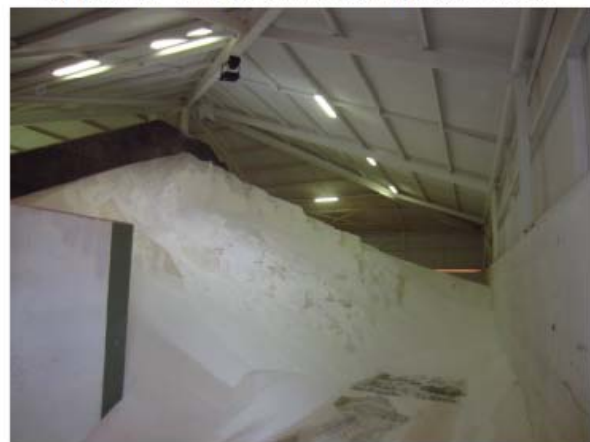
\* Bay 4, shed 3 - no signs of corrosion or product failure

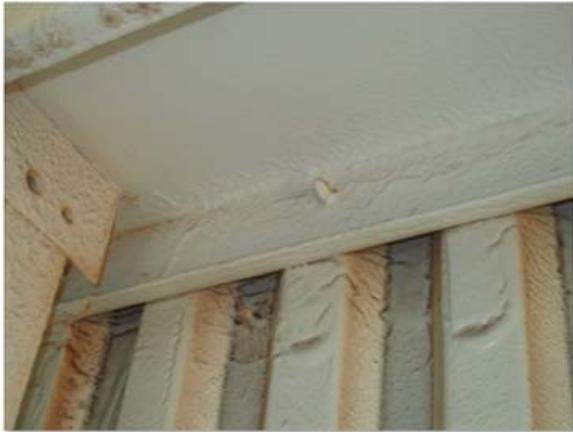
\* Purlins 'flooded' - where tech screws had entered

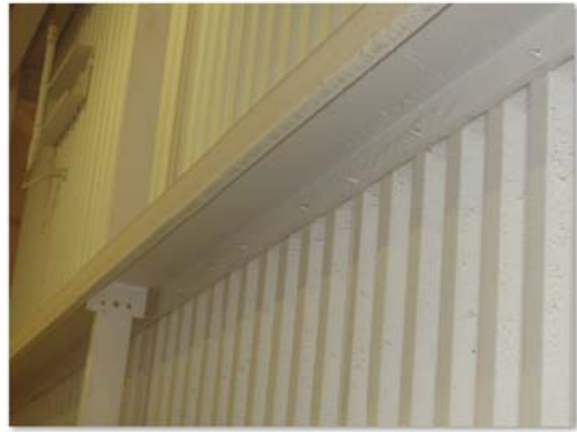
\* Tech screws touched up by hand to ensure 'seal'

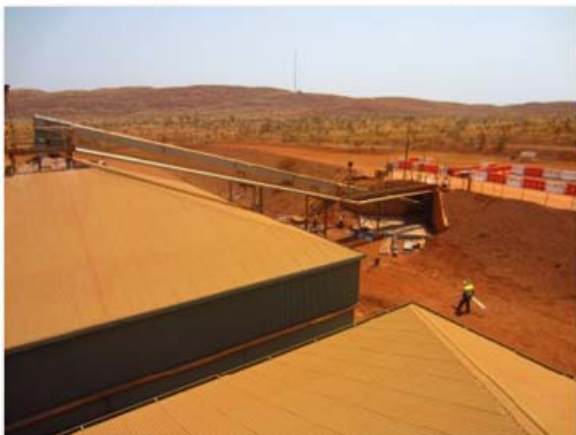
\* Roof sheeting shows little to know build up of AN

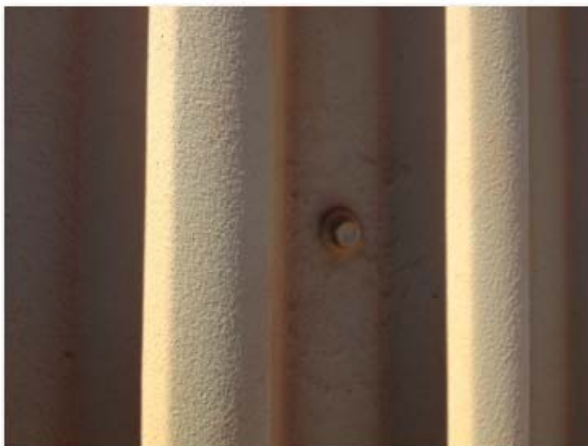
\* Close up of tech screw - has remained 'sealed'

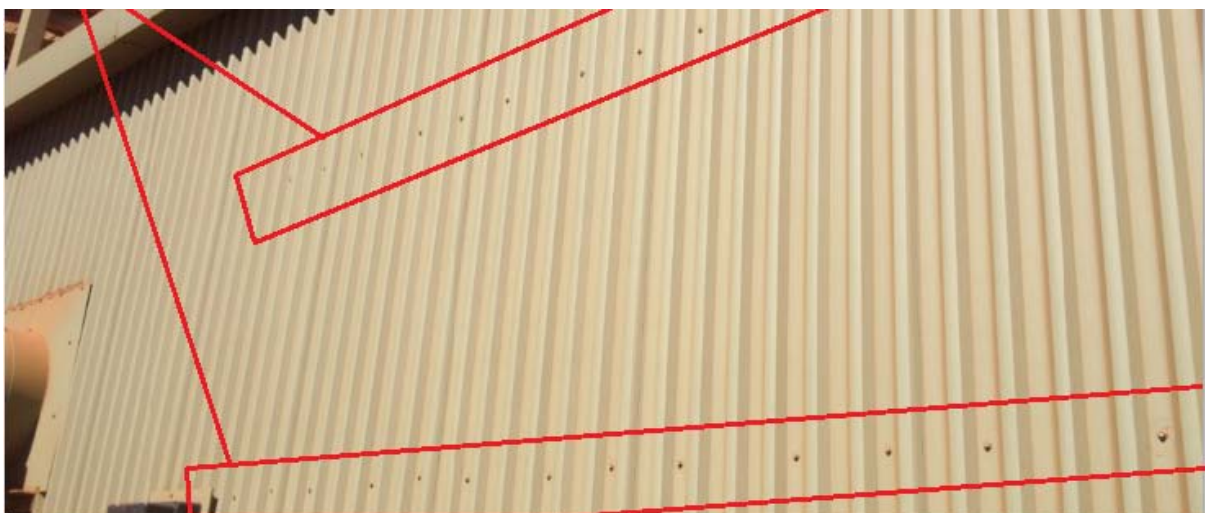
From a wider angle – you can see that the penetrations points remained well sealed:

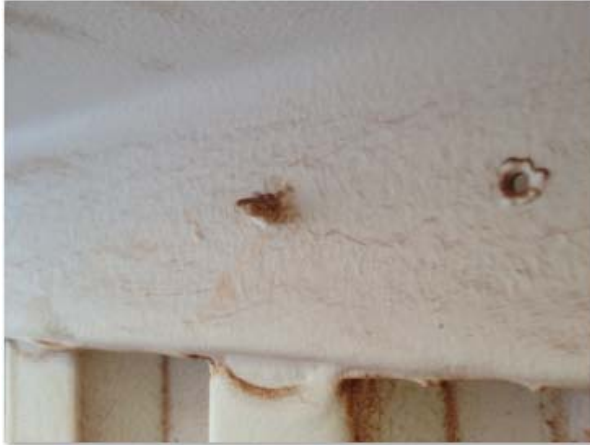
\* Close up internal purlin penetrations - heavily sealed

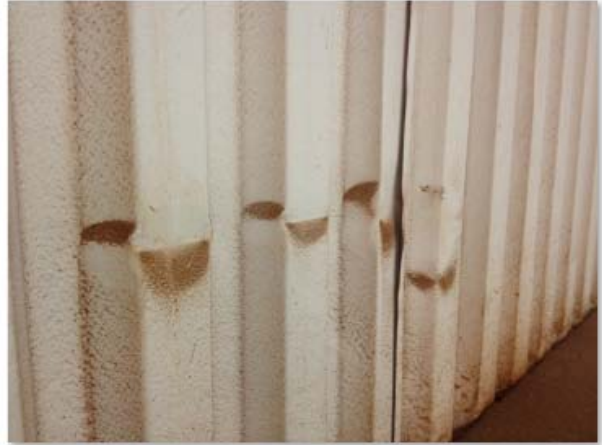
\* Flexible coating undamaged - despite major knock

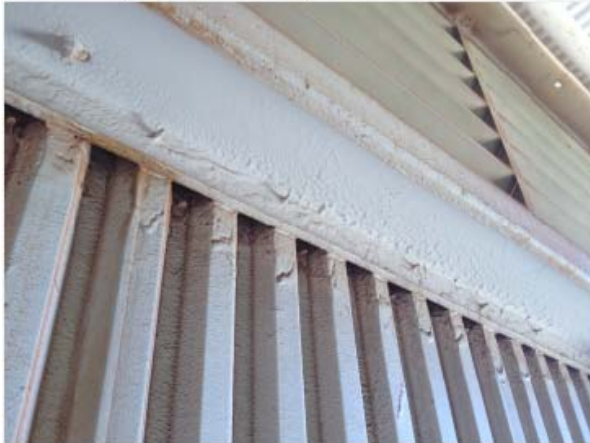
\* Wider angle internal coating - no visible corrosion

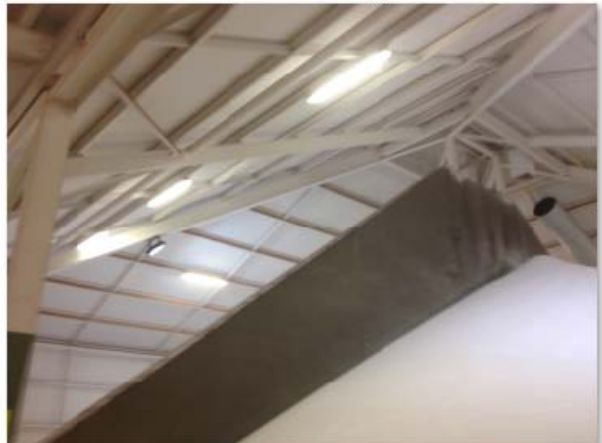
\* Internal roof coating - no visible signs of corrosion

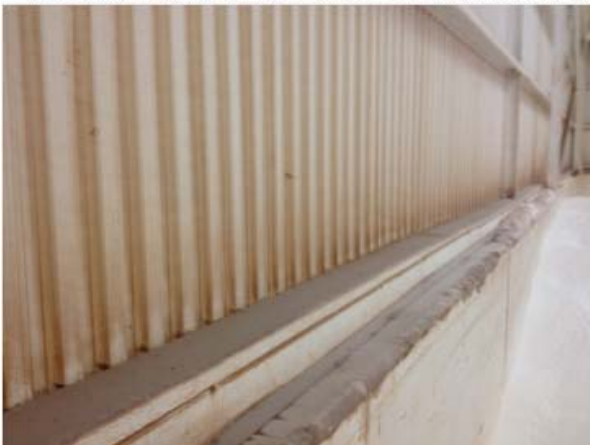
\* Internal coating shed 1 (west) wall - no visible corrosion

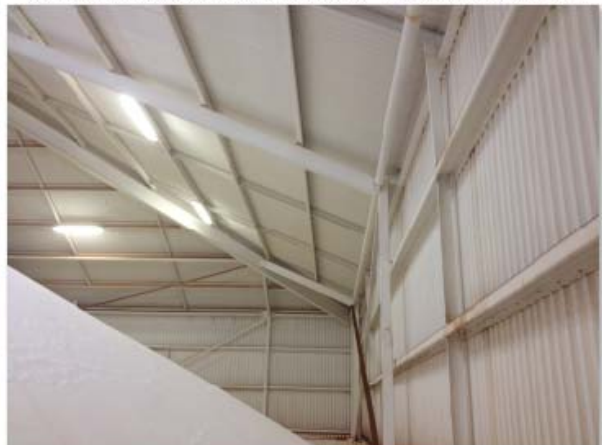
\* Internal coating shed 1 (east) wall - no visible corrosion

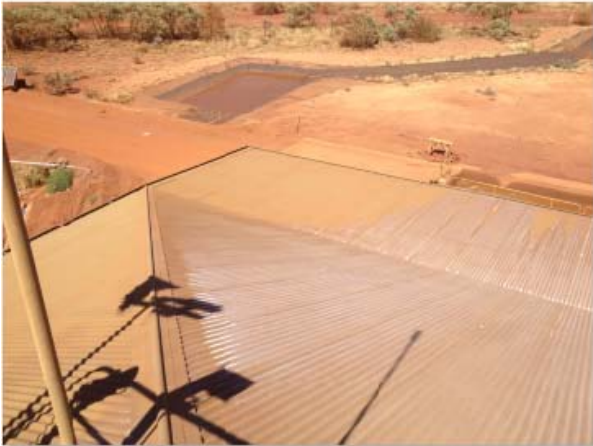
\*Shed 1 roof - no visible corrosion

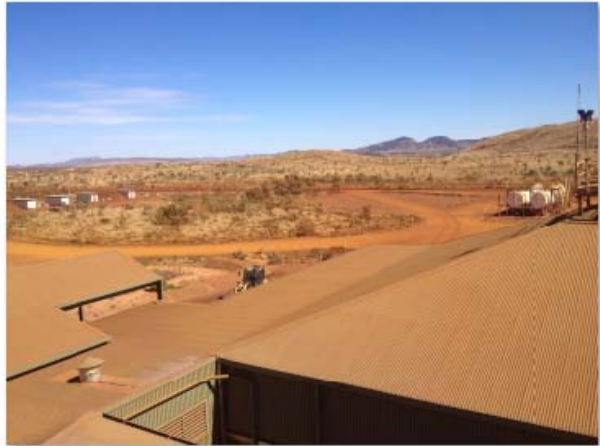
\*Shed 2 roof & front apren - no visible corrosion

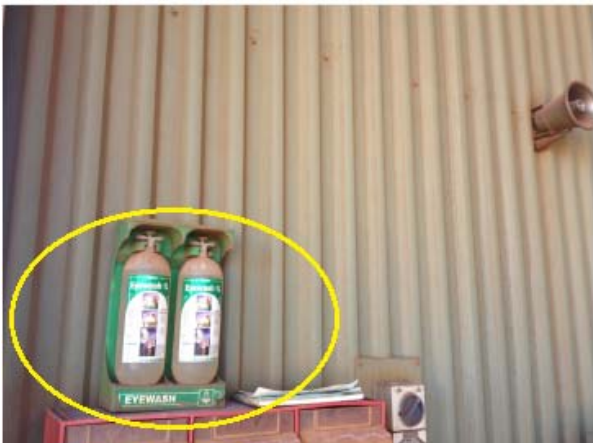
**IMPORTANT TO NOTE** – consideration must be made for new/unsealed penetrations. Below you can see a recent installation of an 'eye wash station' has left unsealed penetrations exposed internally (which can easily touched up next inspection)

\*Eye wash station - located in loading area

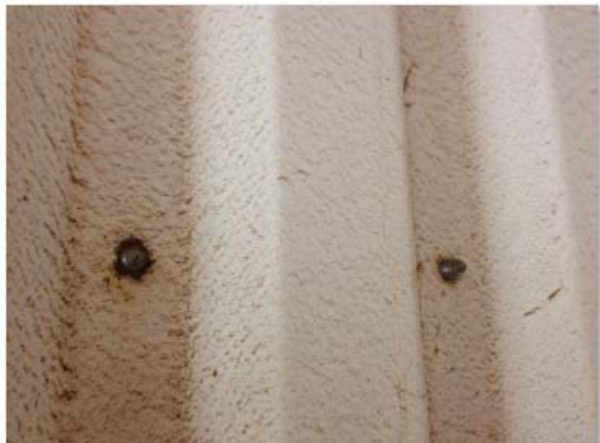
\*Installation required in the ceramic 'seal' being broken

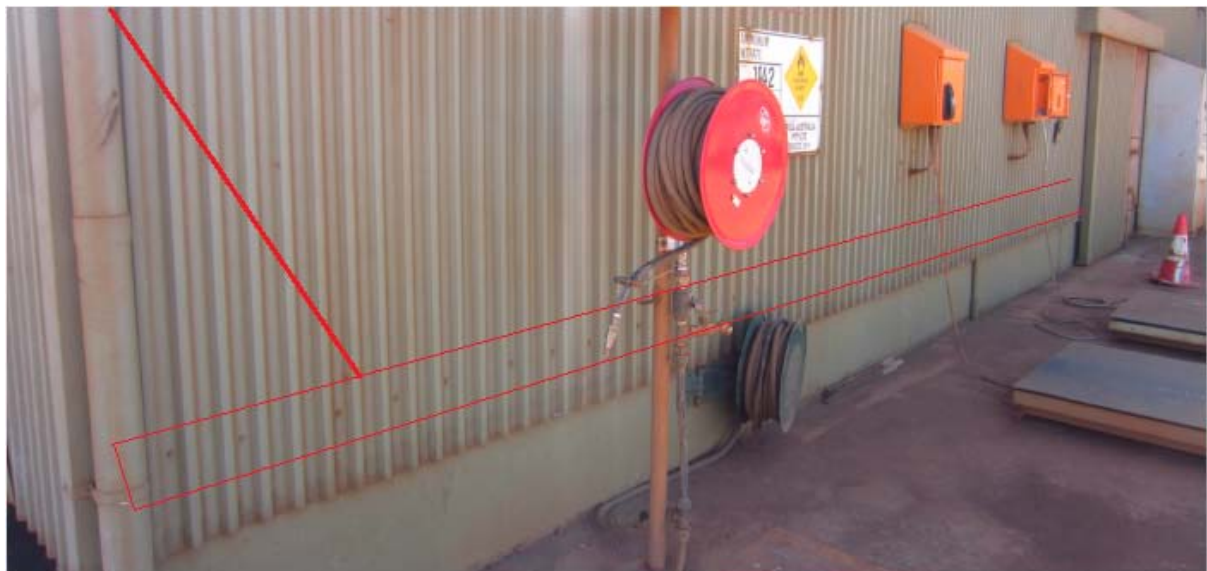
You can see from the below photos that the tech screw 'line' shows no signs of corrosion:

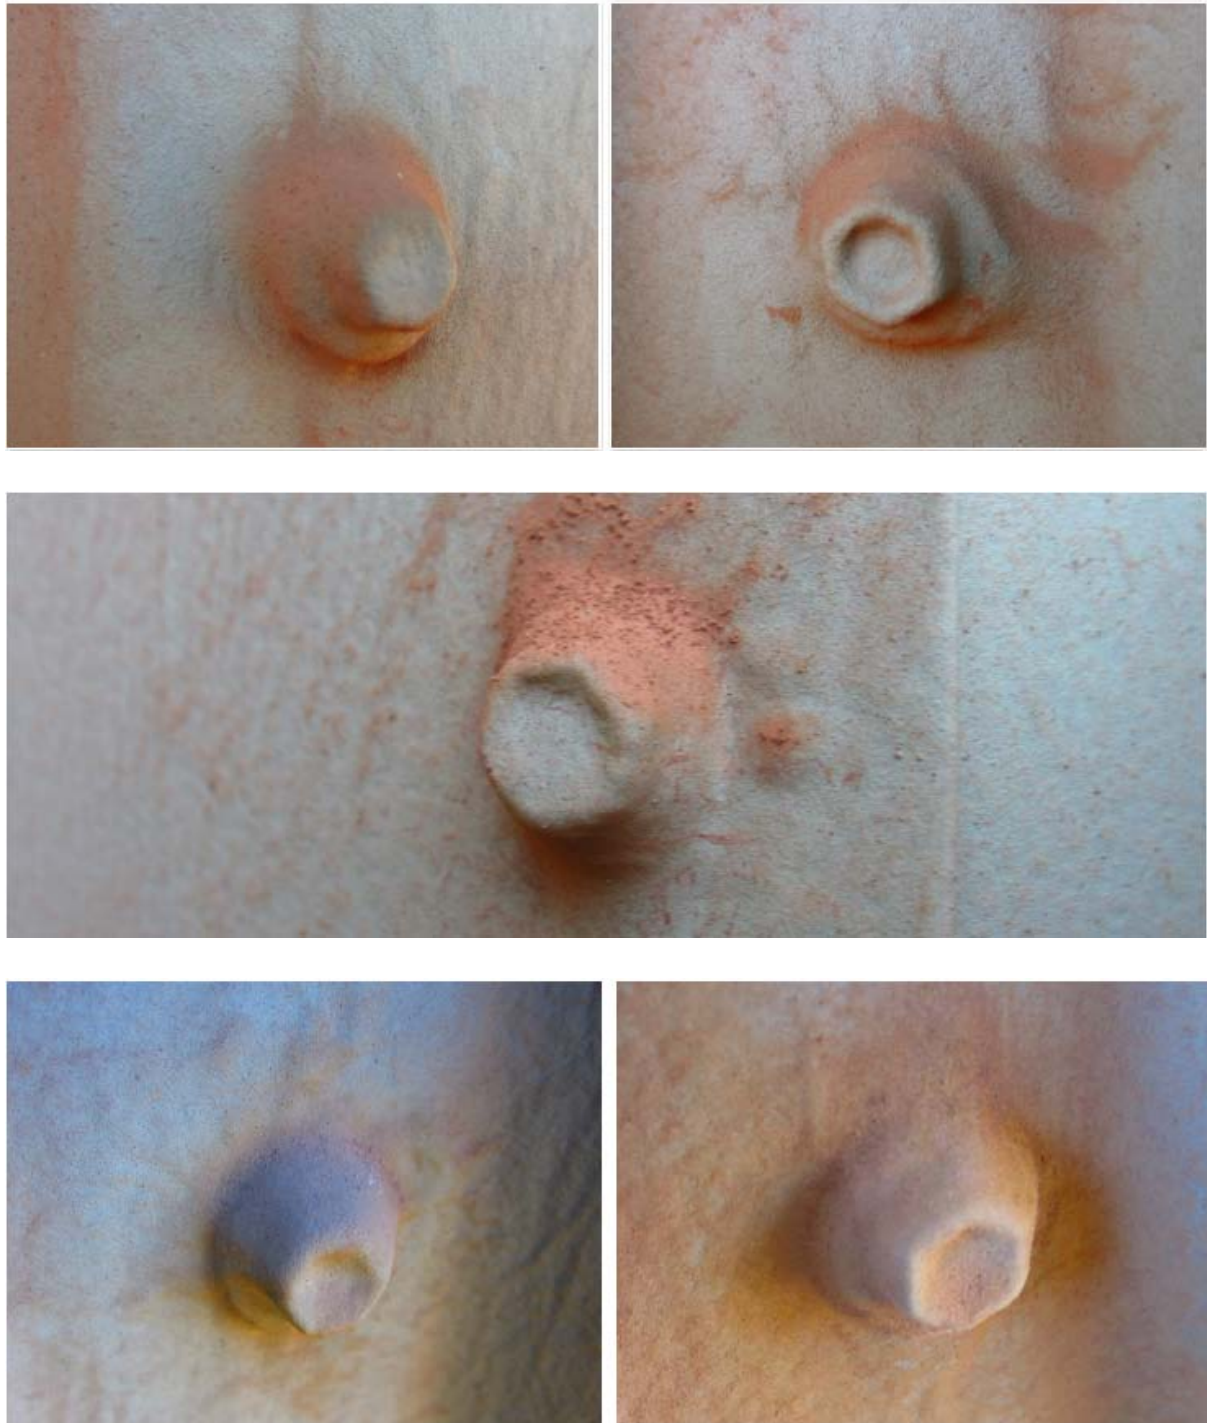
Looking further into the comprehensiveness of the tech screw seals, below are a series of close up photos, demonstrating how the AN contact & vapour hasn't been able to gain access to any metal:

You can see from the above close ups, despite a healthy covering of Pilbara red dust, the coating is showing no signs of deterioration and the metal remains unexposed to oxygen, water & AN exposure.

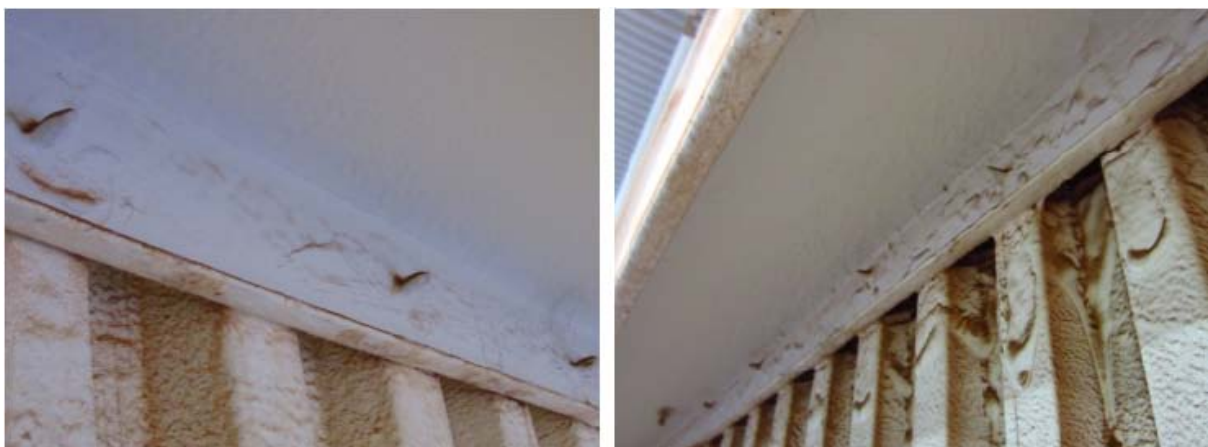
Some close up examples of the reverse side, of tech screw penetrations – which provides the entry point for corrosion to begin from:

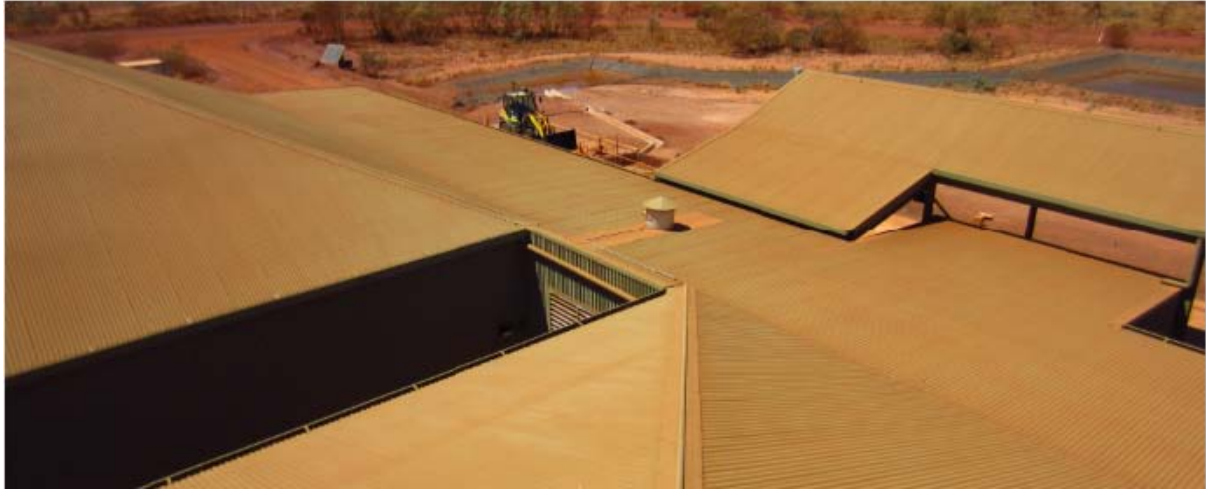
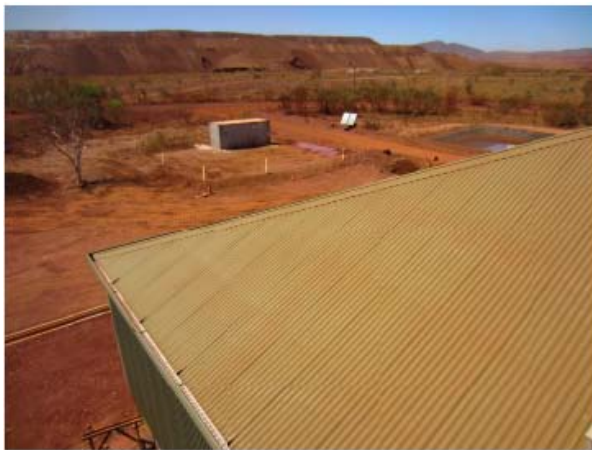
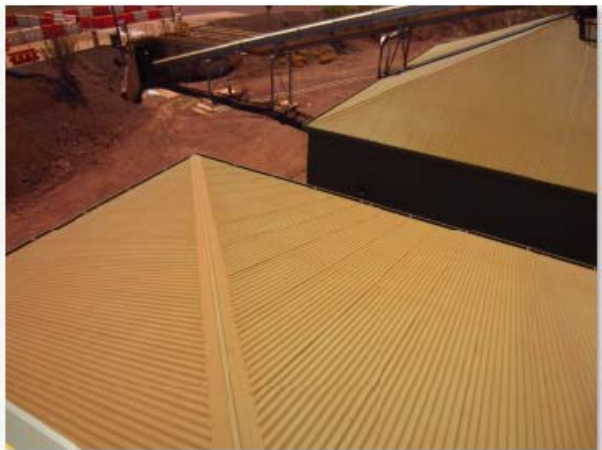
The below photo's show the roof exterior – which shows no sign of corrosion.

In addition, there is still no signs of AN bonding to the coating whereas on an unprotected roof sheet, we saw heaped AN almost 'crystallise' and bond to the sheet ruts.

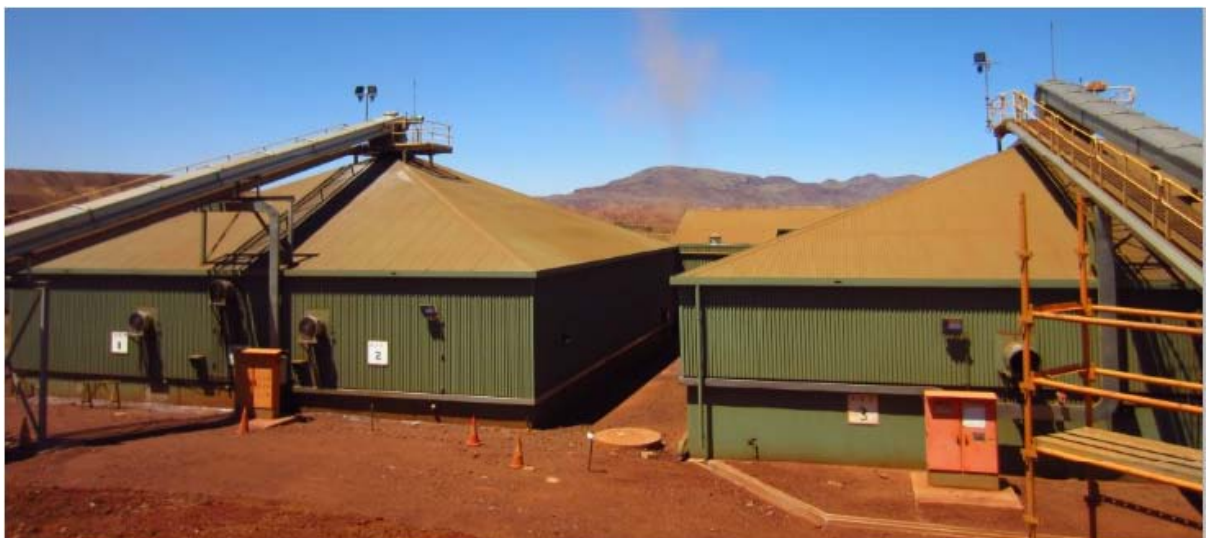
Below is a wide angle – showing no damage to tech screw penetrations:
