Woolworths
Australia's fresh food people

Claremont, Tasmania

Stage 2

Roof Restoration | Corrosion Control | Waterproofing

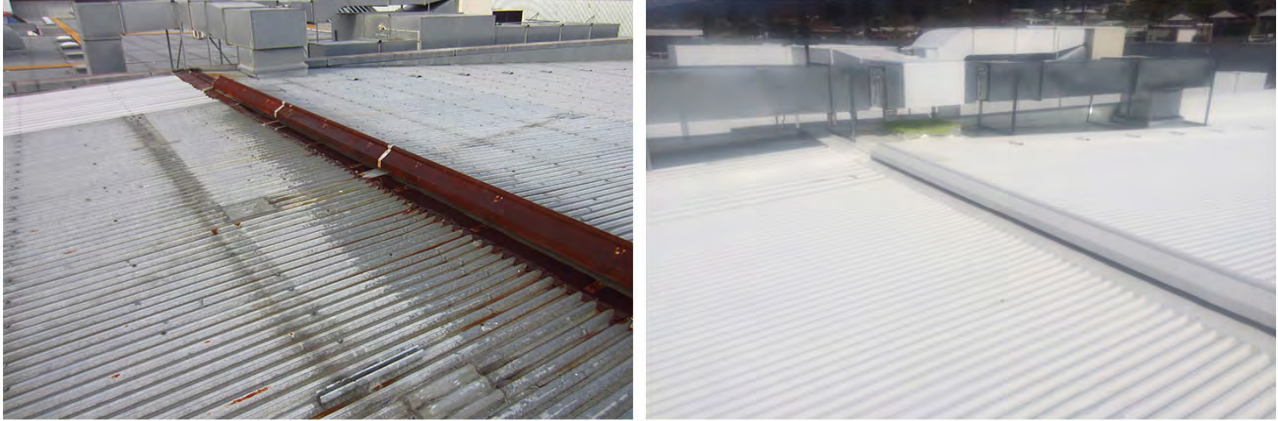
Prior to works commencing, our initial inspections of the stage 1 works were overall very positive as there were no signs of rust re-surfacing whatsoever. Below is a photo & a reminder of how badly rusted the main/original roof had become, compared to 6 months post coating:

If you simply paint over rust, the rust re-surfaces in as little as 1-3days through the paint film. Given there are no signs of re-surface after 6months, we're supremely confident the restoration will remain in great condition up until & beyond the 10year warranty.

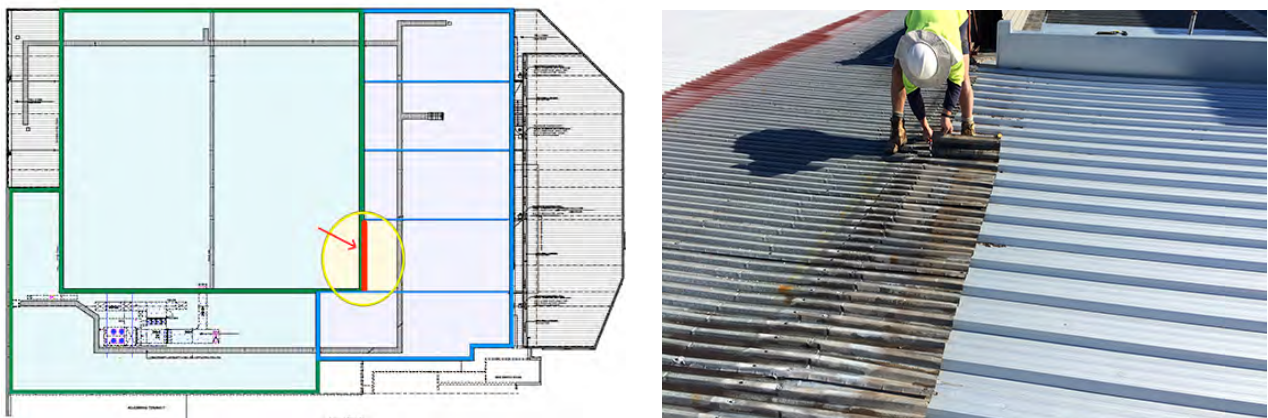
Upon our return, we were of the opinion all roof works were completed and in a condition ready to coat. You can see at the below diagram (blue & green areas being areas we coated), approximately 800mm of roof sheeting was dangling into thin air & wasn't fit for coating:

Prior to works, we cut the excess sheet free allowing approximately 150mm of overhang from the last line of screws into the underlying baton & also screwed down any 'spongy' areas.

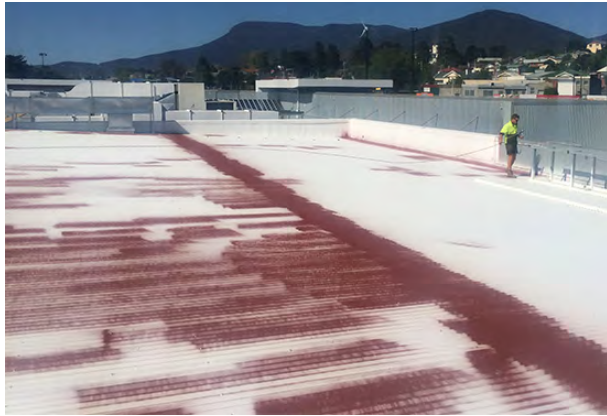
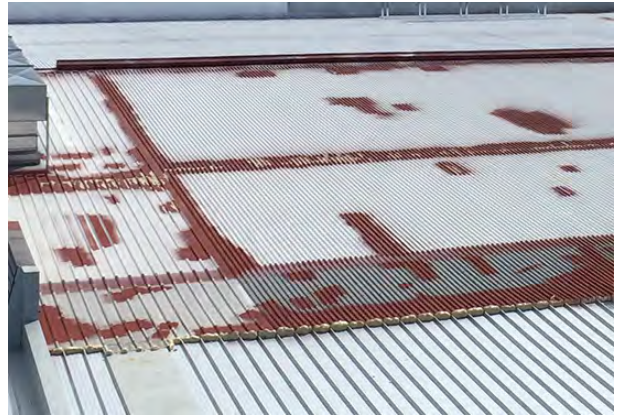
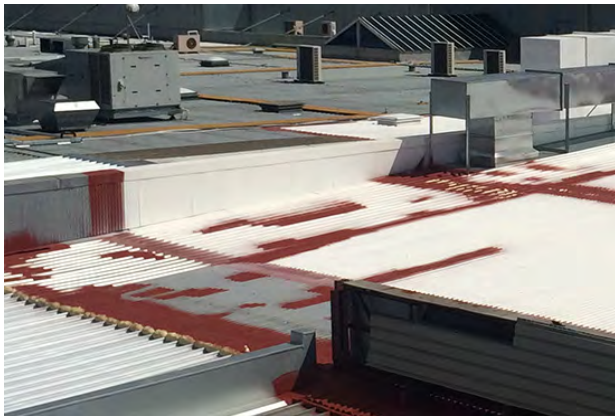
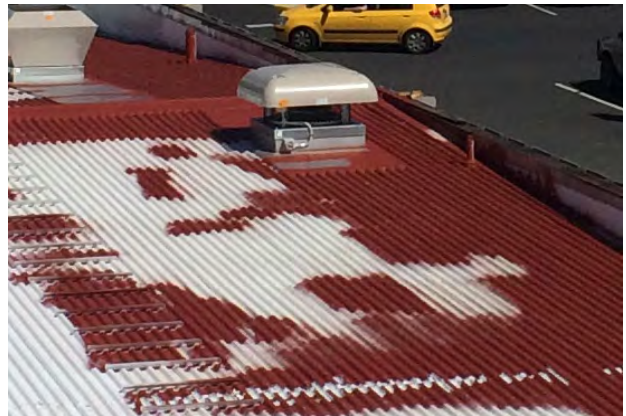
There was excess roof traffic on the finished coating. The installation of HVAC duct work, roof safety walkways, various vents & roof flashing all contributed to the wear. The major damage to the coating was the metal filings left on the roof that formed minor rust on the surface of the Thermoshield coating in isolated areas.

Following power washing (to remove metal filings, general grime & any product flaking), rust inhibitor etch primer was applied due to the minor rust from metal filings.

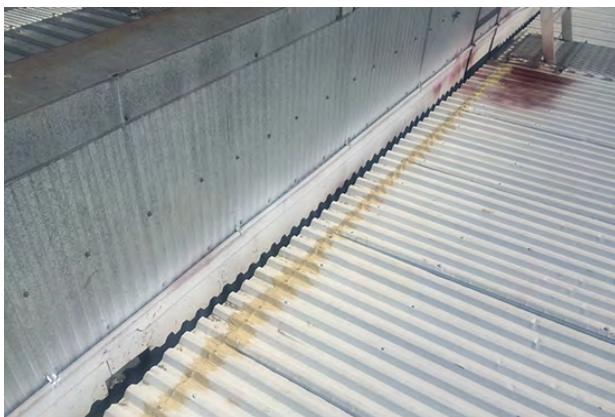
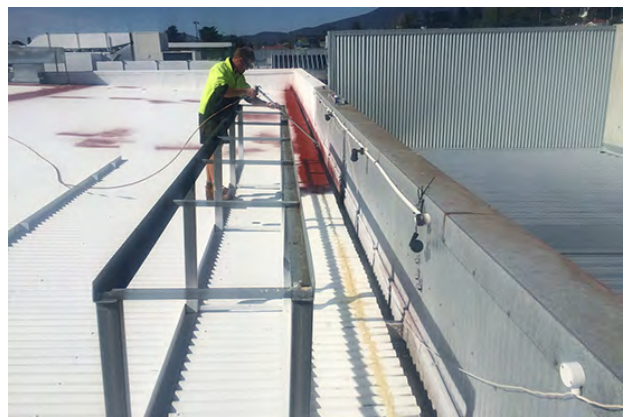
In addition to the surface preparation, there was a suspect sheet lap that we heavily waterproofed after a leak was identified in the produce section of the store (directly underneath):

The 33meter sheet lap was heavily reinforced whilst ensuring water freely runs off into the box gutter without pooling. Etch primer was coated over the join & 2 coats of Thermoshield:

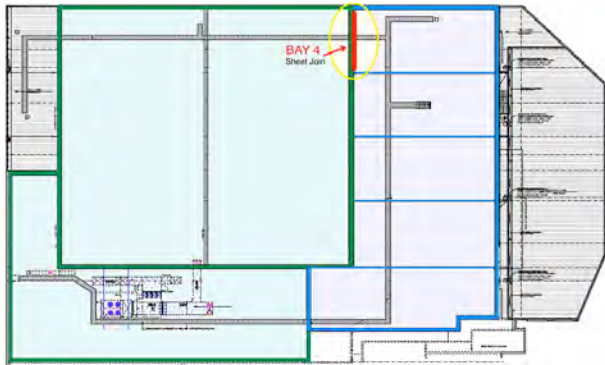
* Area of the roof

Bay 4 sheet join was also a major source of water ingress with evidence of several 'band aid' repair attempt. Prior to rust conversion & waterproofing measures, additional screws were driven in to better secure the sheets & remove the spongy areas.

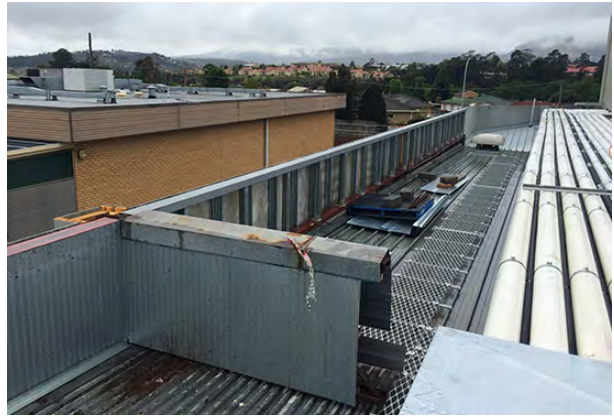
* No capping had been installed

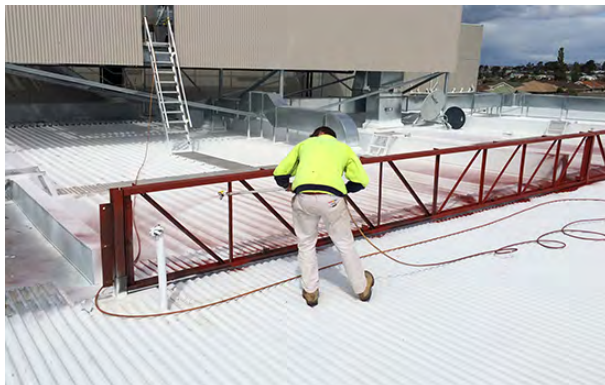
* Frame coated for rust converter
