Asbestos Encapsulation
Thermal Insulation
Waterproofing
Asset Protection

Type of Roof: Super 6 Fibro Asbestos

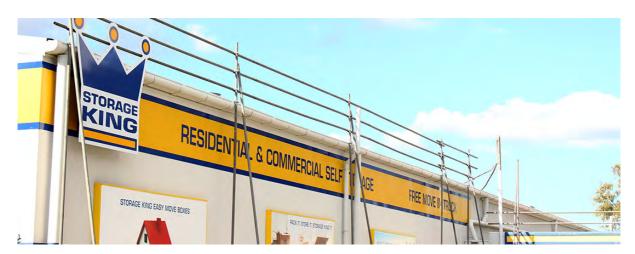
Below series of photos demonstrates the guardrail installation around the roof perimeter:

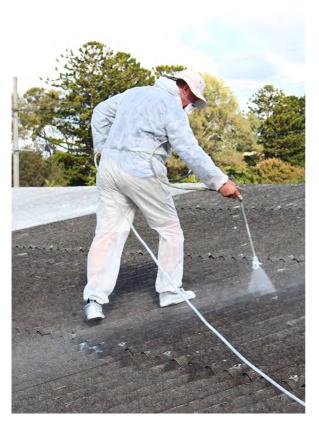
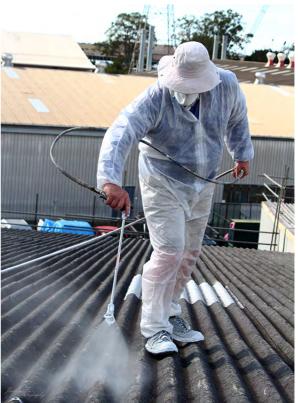
Full PPE worn & guard rails eliminating risk of fall:

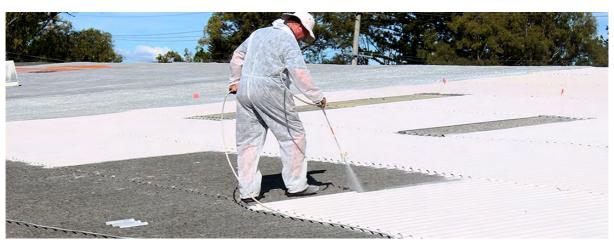
First coat (surf mist):

The asbestos sheeting is quite porous compared to metal sheeting. As a result, an initial coat (in colour surf mist) was applied to ensure maximum contact.

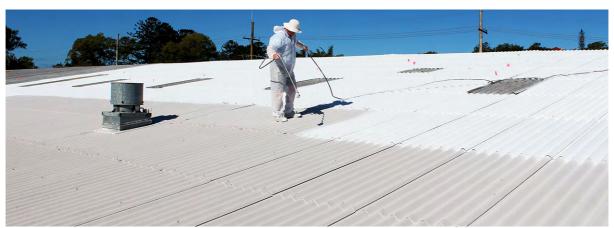
Second coat (white):

The below photos of the white coat, highlights the contrast between the first coat that was completed in 'surf mist'.

The benefit of applying a tinted coat is to ensure evenness between coats so that the protective membrane is applied to a consistently thick, even coat.

When applying layer of white onto white, it is increasingly difficult to track progress & can result in potentially thin patches of coating.
