THERMO SHIELD®

Boroondara City Council
Ashburton Library
Roof Refurbishment and Insulation

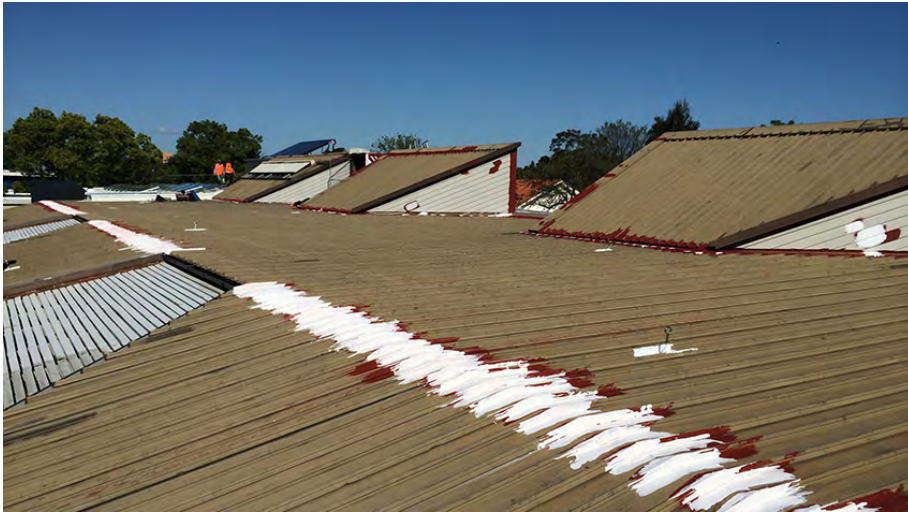
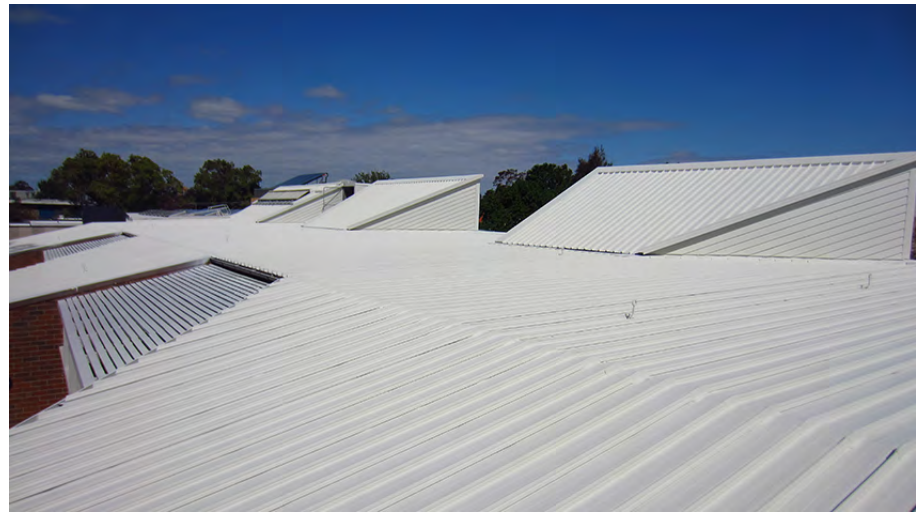
The roof at Ashburton Library had widespread waterproofing issues and areas where water penetration was beginning to show initial signs of corrosion.

In addition – the heavily weathered roof sheeting had become highly unsightly and was affected by moss, mould and general grime over the heavily faded sheeting.

Below are two before / progress shots of the library roof - followed by two completed photos:

- **Power washing** (minimum 3,500psi)
- **Rust Conversion**
- **Waterproofing** (applying high strength flexible micro-fibre membrane)
- **Etch priming coating** (to ensure maximum adhesion)
- **2 coats of Thermoshield** (to a wet film thickness of 500 micron)

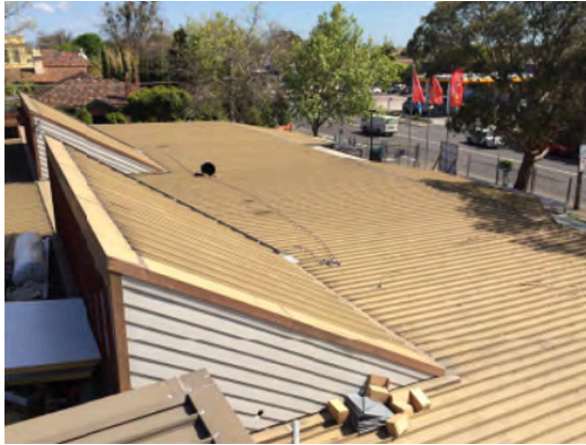
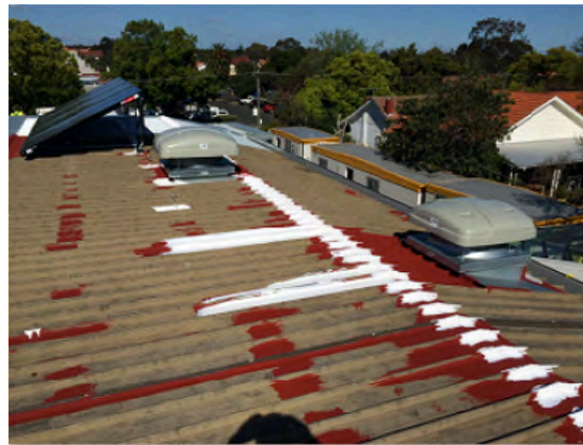
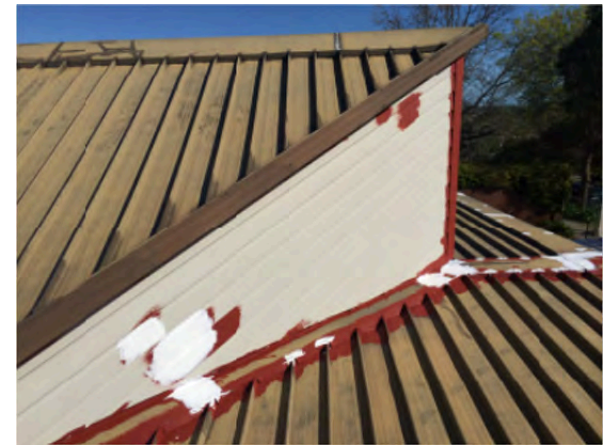
BEFORE or PROGRESS SHOTS:

The photos show how the roof was treated for rust, conversion & waterproofing – prior to the Thermoshield coating:

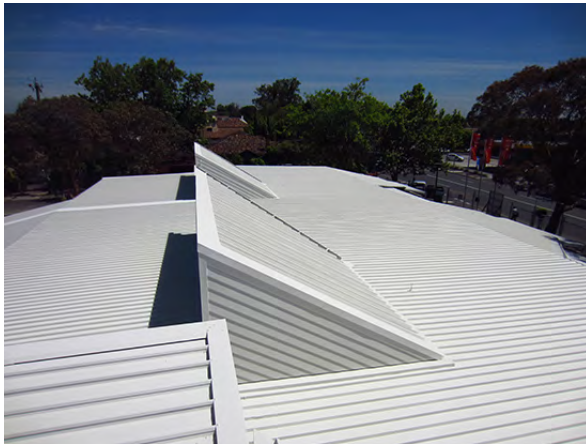
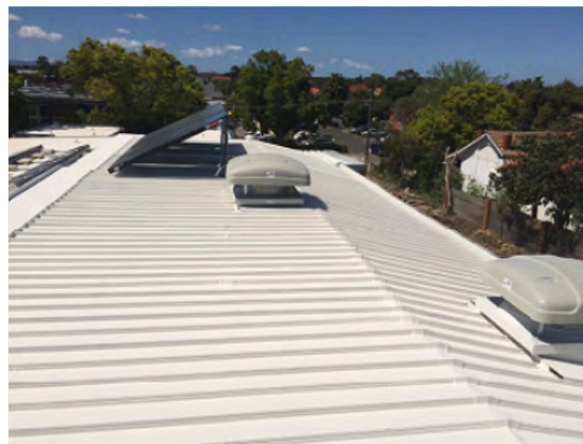
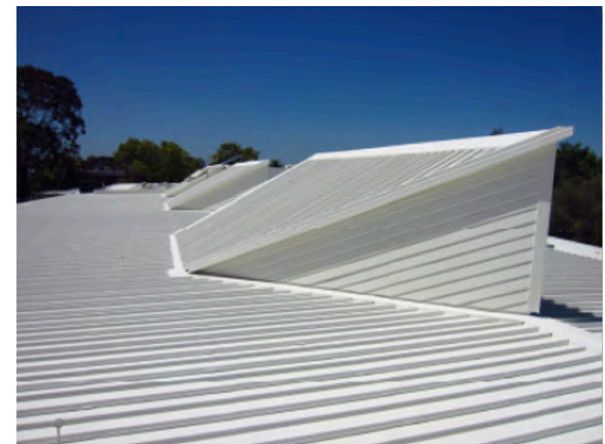
COMPLETED SHOTS:

Below are a series of either before or progress shots, followed by two completed photos:

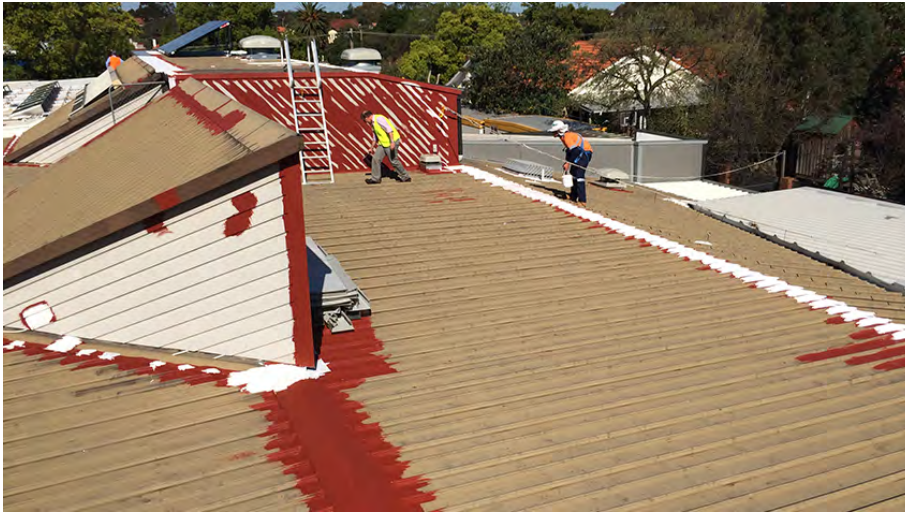
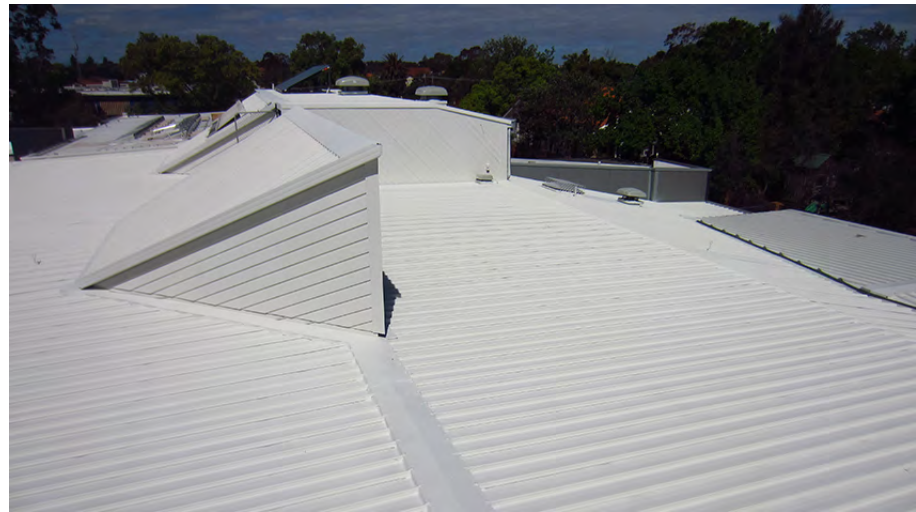
Finally one last progress example of the library roof - followed by the accompanying completed photo:
