Arndell Park, NSW  
Insulation Panel Waterproofing - Roof Protective Coating Works

### **Insulation panel waterproofing – Roof protective coating system**

**Project Site:** Americold

**Site address:** 21 Holbeche Road, Arndell Park NSW

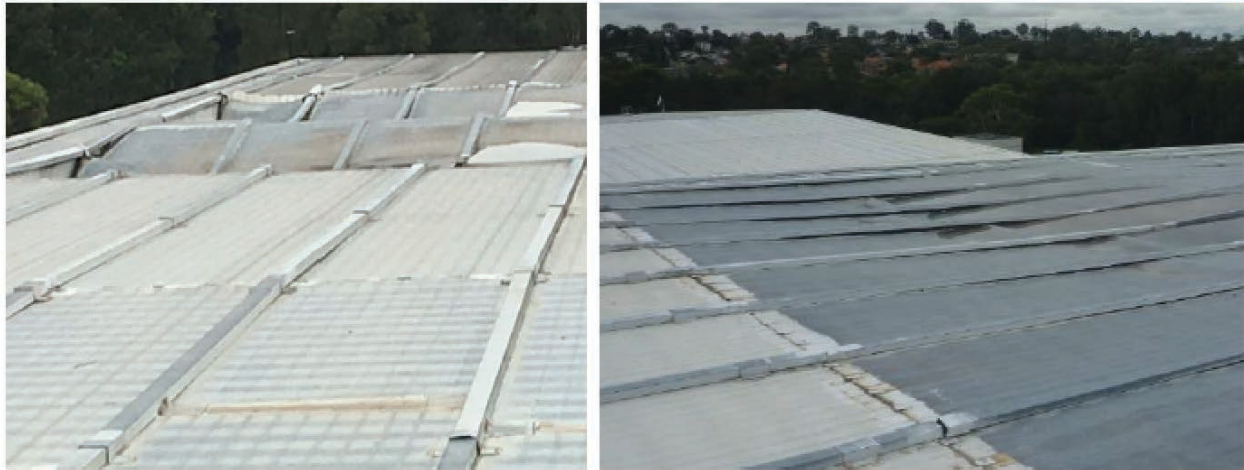
You can see from the below photos that the 20+ year old existing insulation panels were damaged, dangerous and in no way functional:

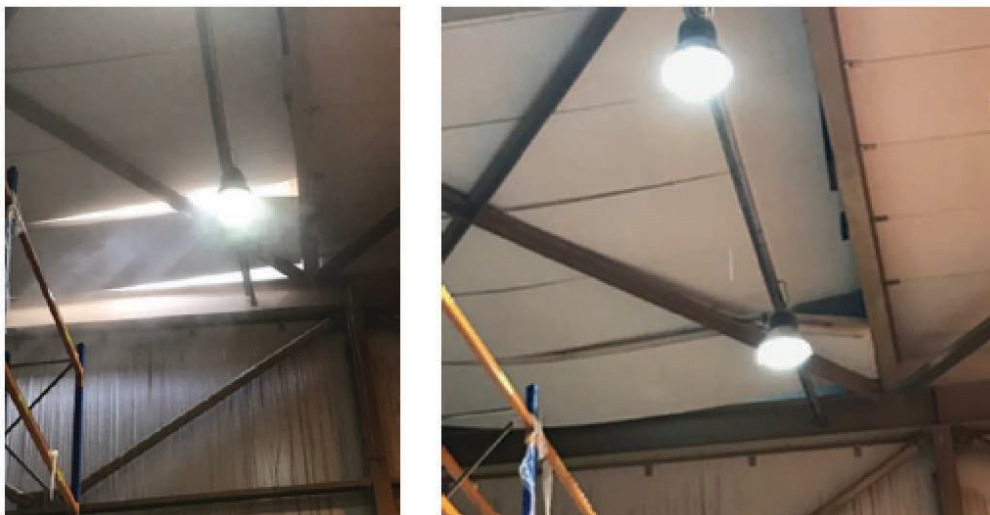
The panels had absorbed so much water the weight had become far too heavy for the roof structure below it, which had become unable to prevent the roof falling into the freezer itself:

The external thermal expansion over time lead to panel joins losing their waterproofing integrity and over time, the constant water ingress caused their ultimate demise.

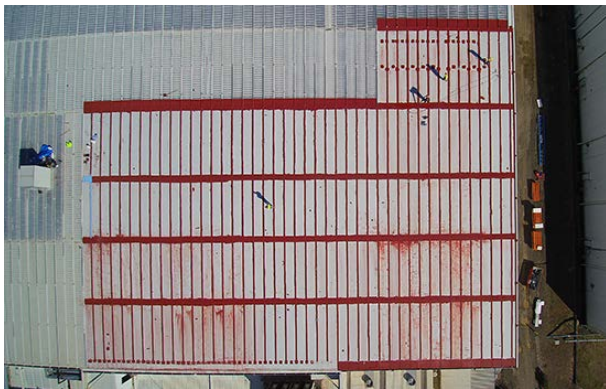
Butt joints (228LM) & mushroom heads bandaged:

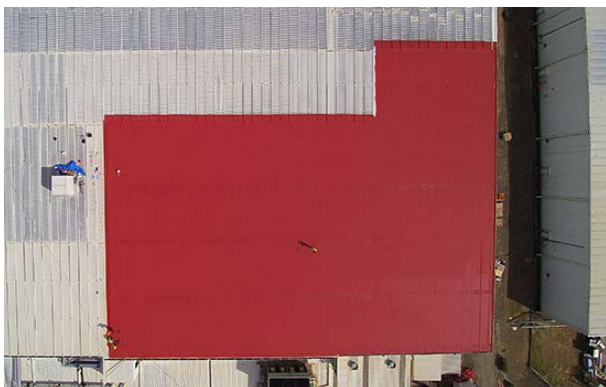
Etch primer :

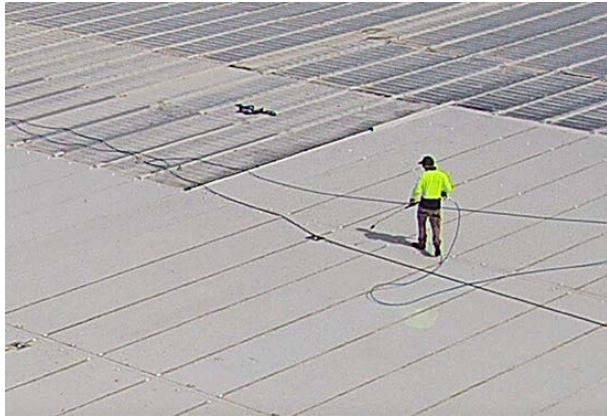
All surfaces cleaned under high pressure water prior to coating works:

A fairly self explanatory process, the power washing removed grime, dirt & as much as the excess silicone that had been trampled around the roof under guys feet.

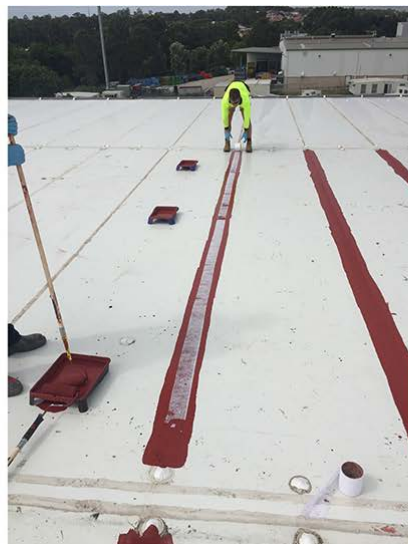
Laying bandage over join:

- Apply specialised etch primer (centred) along the **panel joins**.
- Lay 100mm polyester/fibreglass waterproofing bandage over wet primer
- Re-apply etch primer above bandage to wet & seal the waterproofing bandage

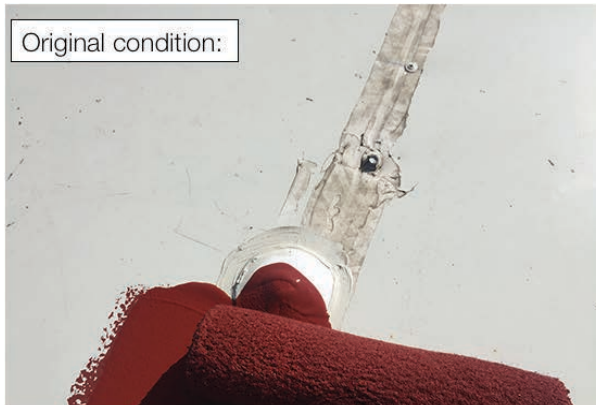
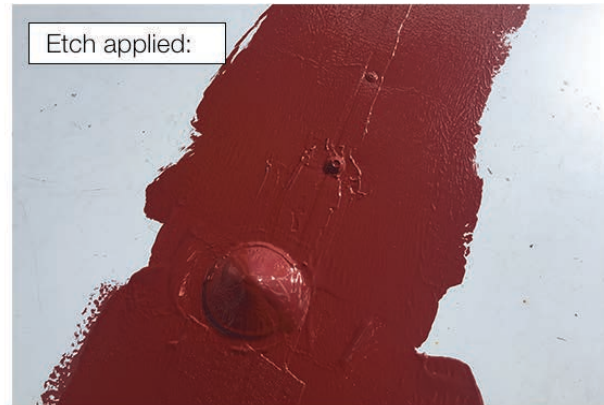
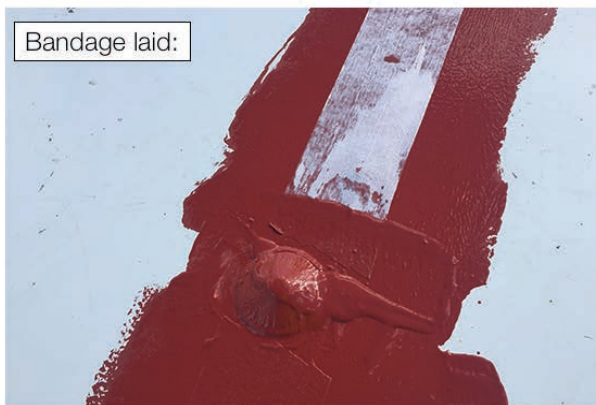
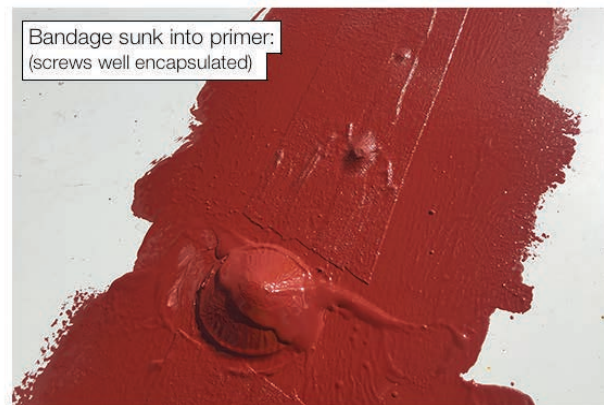
This process was repeated along all joins, totally 1,530LM.

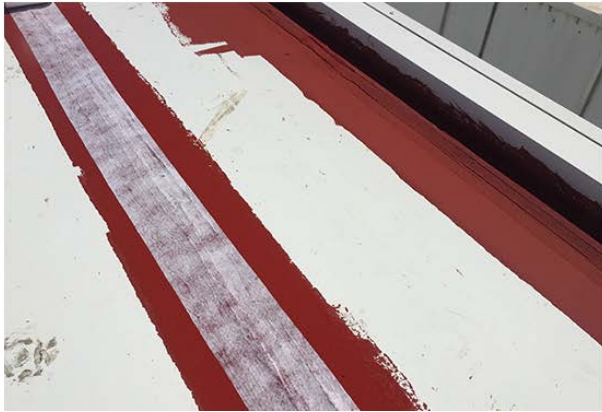
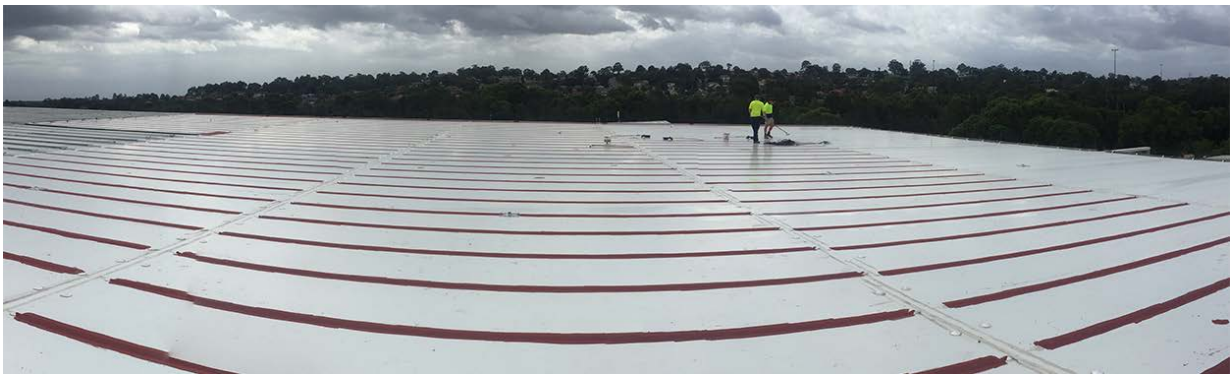
Waterproof bandage applied over panel joins & include side capping:

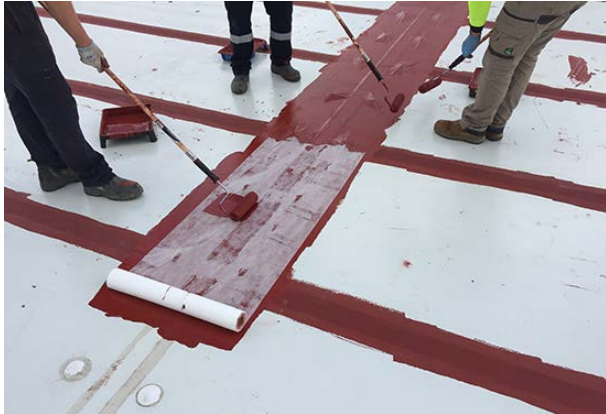
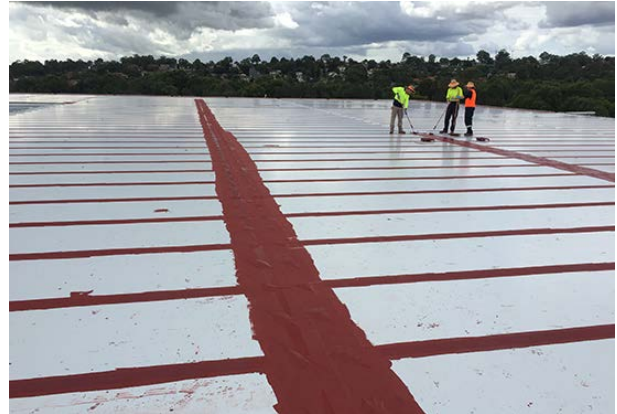
The butt joints (the run perpendicular to the panel joins) we then sealed beneath the waterproofing bandage & primer combination.

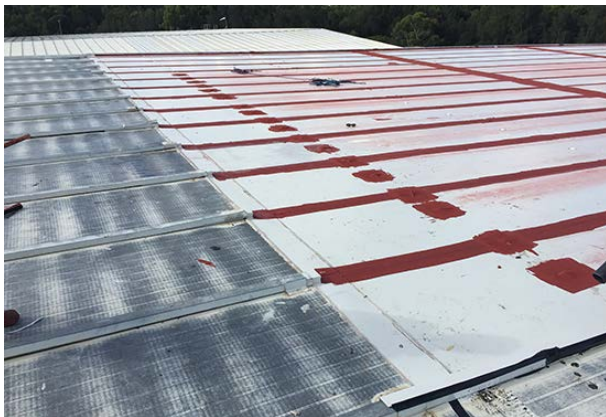
Wider angle new/old roof join:

The new roof to old roof join particularly problematic in that there was/is a lack of fall over the joint. You can see from the closer in (below) image that there is large water pooling & an extremely thick coverage of silicone.

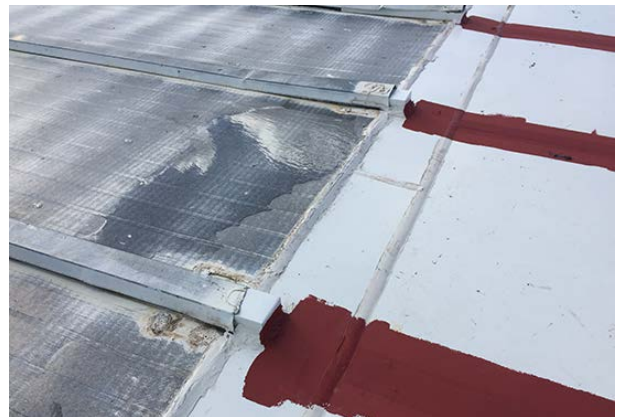
Water pooling – upslope in fall:

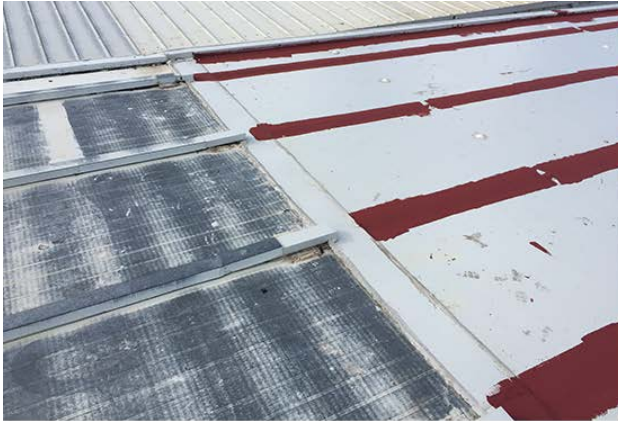
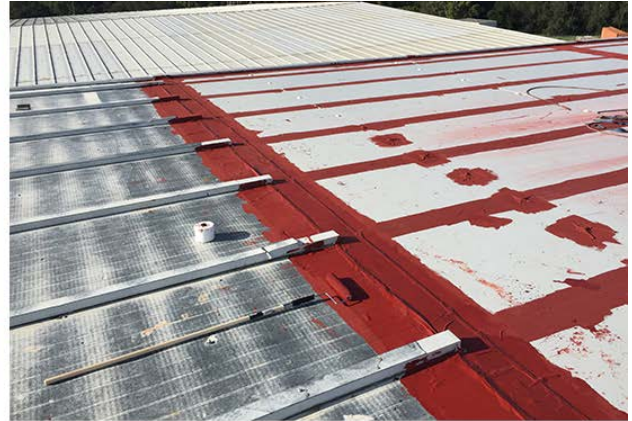
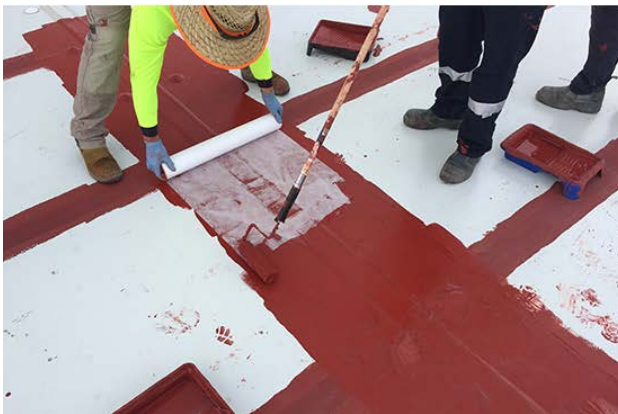
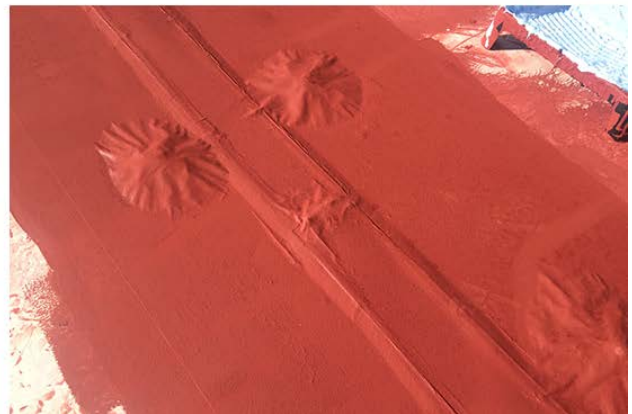
More examples of butt joints & 'mushroom head' bandage coverage:

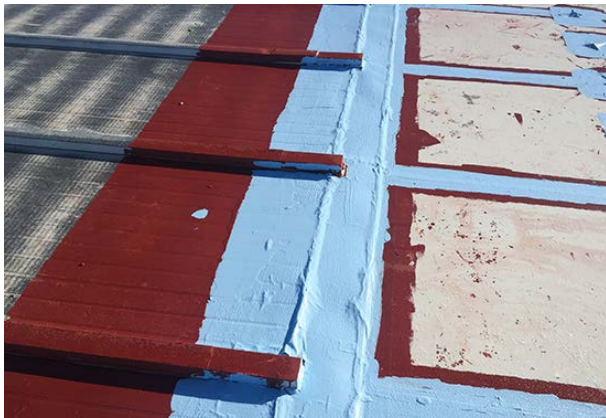
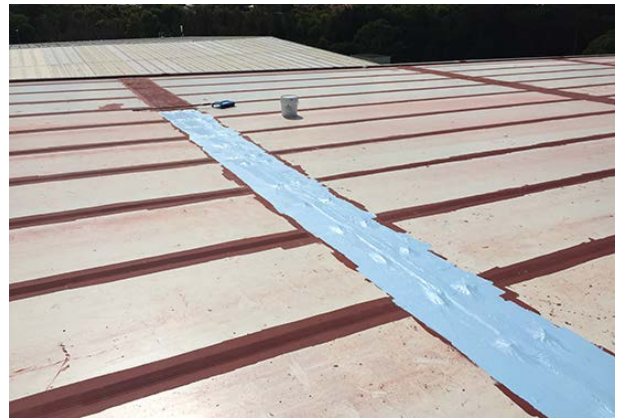
We applied a product designed to hold water. A micro-fibre reinforced polyurethane membrane was applied to approximately 500micron over the bandaged areas (only).

Photos below show the vivid light blue of the waterproofing membrane:

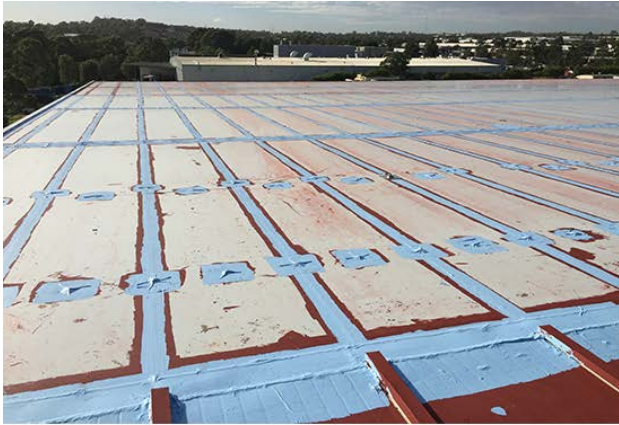
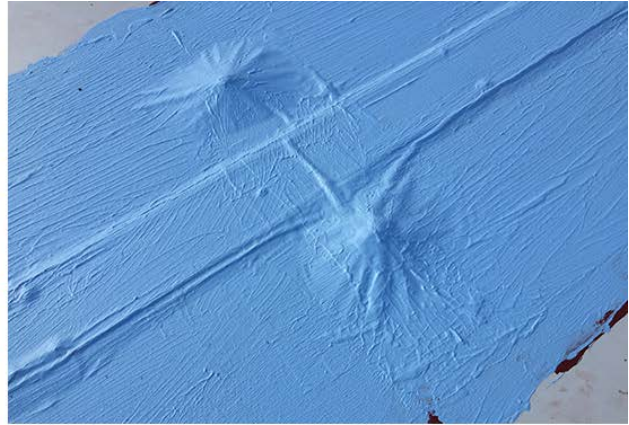
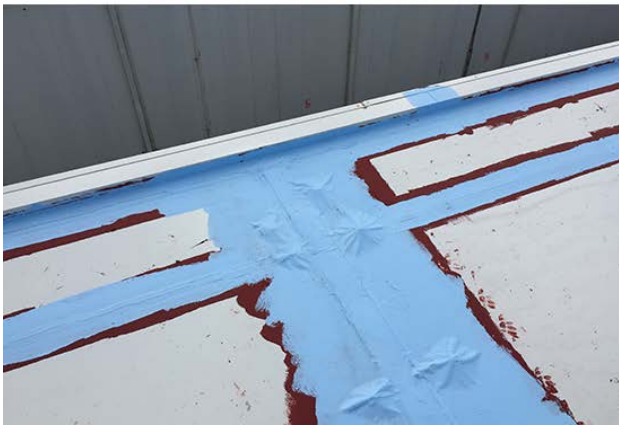
More examples of waterproofing membrane applied over all panel join, butt joints & all roof penetrations:

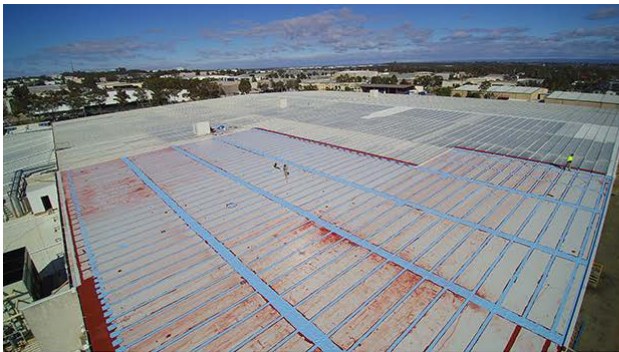
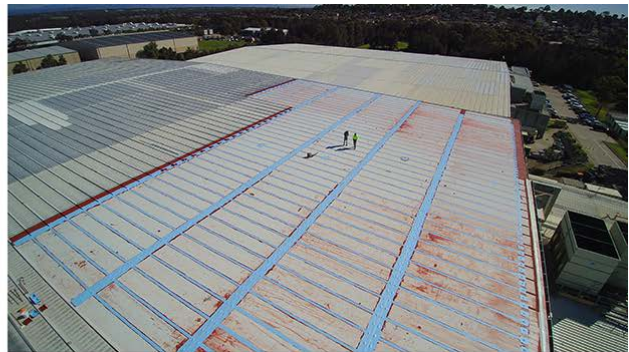
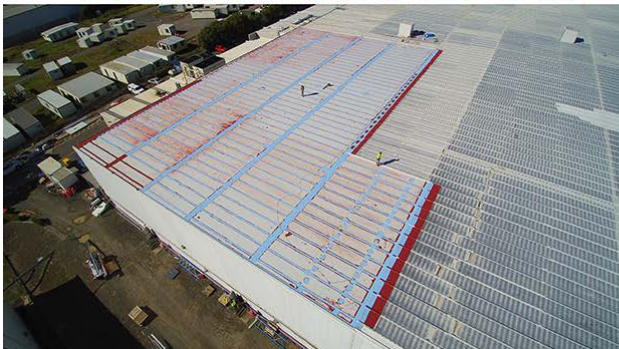
Aerial view:

Once the waterproof bandage had been laid over all area of possible water ingress (panel joints, butt joints & any penetrations) – a dedicated waterproofing membrane was applied.

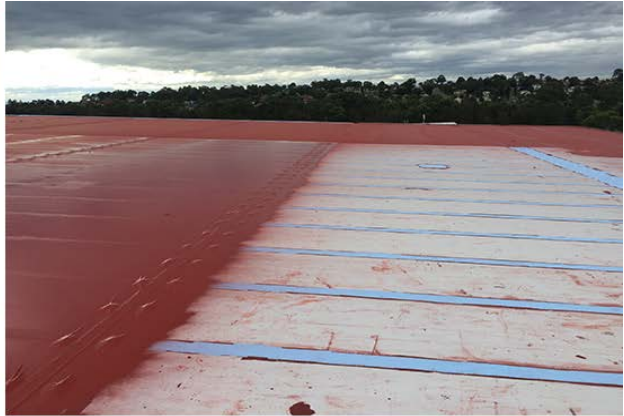
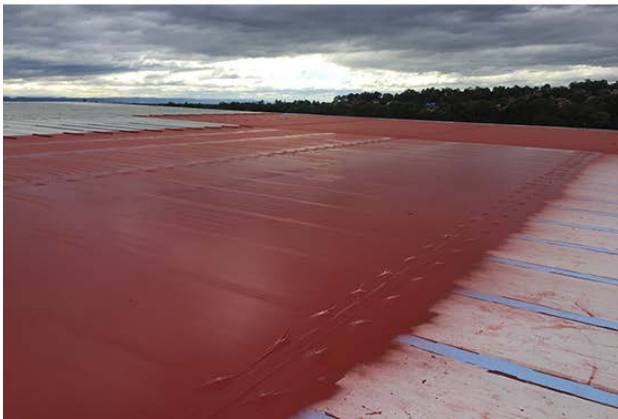
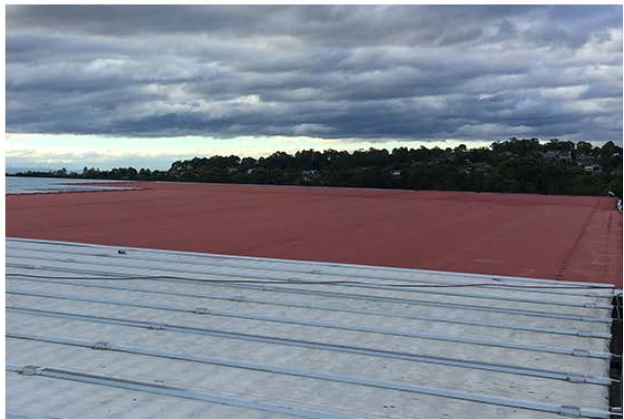
Etch primer is then applied over all areas prior to the ceramic top coat.  
This particular etch primer ensures maximum adhesion to the colourbond polymer coating.

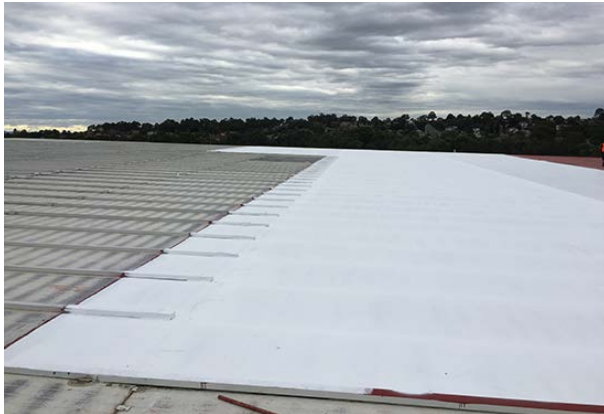
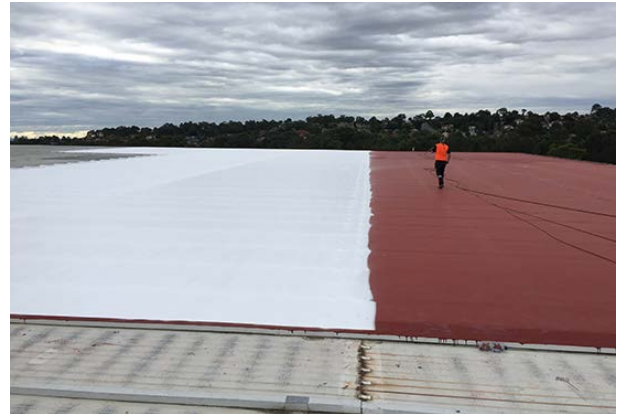
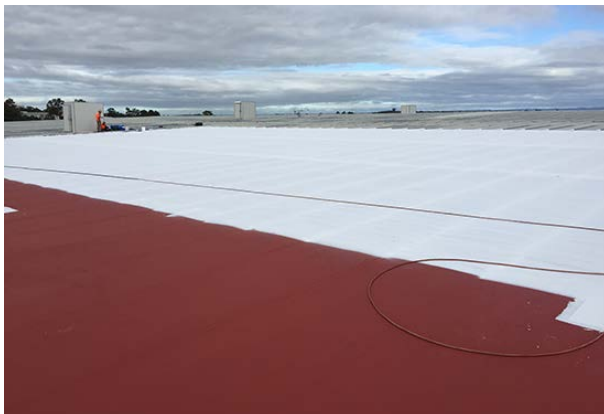
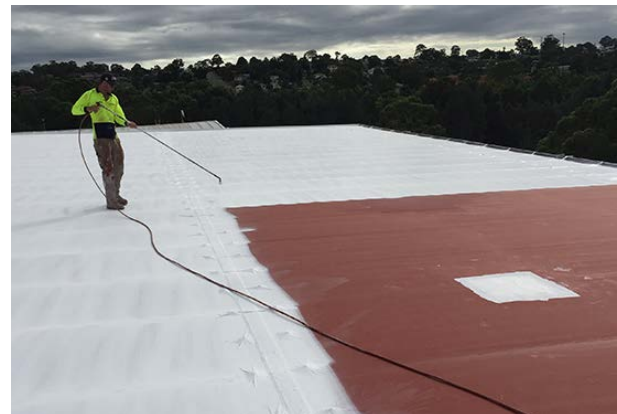
First coat photos:

Thermoshield thermal ceramic coating creates a thick, non-permeable membrane that acts to thermally insulate the roof sheeting & add another layer of waterproofing protection.

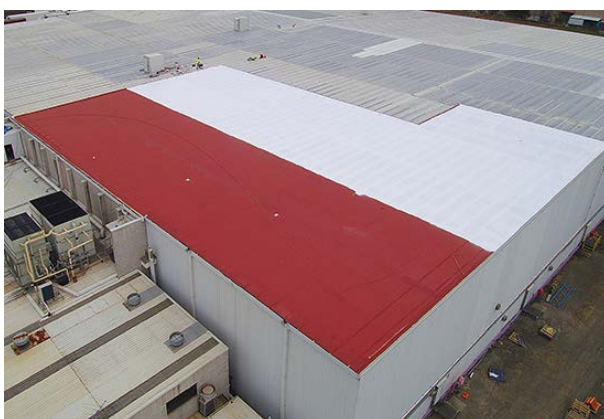
Aerial progress (half way) photos:

Waterproofing installations have the ability to fail due to thermal expansion over & along roof joints. By eliminating the extreme peaks in surface temperatures the thermal expansion is near eliminated. This ensures the waterproofing measures have the ability to remain intact.

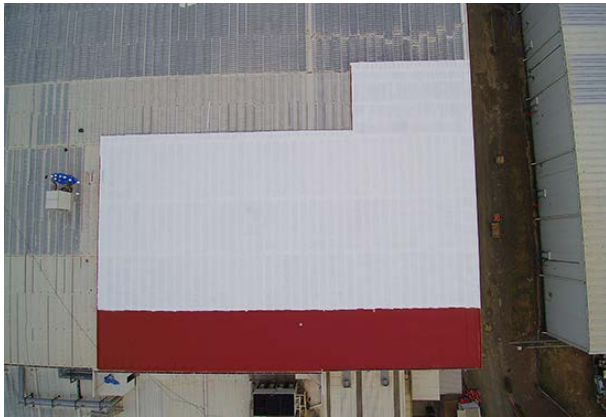
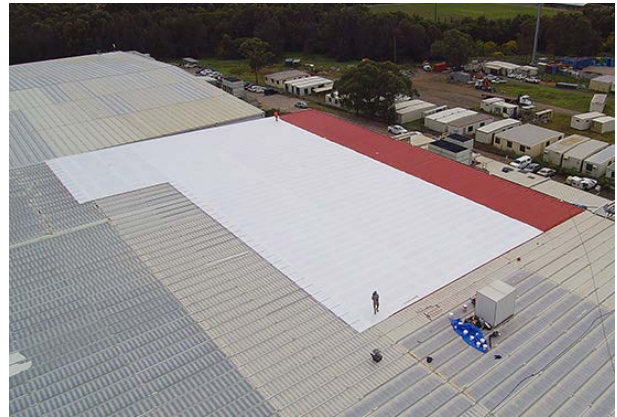
Aerial progress (3/4) photos:

Above right, you can see the slight visual difference in the 1<sup>st</sup> and 2<sup>nd</sup> coats.

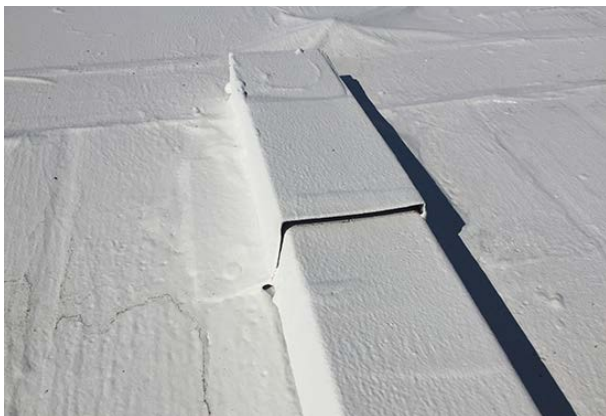
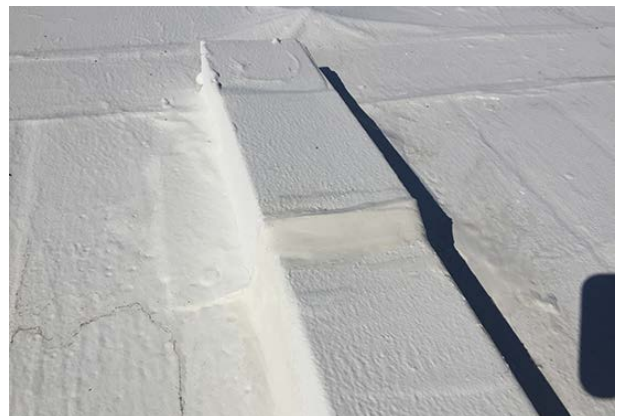
Below photos shows a before & after caulking touch ups. The below photo shows a loose fitting capping in which water could pool. You can see it was caulked & smoothed for water run off.

These were carried out on a needs basis, where required:

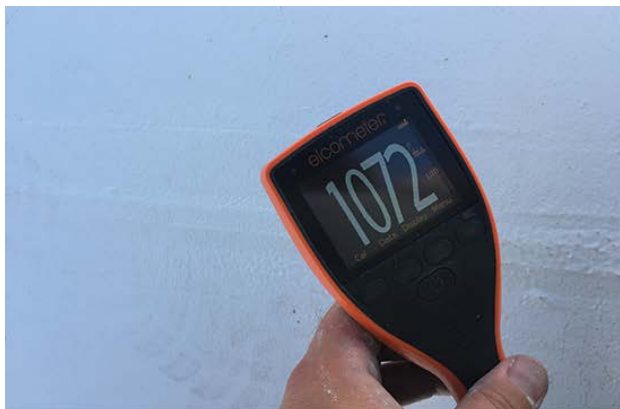
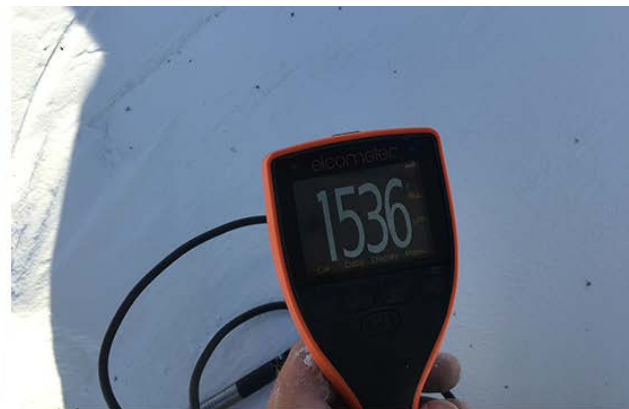
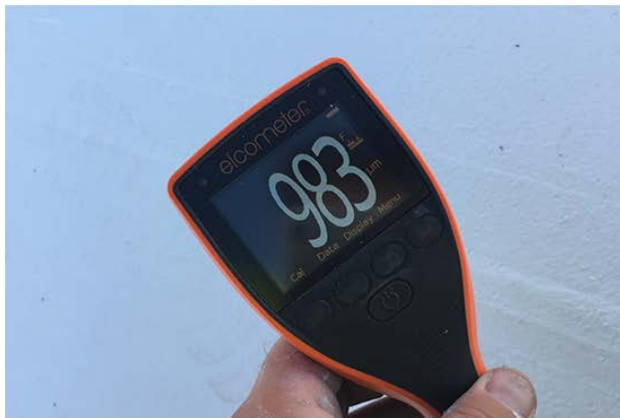
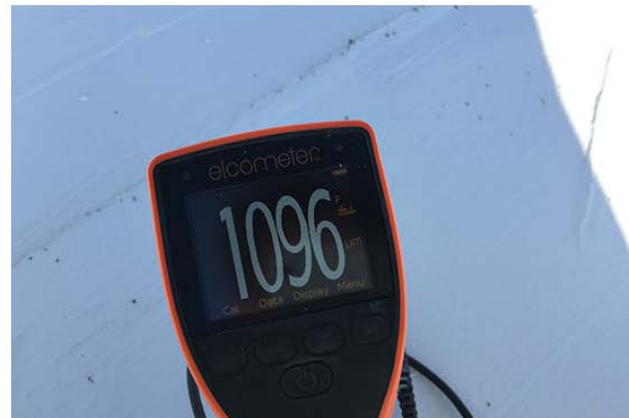
**Along joins** – etch primer& bandage 100micron /waterproof membrane 500micron / Thermoshield ceramic coating 350micron – **total thickness along joins 850micron**

**Panel joins | Butt joins | New/Old roof join – thickness testing achieved:**

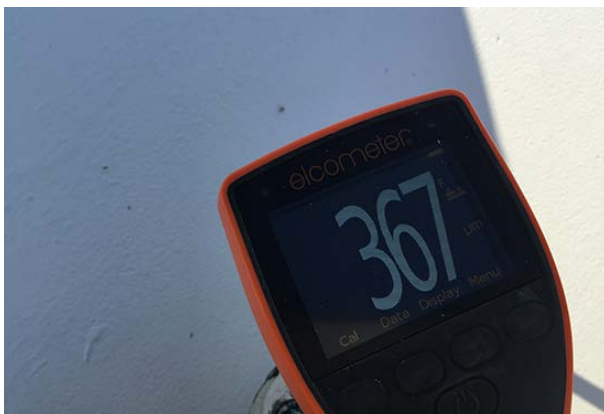
**Panels excluding joins** - Thermoshield ceramic coating 350micron minimum  
- **total thickness along roof panels 350micron**

**Roof panels excluding joins – achieved:**

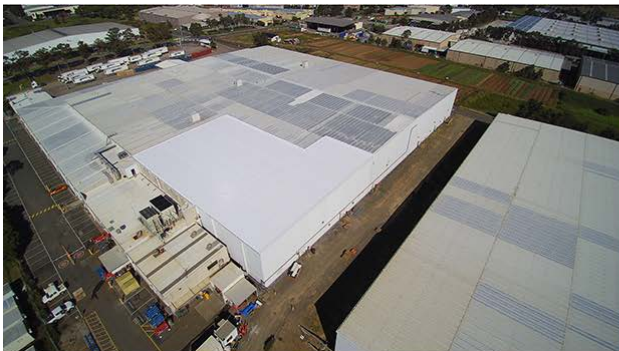
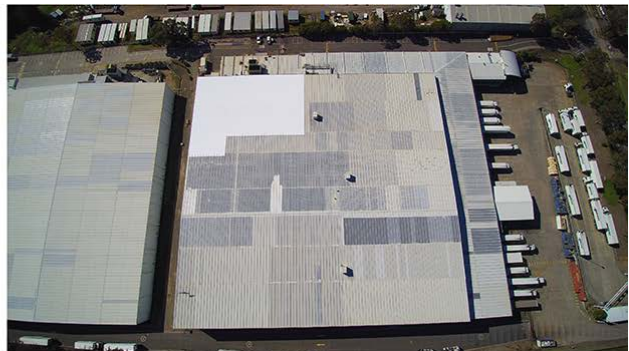
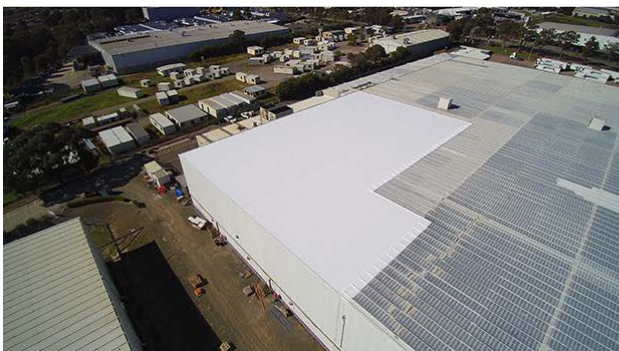
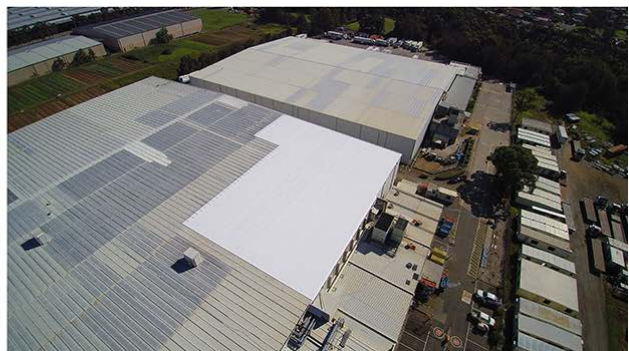
**Aerial completed photos:**

The very comprehensive waterproofing measures have been well sealed beneath a thick, ceramic thermal barrier. This will eliminate the ability for thermal expansion to apply force across the waterproofed joints.

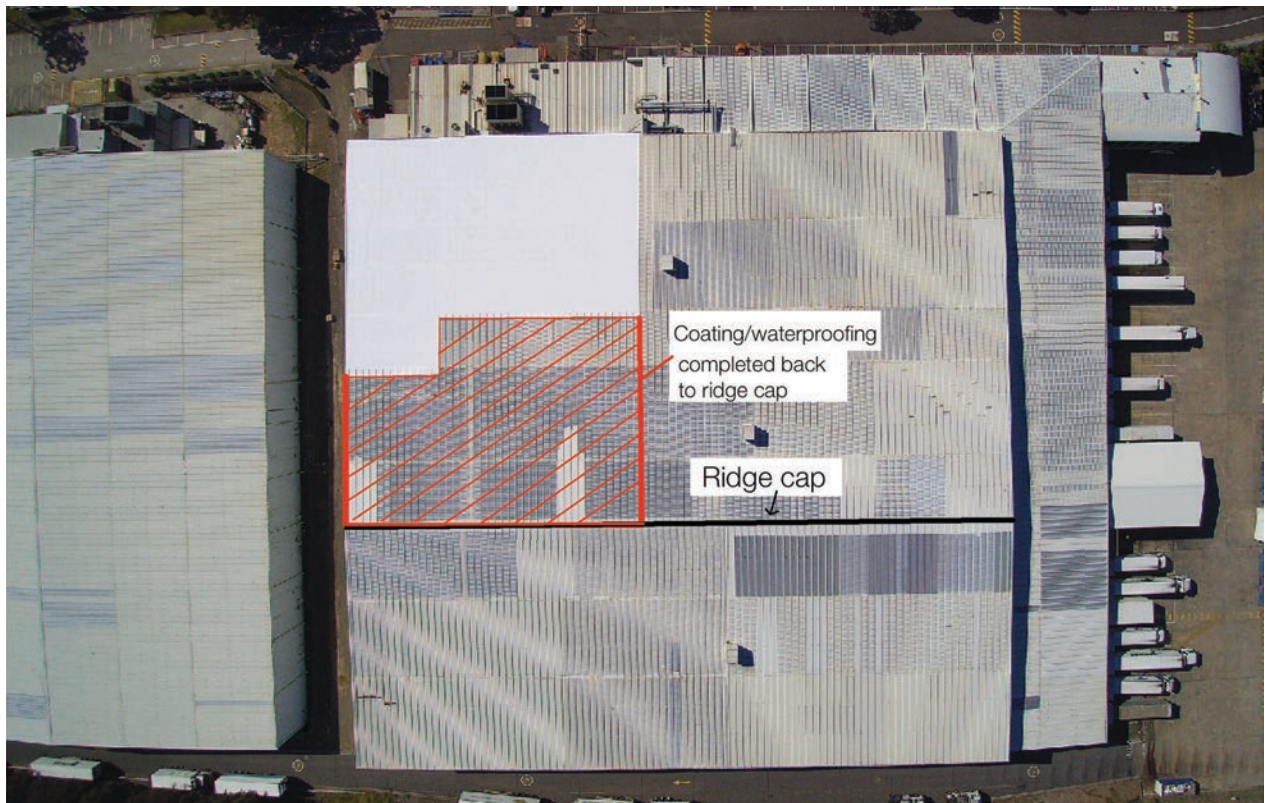
There appeared to be evidence of water ingress above the new roof, in the old/existing roof sections. Water could have the ability to enter & track down to the new roof section & potentially under the coating .

Ideally an extension of the waterproofing works all the way back to the ridge cap:

If this were completed, any leaks in this section could only be attributable to the coating system failure. If left as is, any leaks could be a result from a variety of factors but most likely due to the very highly prone leaking areas above the new roof.
