# THERMO SHIELD<sup>®</sup>

## Roof Restoration Future Proofing Building B

### **Rust Conversion | Insulation Coating | Asset Protection**

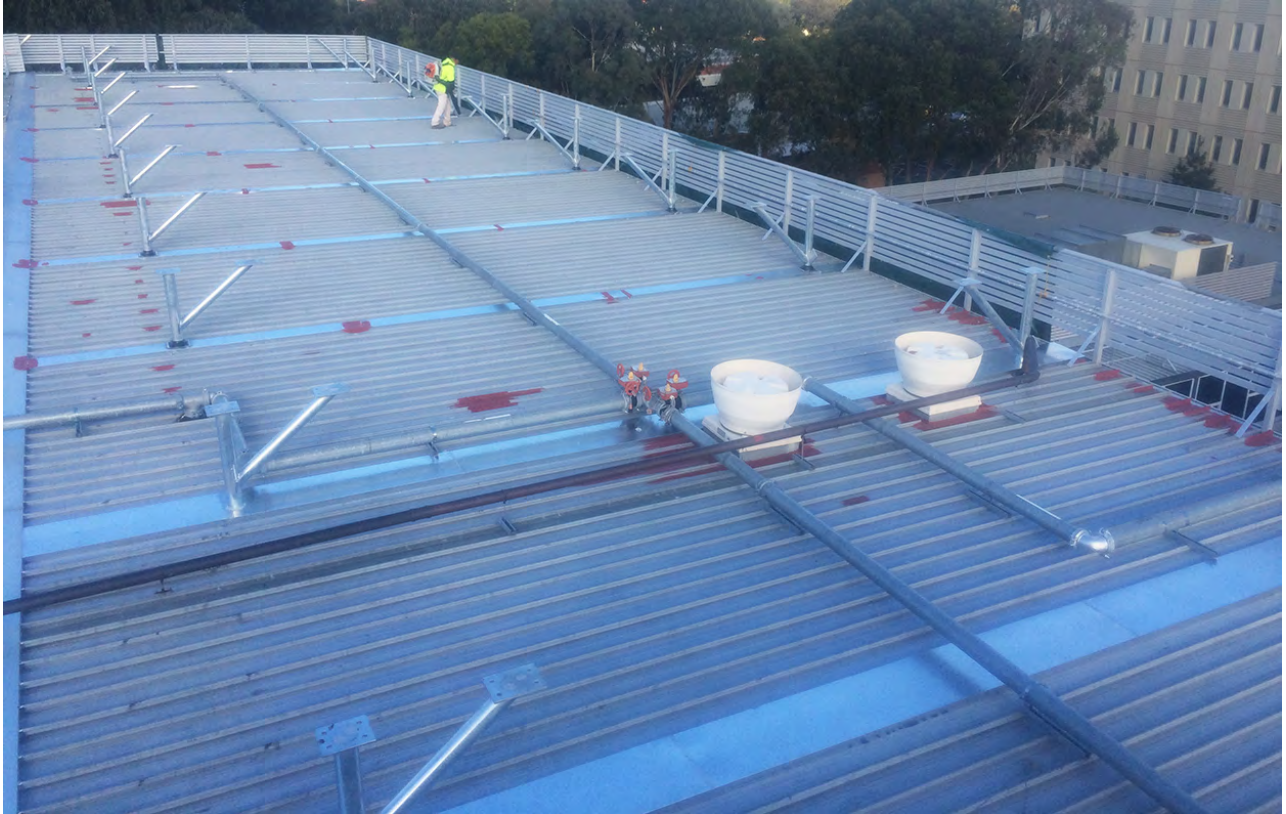
Following high pressure washing, tarps were applied to the perimeter fencing so that the coating could be covered overnight.

Final preparations prior to coating:

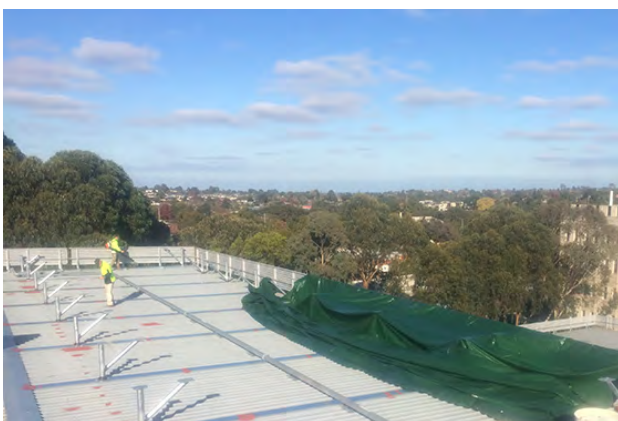
Securing tarps:

With coating works being completed in May, weather conditions were/are highly unpredictable during this time in Melbourne. Once 'touch dry' it was essential for the coating to be covered to ensure the product had every chance to cure through.

With overnights less than 10 degrees C, the covers so slightly aided heat retention for curing.

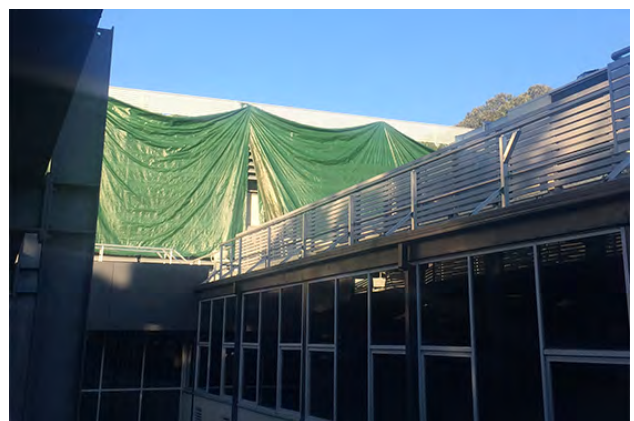
Tarps in place for easy application:

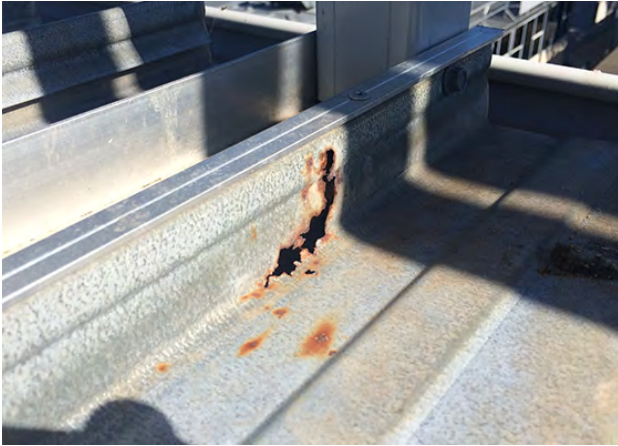
Near gutters, on sheet ends – there were areas of isolated corrosion that were resolved prior to the coating system. The below series of photos demonstrates the steps taken to repair the rust, waterproof the area while promoting free water flow:

Original condition:

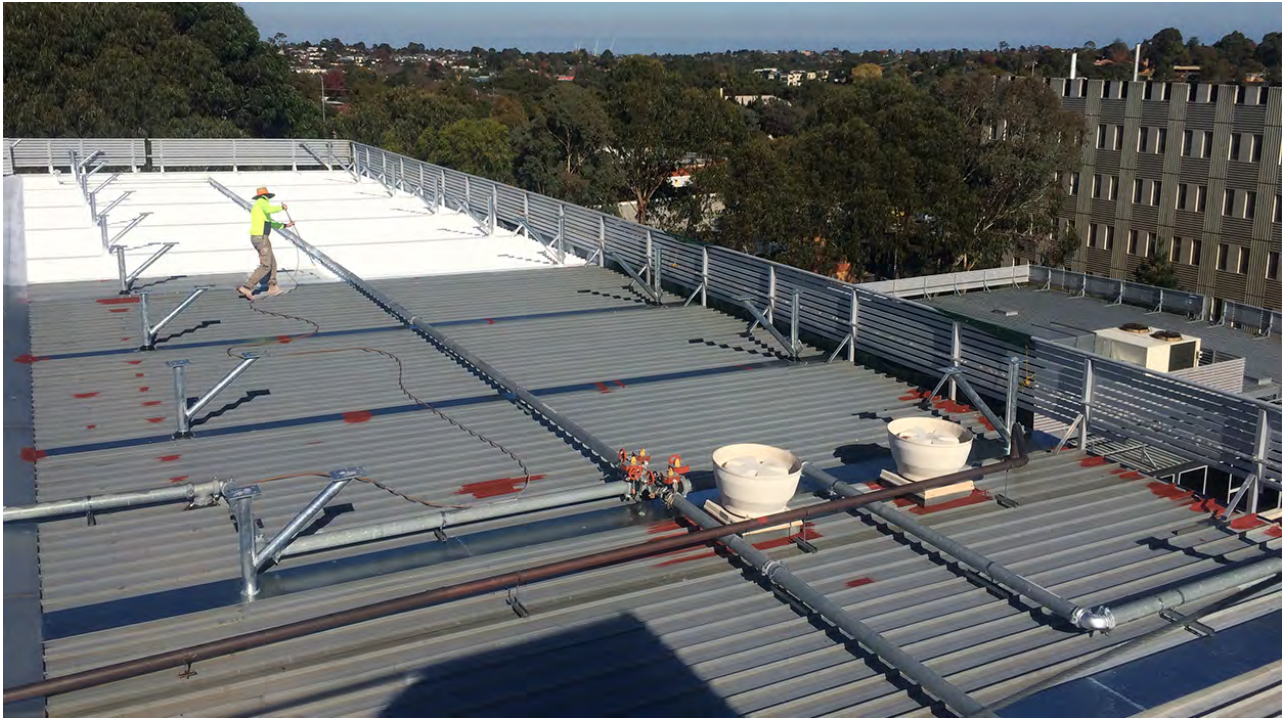
Below photo shows 1<sup>st</sup> coating commencing in [white] Thermoshield.

You can notice sheets appearing significantly darker than normal – this is due to the misting on of the etch primer. In addition, you will notice many red spots. We applied this over non-paintable silicone in the hope we could get maximum adhesion for the product. We had requested a specific silicone be applied, but unfortunately the message didn't trickle down.

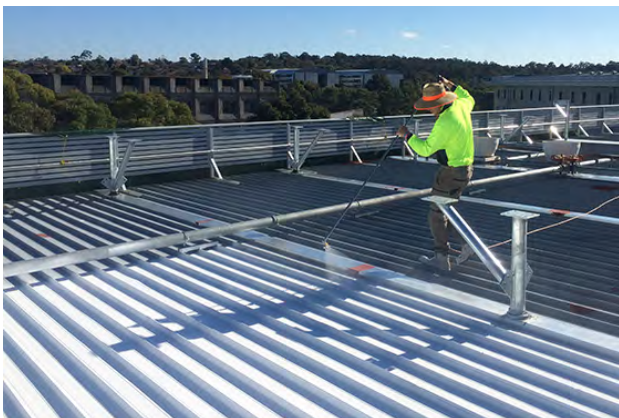
Below left photo, the tip is angled back at an approximate 45 degree angle in order to coat the reverse sheet profile. Below right photo, shows the tip in the forward position for front side.

Backhand pass:

This method ensures complete coverage and the sheet troughs receive [almost] double coating.

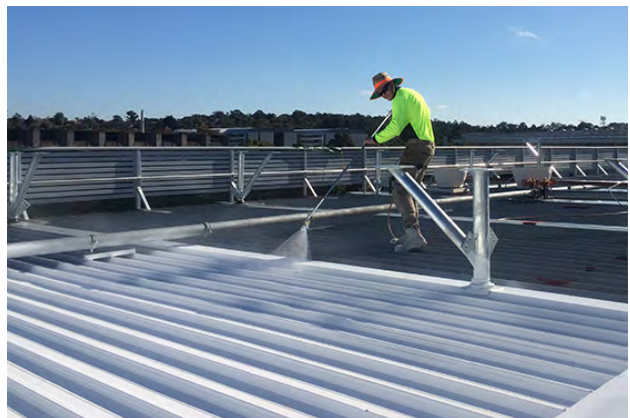
Forehand pass:

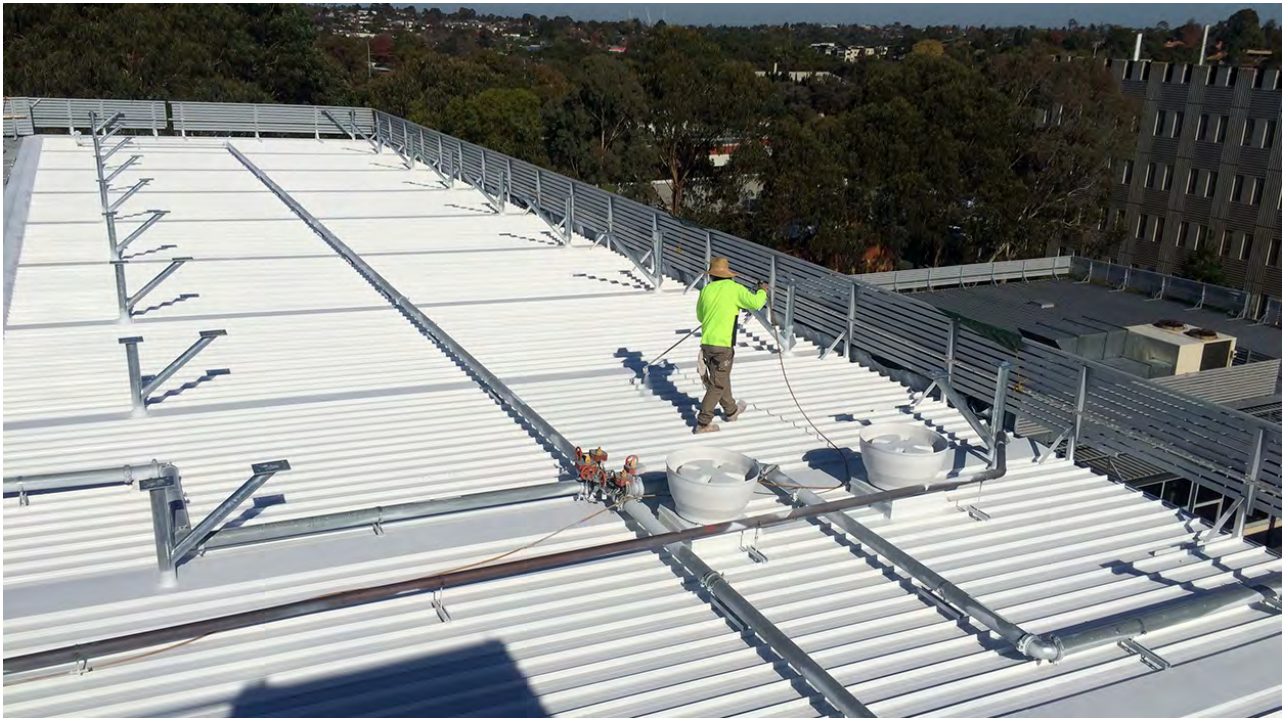
Below photos shows the 2<sup>nd</sup> coating being applied in [white] Thermoshield.

Just over half way, completing a backhand pass. White on white:

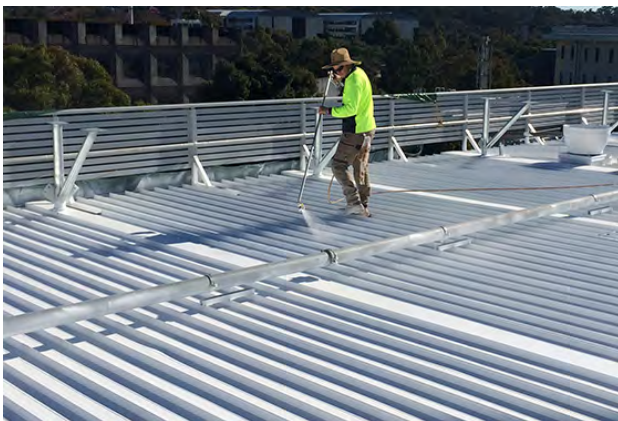
Backhand pass:

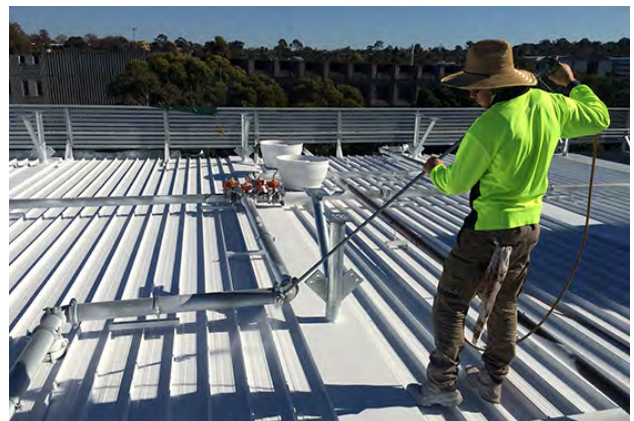
Forehand pass:

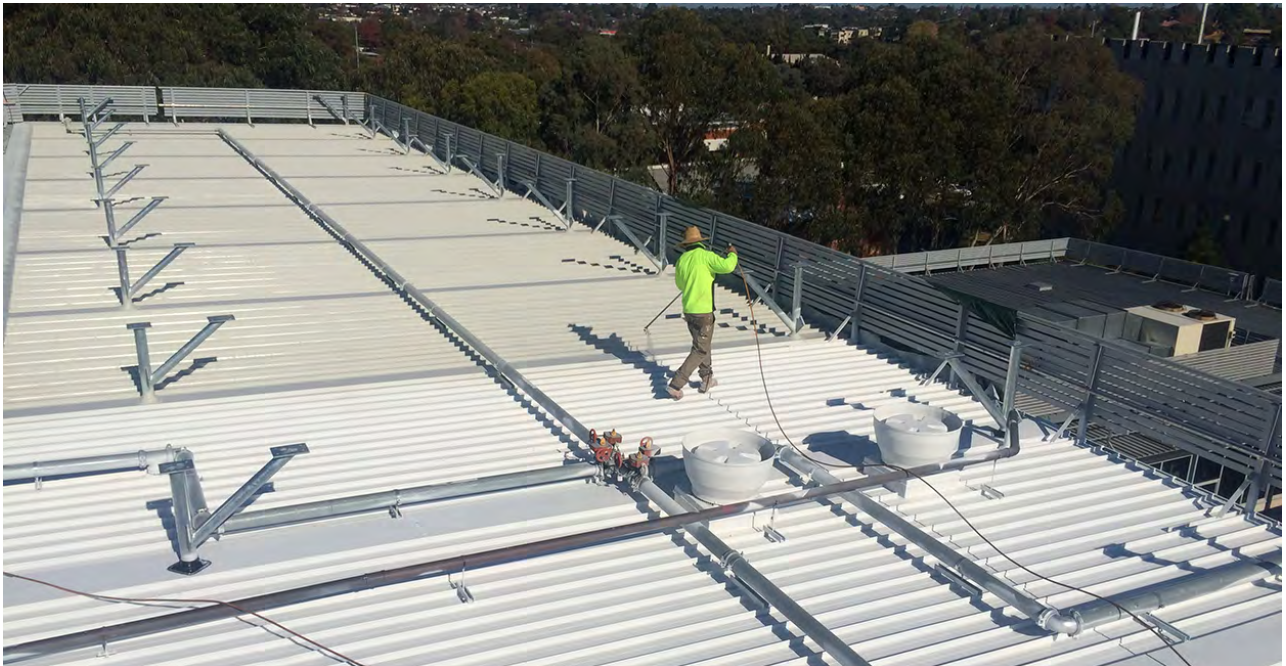
With heavy rain forecast, final two coats in 'shale grey' were applied then covers were applied and left for 3 days to ensure the last coats had the ability to cure through. Below progress photo shows a clear differentiation between the white coats & 'shale grey':

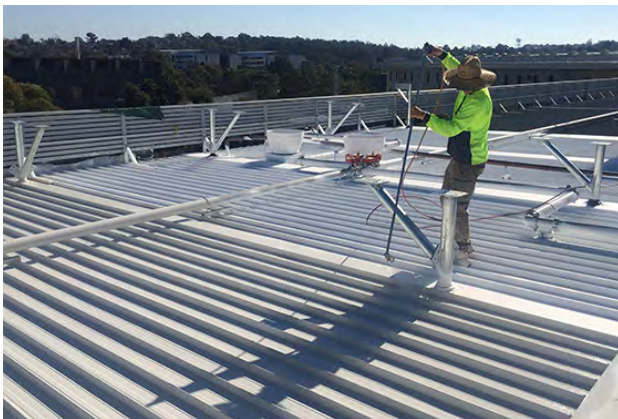
Backhand pass 'shale grey':

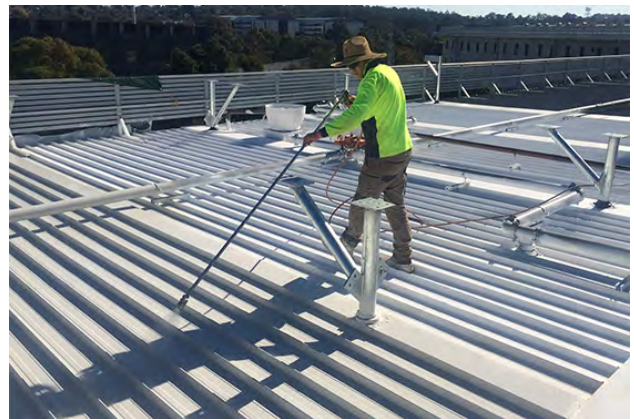
Forehand pass 'shale grey':

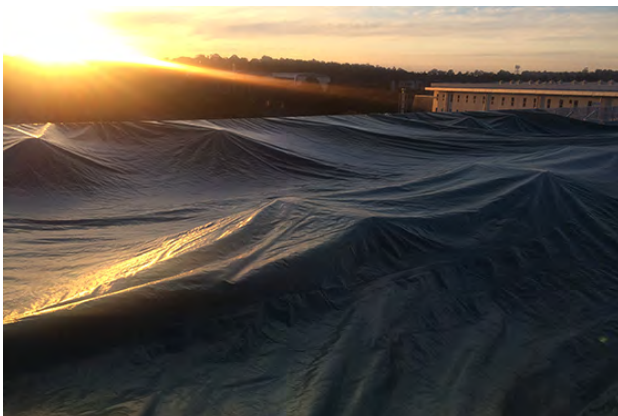
**\*\*Returned in the evening to apply covers, to protect from the 2+ days of rain to follow\*\***

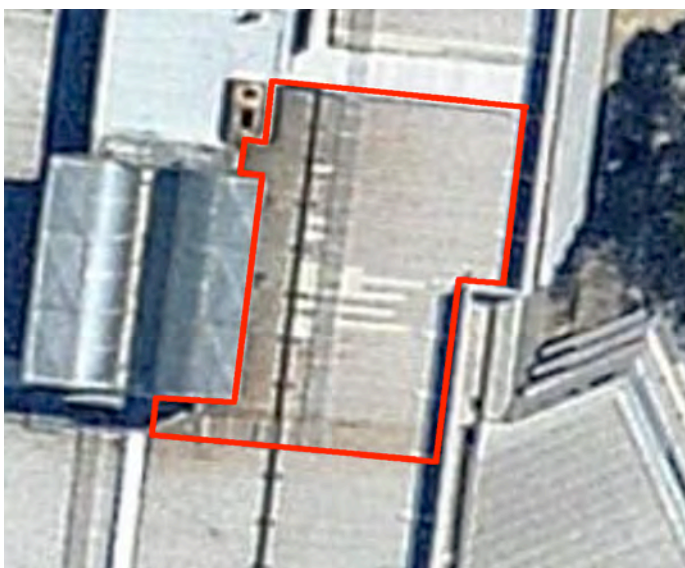
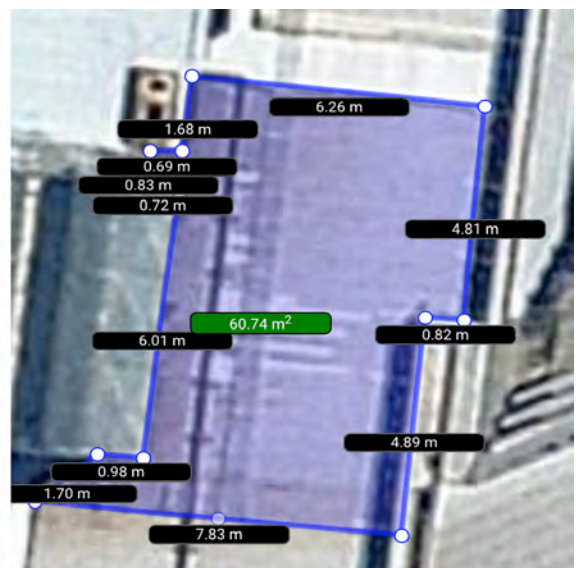
The below area despite small, widespread surface rusting had become highly visible & with the installation of a platform for HVAC equipment due to be located atop, the need to restore the area was crucial.

Closer up view of the area in question:

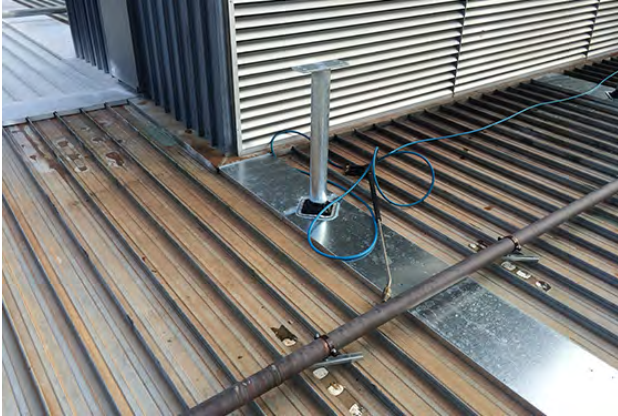
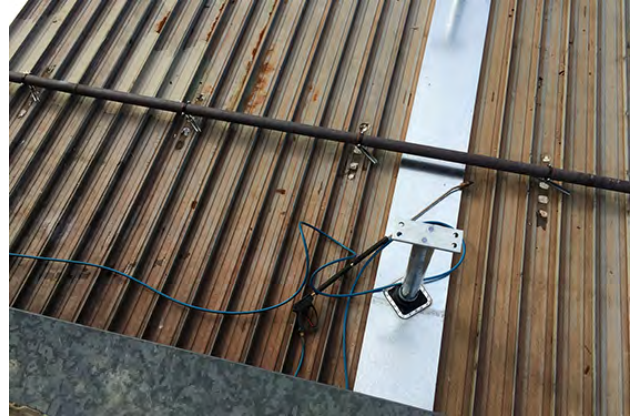
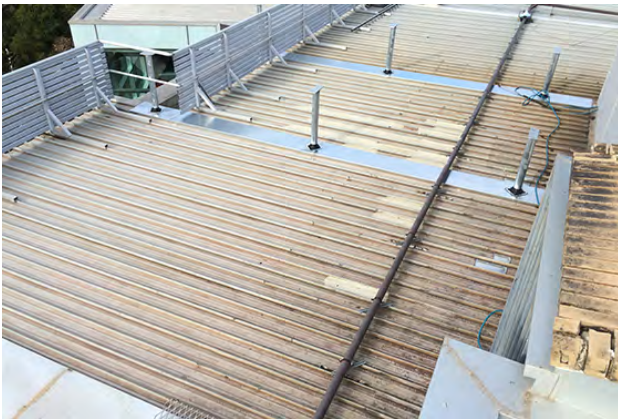
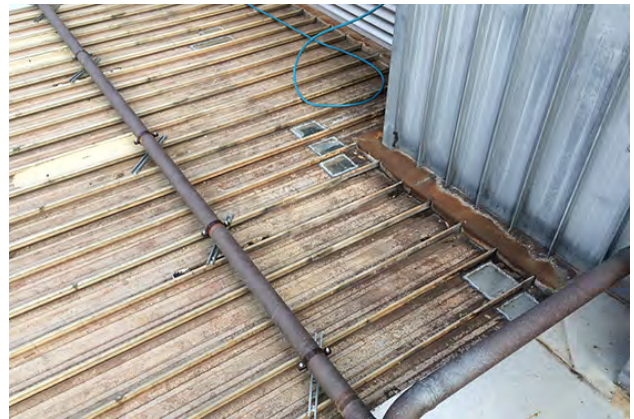
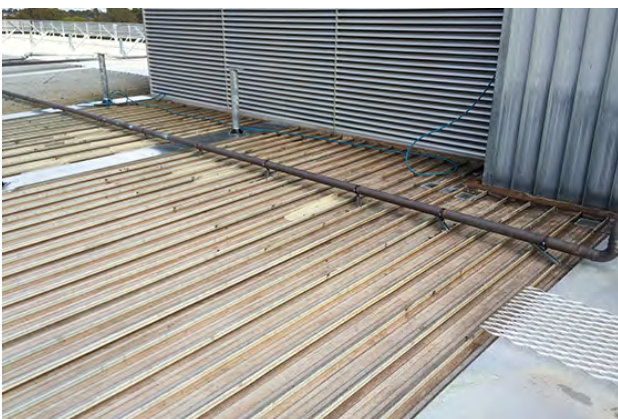
**Before:**

You can see rust bloom had become visually widespread.

The roof actually looked worse than it was due to staining, rather than full blown corrosion. Following power washing, the sheets revealed very mild surface rusting & in good condition.

If left untreated, I'd estimate the remaining lifespan could be as short as 5 years.

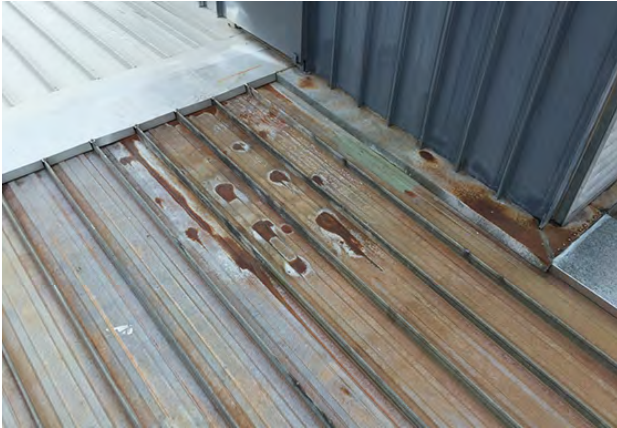
Original condition:

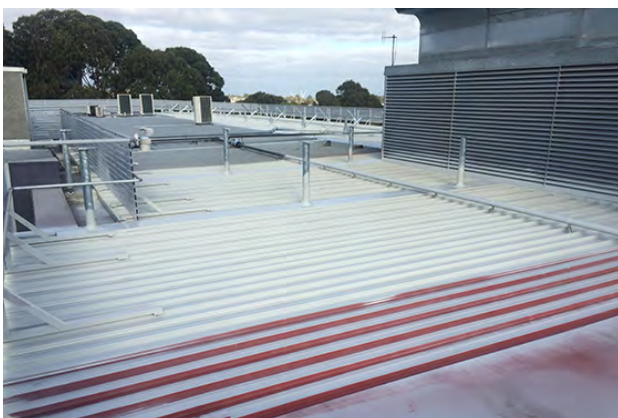
Nearing completion:

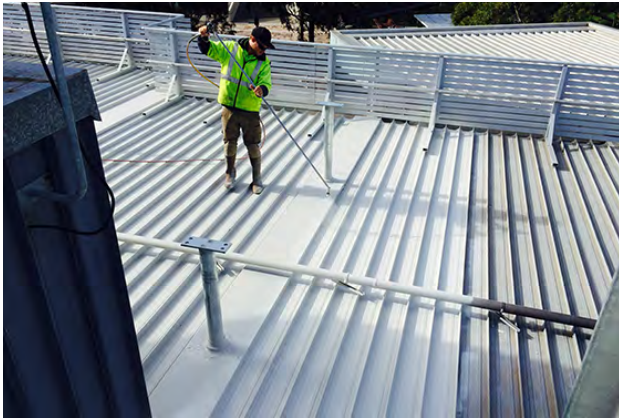
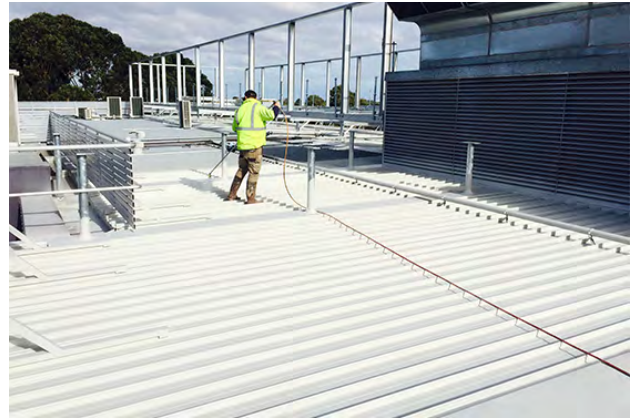
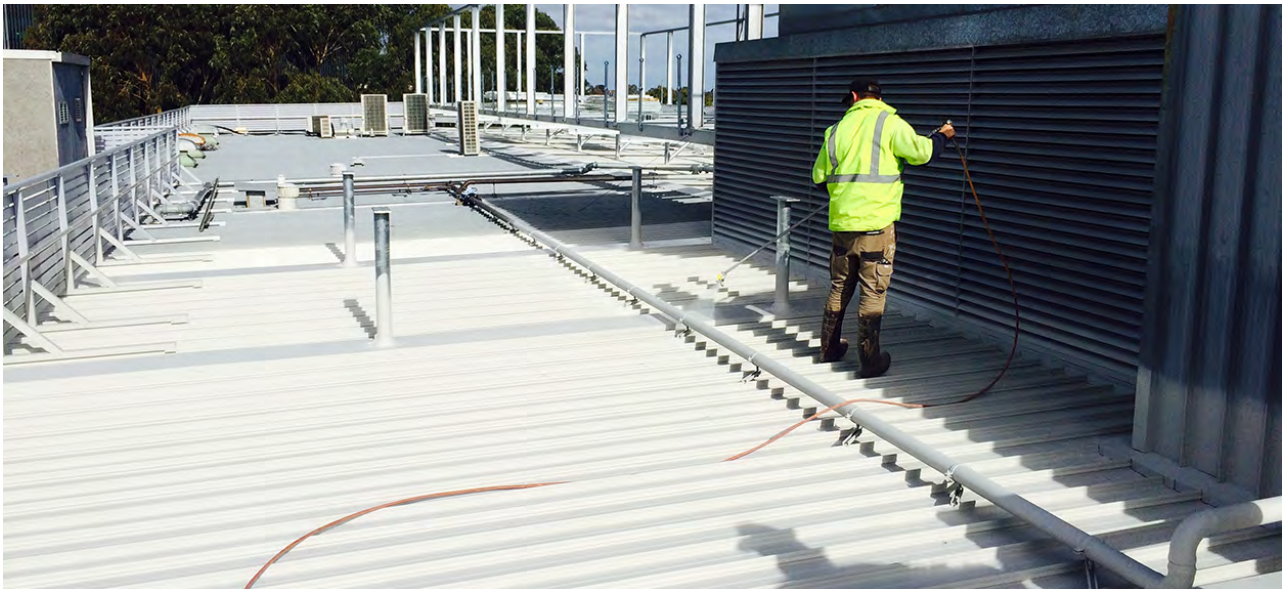
In total, following the rust conversion coating, 3 coats of Thermoshield were applied.

Below are photos of the final coat being applied:

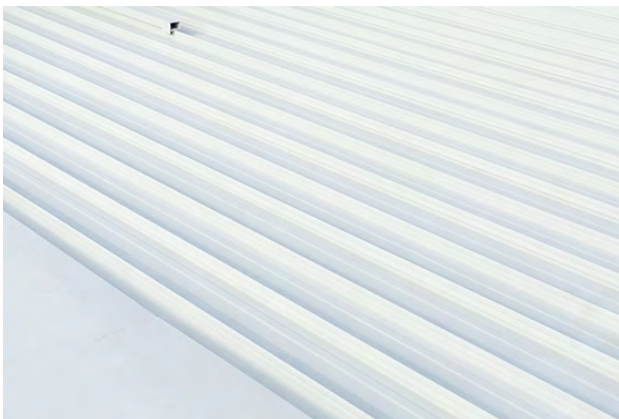
Sheets appear 'like new':

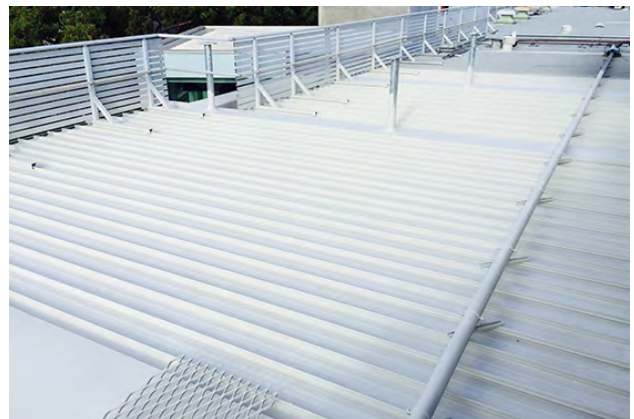
Even, thick coating applied:

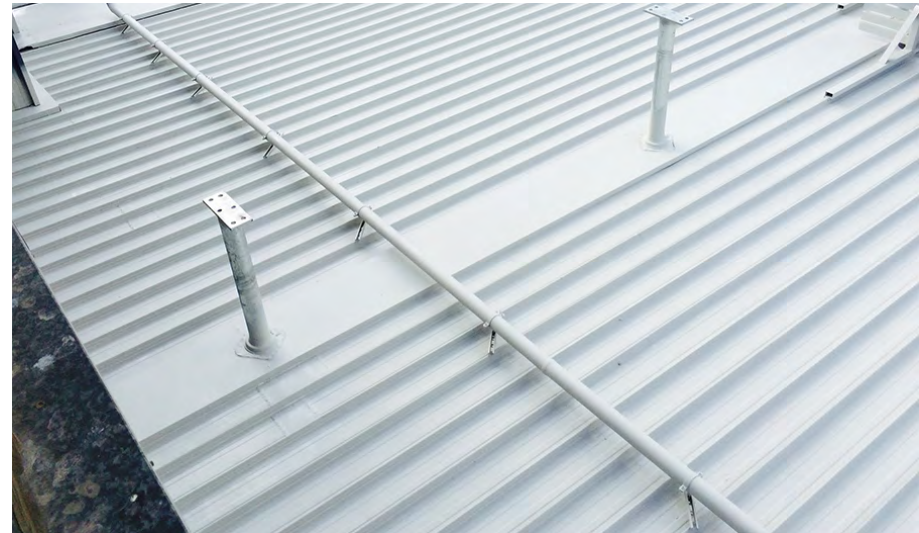
\* 'After' – completed coating system:

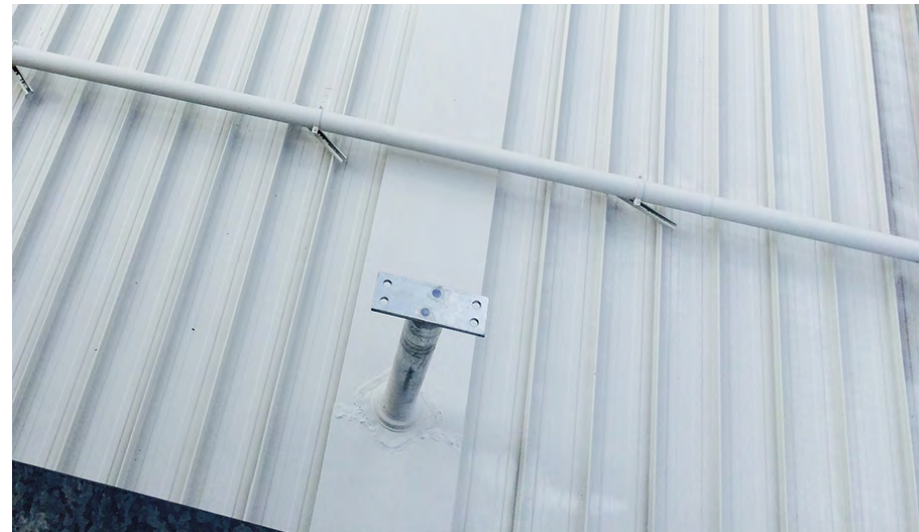
\* 'After' – completed coating system:

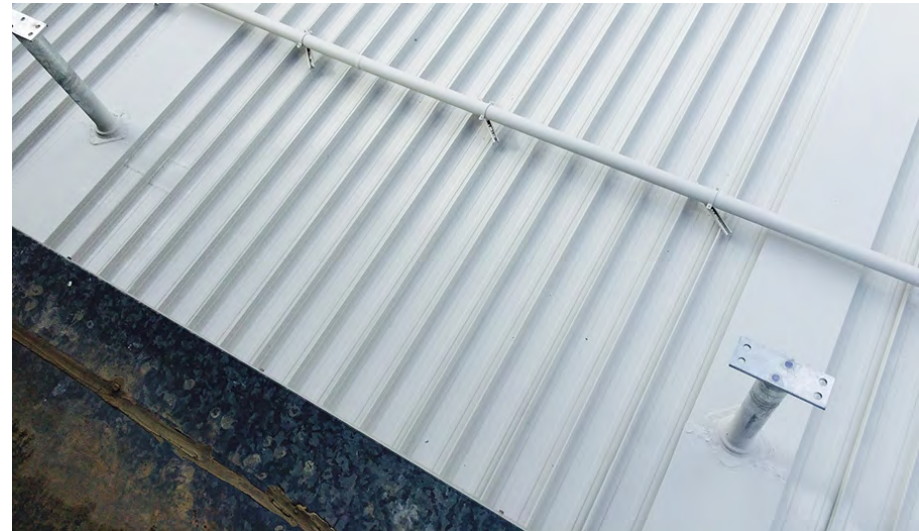
\* 'After' – completed coating system:
