#### **FUTURE PROOFING RESTORATION**

#### **Rust Conversion | Insulation Coating | Asset Protection**

Building M was in the midst of major construction works.

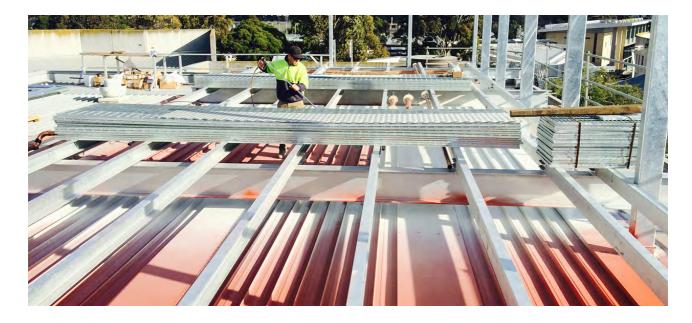
# Thermoshield over rust inhibitor etch primer:

In essence, if we are able to find no visual evidence of the vivid red etch priming coat, we can be confident of the coating has provided an un-interrupted 'protective blanket' for future proofing.

Following the high pressure washing of the roof sheets, a rust inhibitor etch primer was applied to the sheeting.

The etch primer is a vivid red, which makes it extremely clear to see areas coated in preparation for top coats:

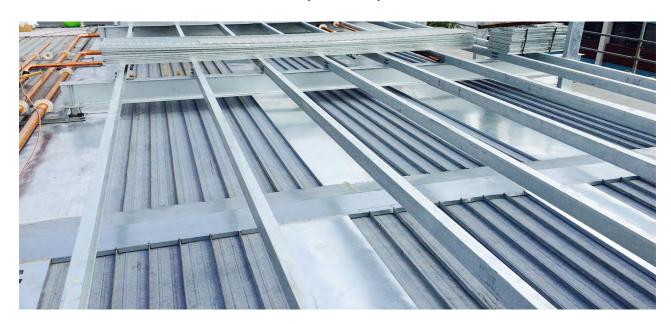
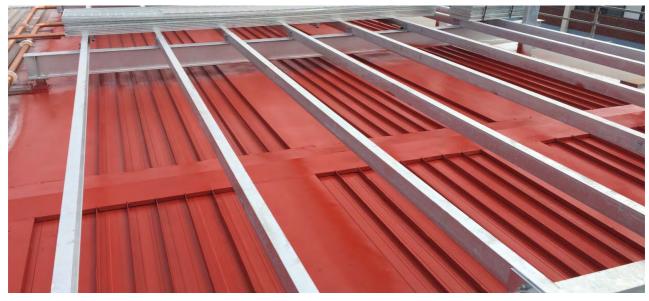
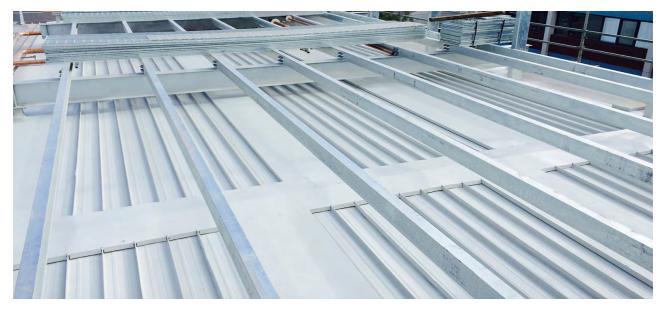
# BEFORE | DURING | AFTER

Part of the works involved installing a platform for a large air conditioning system to be installed on. The concern was that the ageing roof was beginning to show signs of deterioration such as rust bloom.

The vivid red primer coat makes a sound base for ensuring top coat(s) coverage is complete & comprehensive. If no red can be seen, it proves an unbroken protective 'blanket' has been achieved by the Thermoshield ceramic coating:

By applying [3 coats] of the Thermoshield ceramic coating, the underlying steel is starved of environmental exposure, which will significantly prolong the life of the roof.
