Municipal Pound | Insulation Coating

Heat Reduction | Comfort Improvement

Original site review:

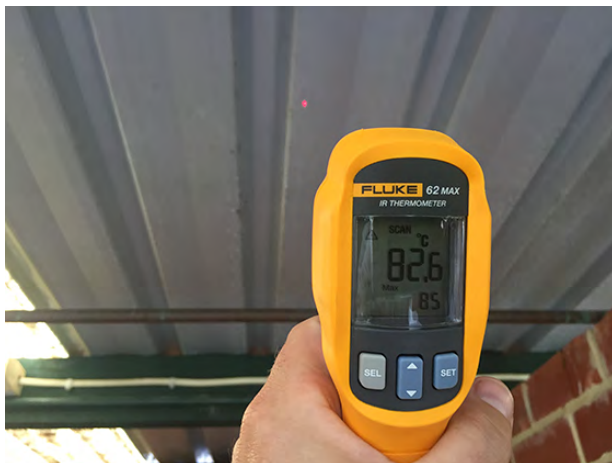
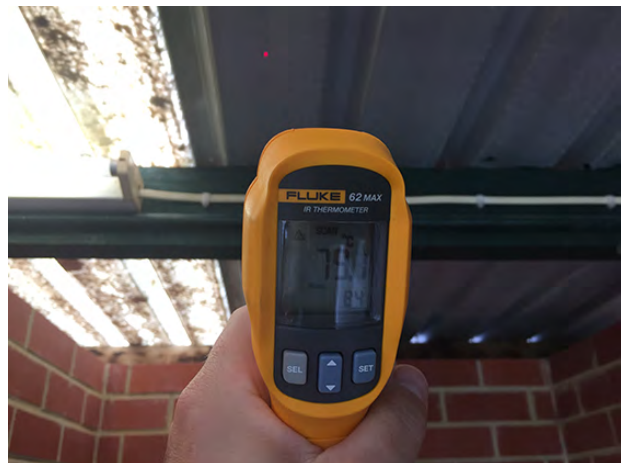
At the time of inspection, the under side of the sheets were extremely hot to touch & you could feel the radiant heat in the small individual brick kennels.

The temperature readings from the underside of the sheeting showed why it was hot to touch:

Underside temperatures ranged from **79C-85C** inside the various kennels (1:49pm).

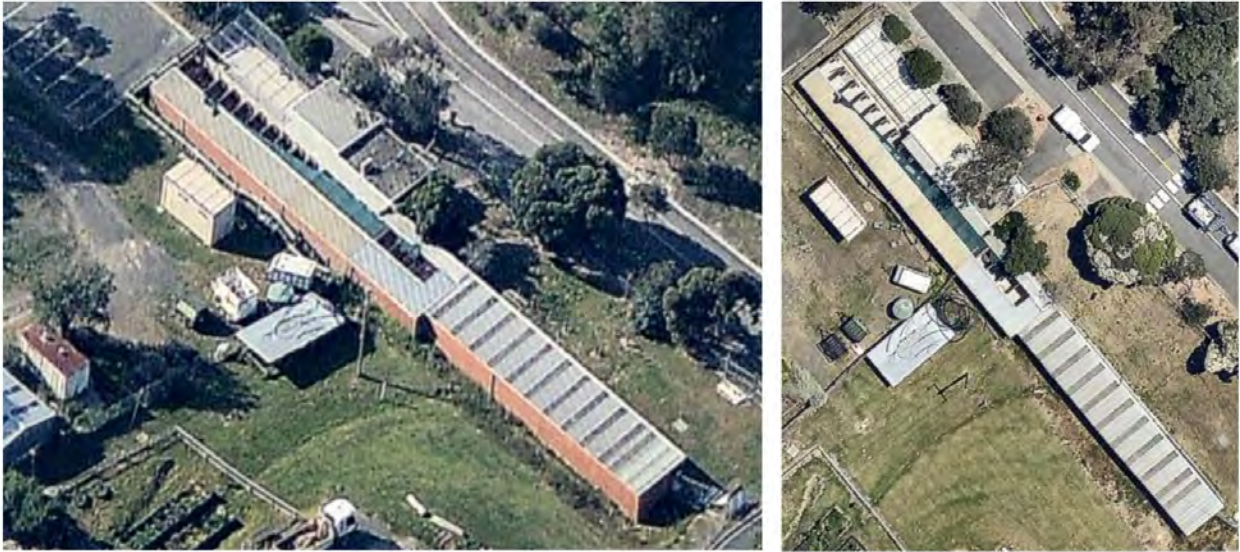
Below is an aerial view of the long, skinny line of kennels:

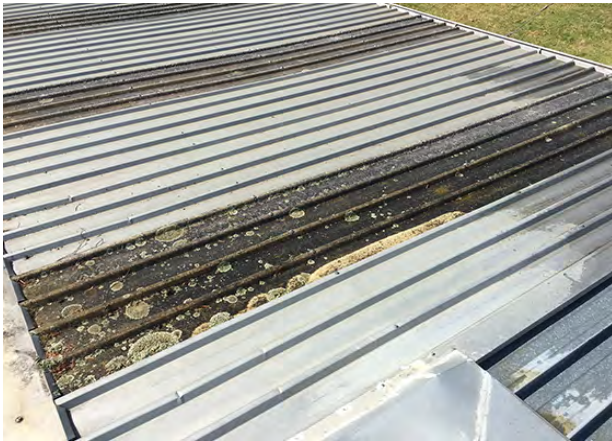
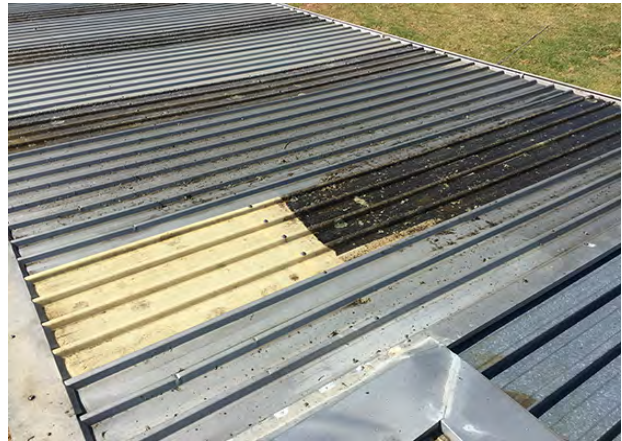
You can see below left is the original condition, next to it below right is partial completion of the cleaning process with demonstrates how dirty the roof had become:

Before cleaning:

Work commenced on pressure cleaning the roof.

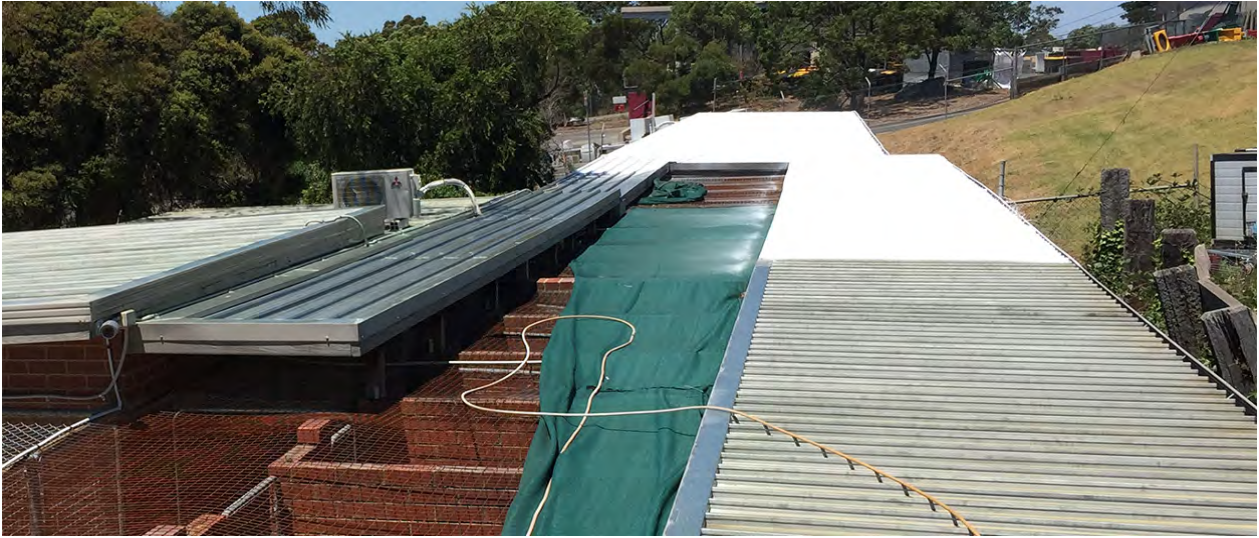
Half way through the first coat:

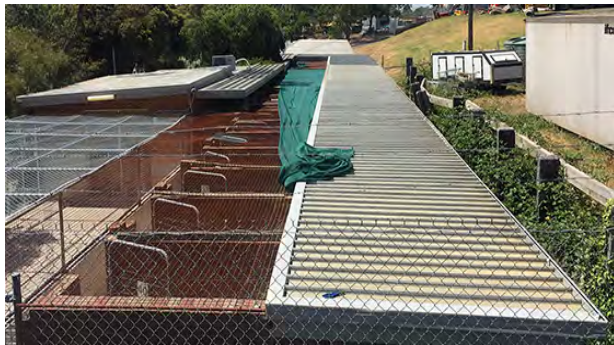
Before condition (post cleaning):

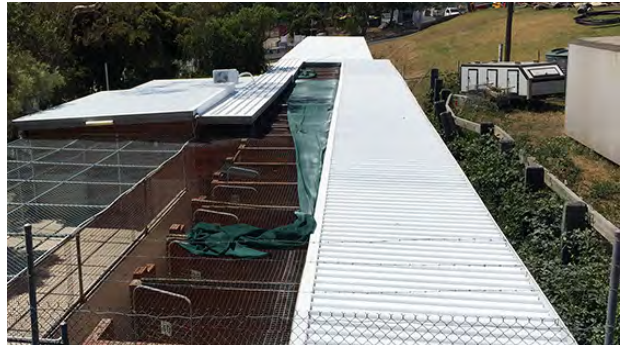
After:

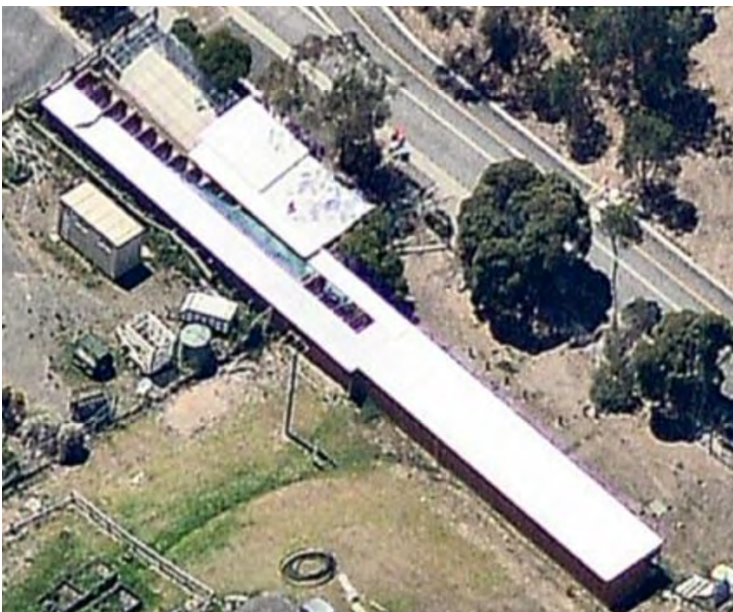
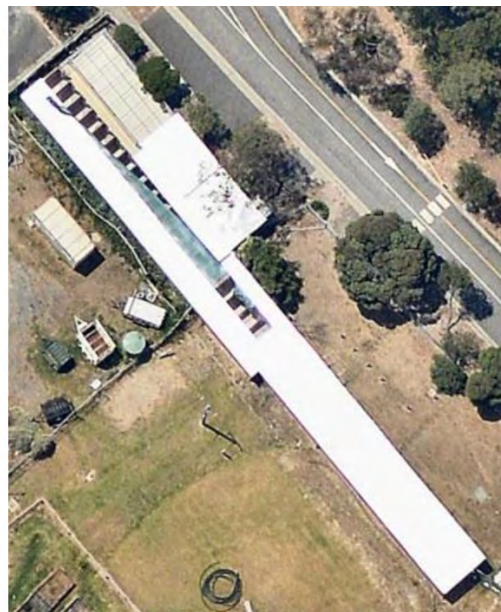
Aerial photo of the completed coating:

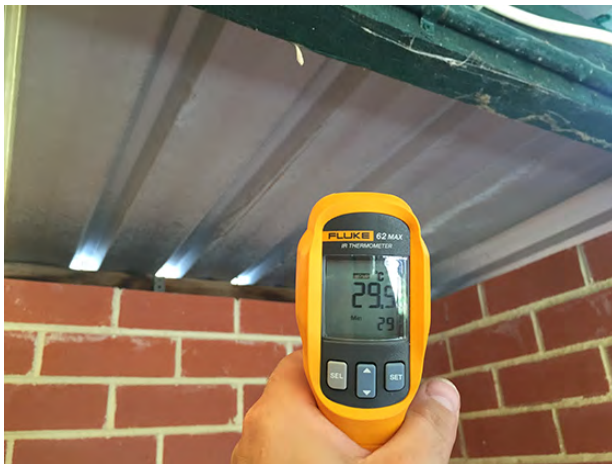
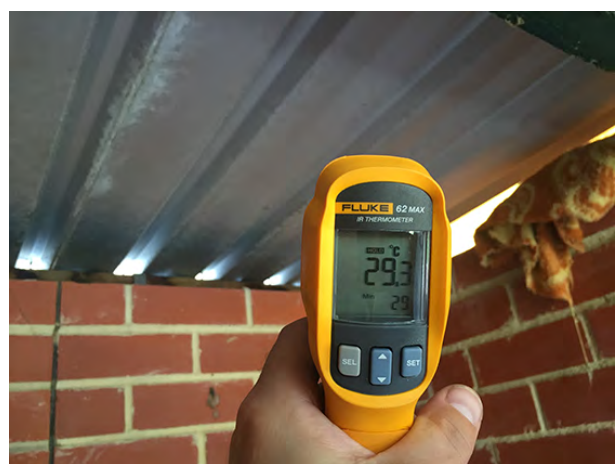
Inside the kennels it felt noticeably cooler & the underside of the metal was cool to touch.

The temperature readings from the underside of the sheeting confirmed

Underside temperatures ranged from **29-C-30C** inside the various kennels (1:30pm)

64% reduction in [underside] surface temperature.
