Insulation coating and performance report

heat reduction | energy savings

Heritage Chocolates is a Victorian based chocolate manufacturer.

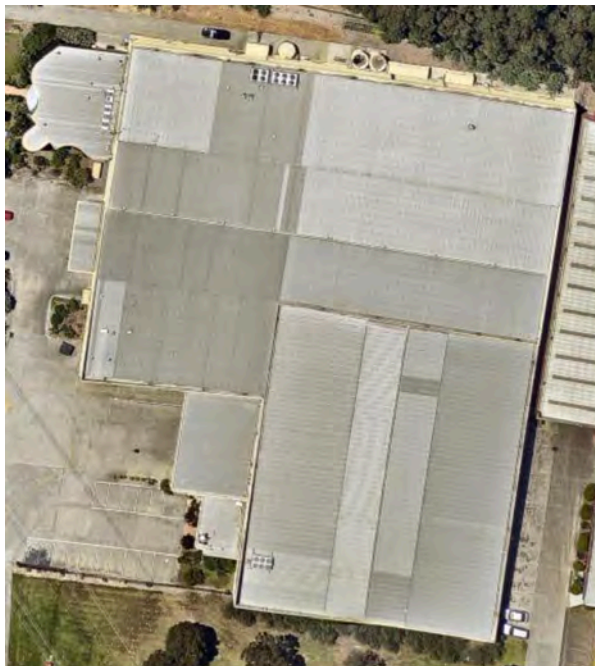
Before:

Below is a aerial photo of the Heritage Chocolates site – before & after coating:

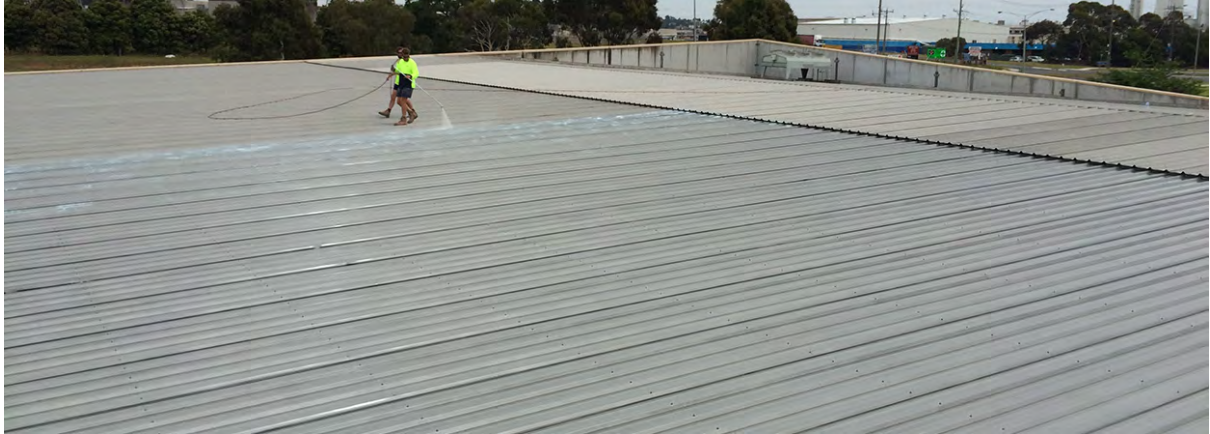
Etch primer:

- Power washing (zincalume sheeting) at 3,500psi
- Etch primer coating
- 2 coats Thermoshield ceramic membrane (500 micron wet film)

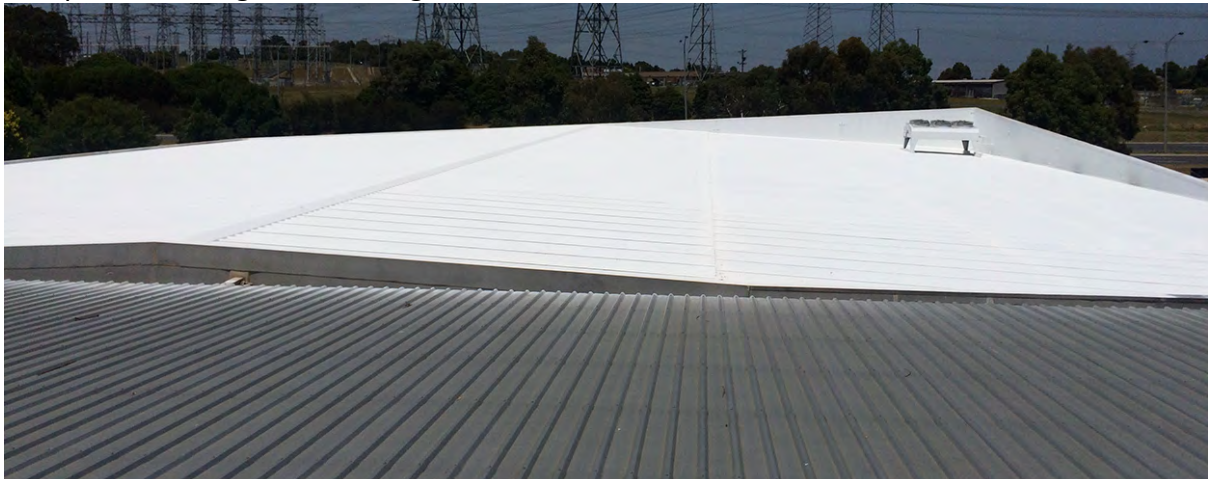
Completed coating on finished goods warehouse:

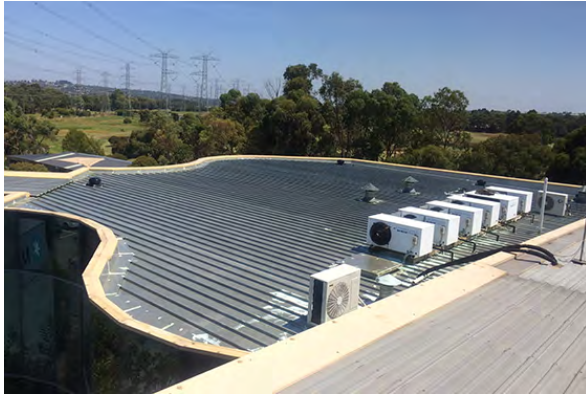
Before (office area):

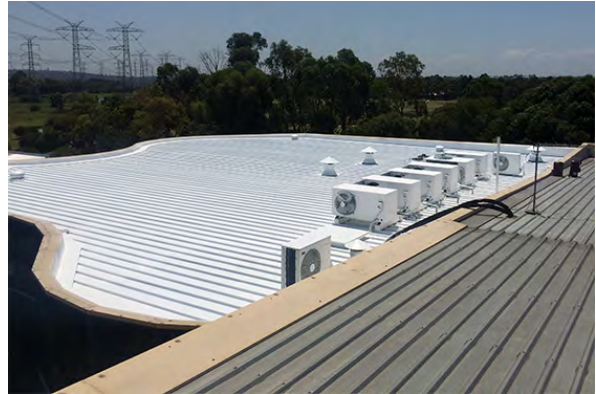
After (office area):

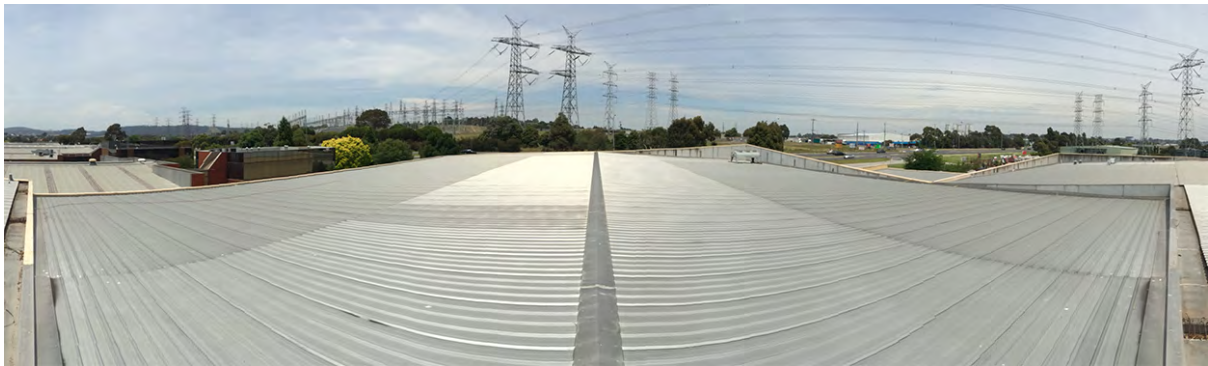
Before (finished goods warehouse):

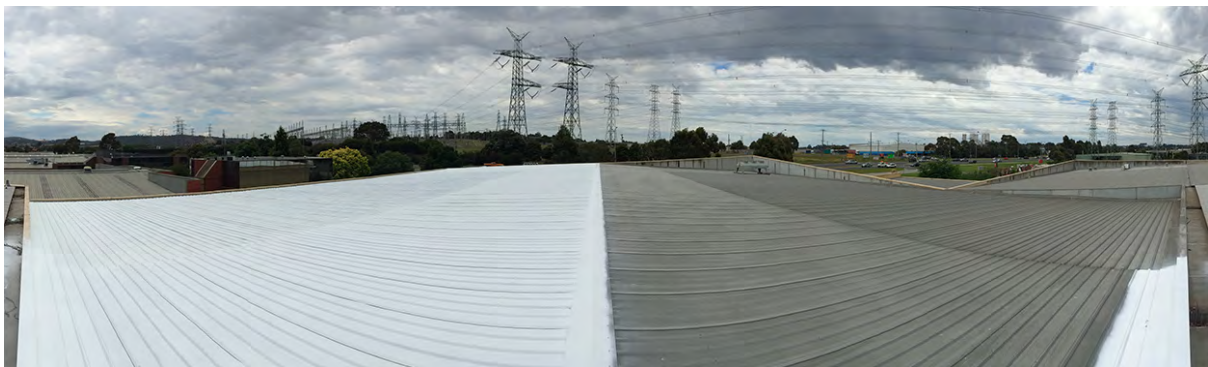
Mid point of first coat:

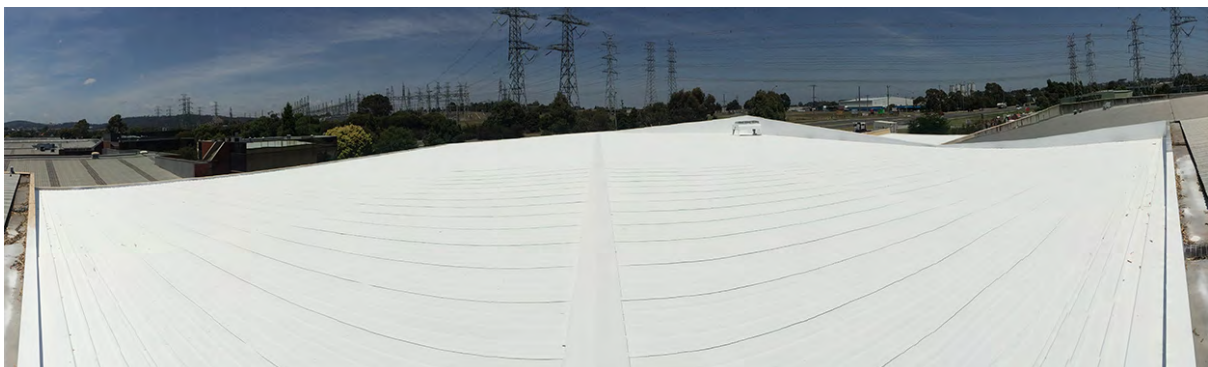
Finished coating (2 x 500micron coats of Thermoshield):

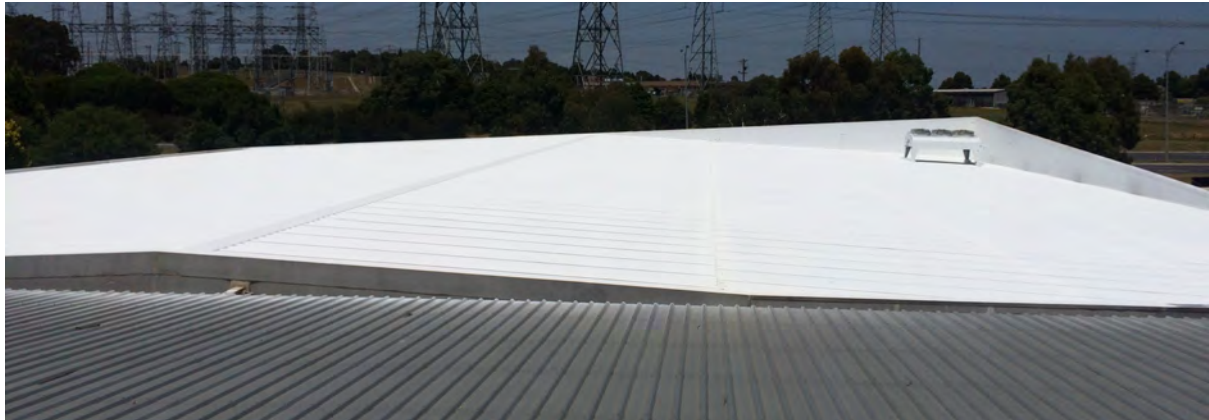
Following the application we measured the temperature variation between meeting point of the below coated roof & un-coated roof:

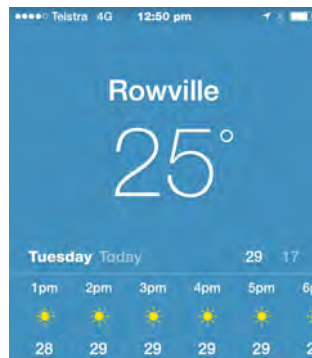
At the time of the temperature readings [12:50pm], local temperature was 25 degrees:

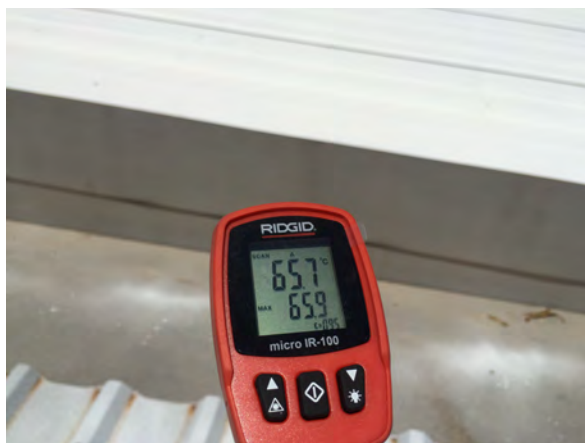
Uncoated temperature – 65 degrees:

Uncoated temperature – 65.7 degrees

52.8% reduction in [outside] surface temperature.

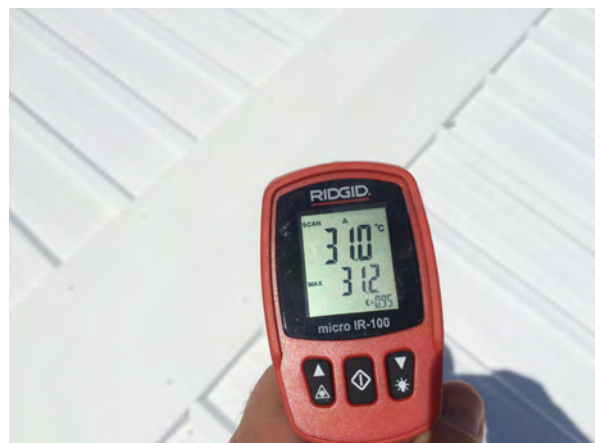
Coated in Thermoshield – 31 degrees:

Coated in Thermoshield – 31 degrees

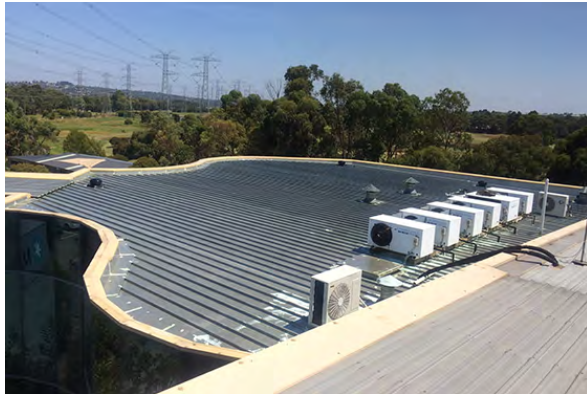
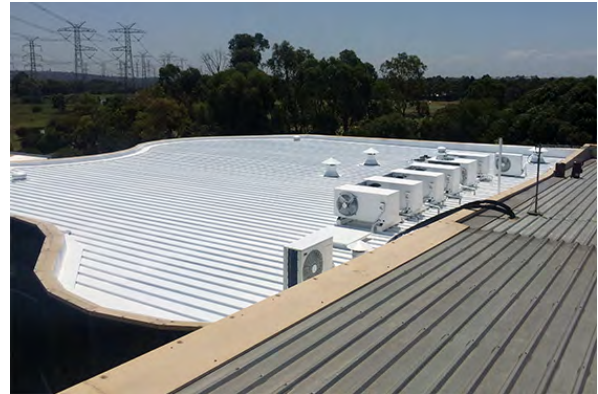
The following week when we returned to install temperature loggers, we again re-tested surface temperatures on the edge of the coated office roof & uncoated production roof:

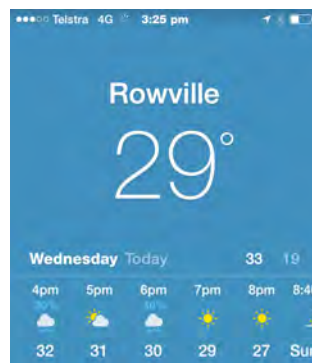
At the time of the temperature readings [3:25pm], local temperature was 29 degrees:

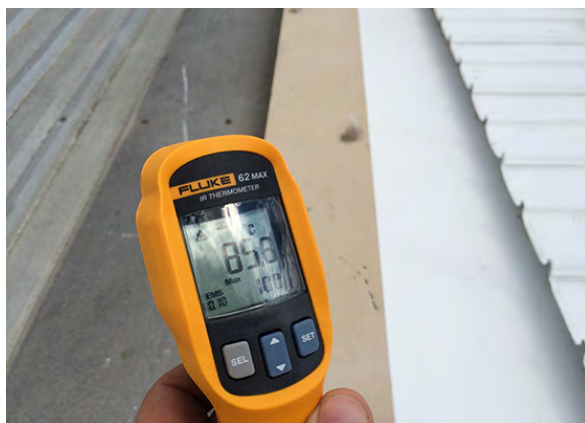
Uncoated temperature – 85.8 degrees:

Uncoated temperature – 85.8 degrees

60.4% reduction in [outside] surface temperature.

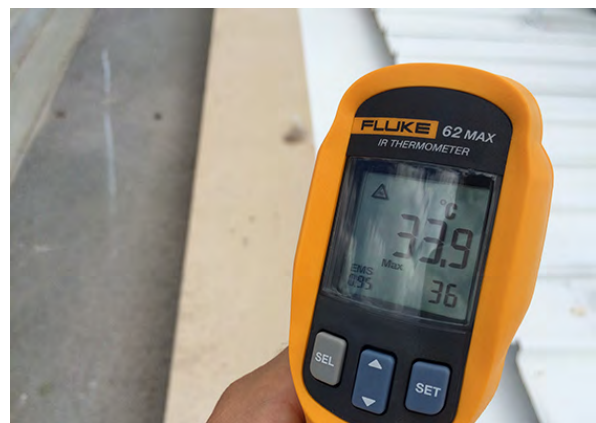
Coated in Thermoshield – 33.9 degrees:

Coated in Thermoshield – 33.9 degrees

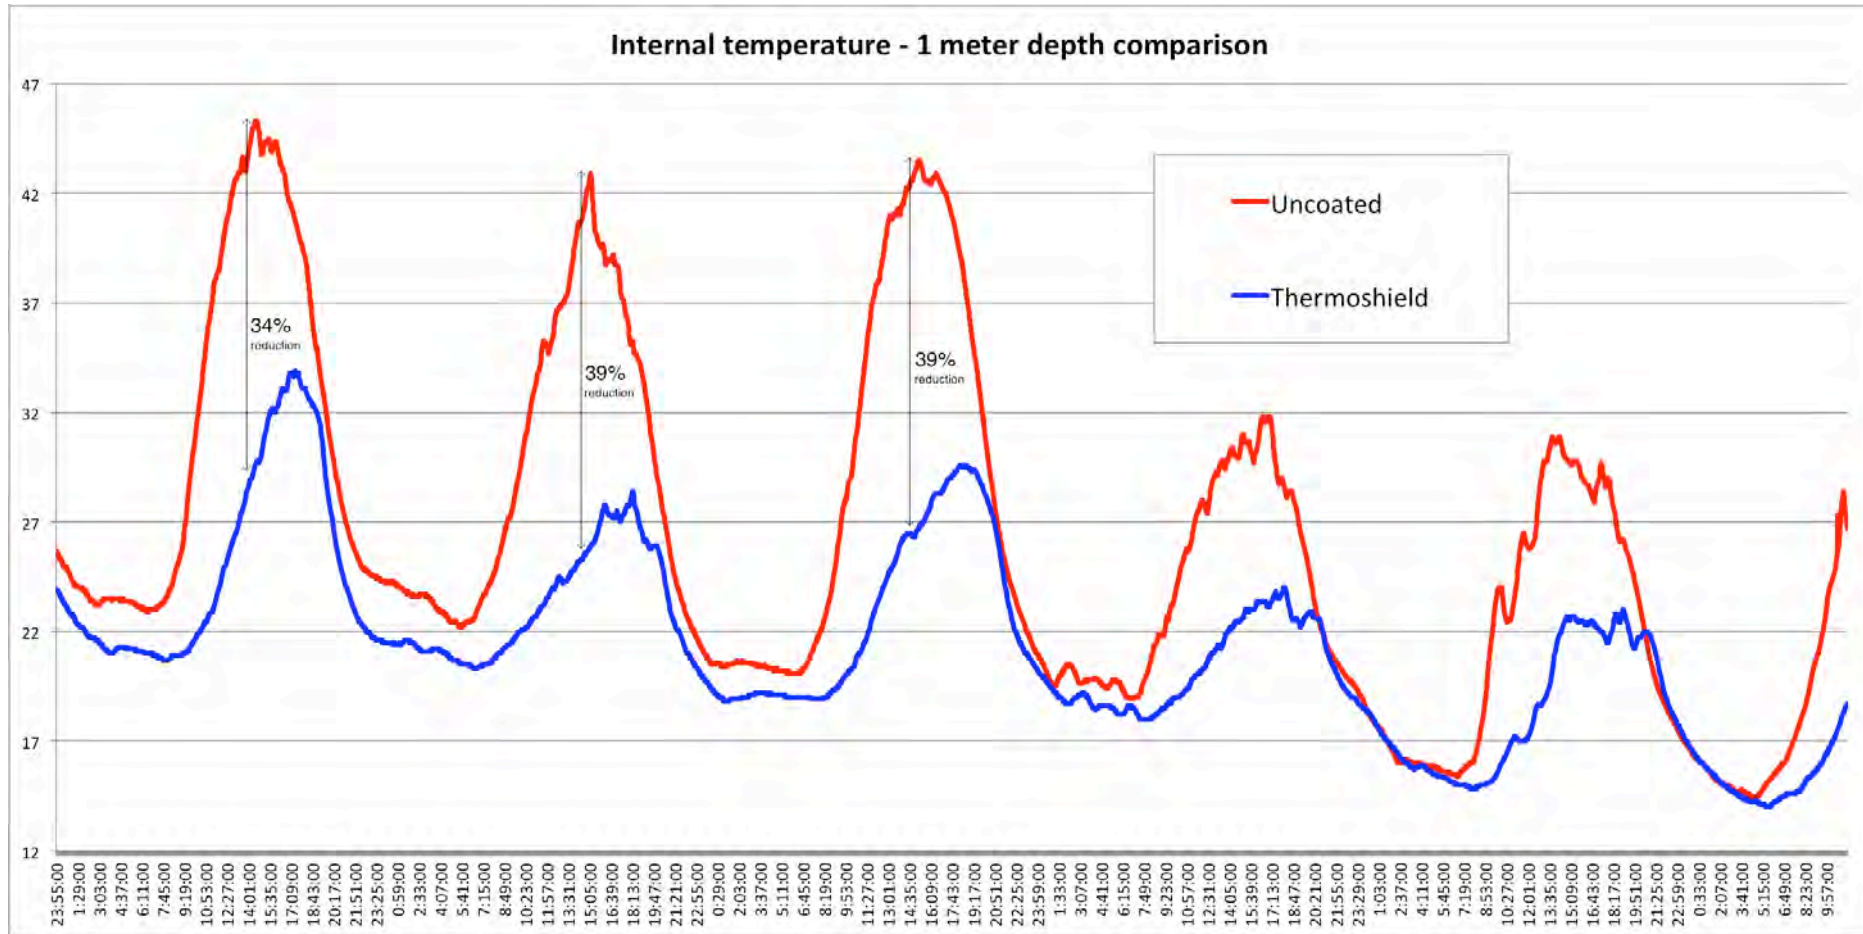
Below is the un-interrupted temperature data returned during the evaluation period:

You can see a significant reduction in internal temperature between the coated & uncoated roofs.

I have no doubt this is resulting in a reducing the A/C load for the finished goods warehouse and look forward to monitoring its effectiveness.
