THERMO SHIELD[®]

Luther
College

Roof Restoration

Rust Conversion | Thermal Insulation | Asset Protection

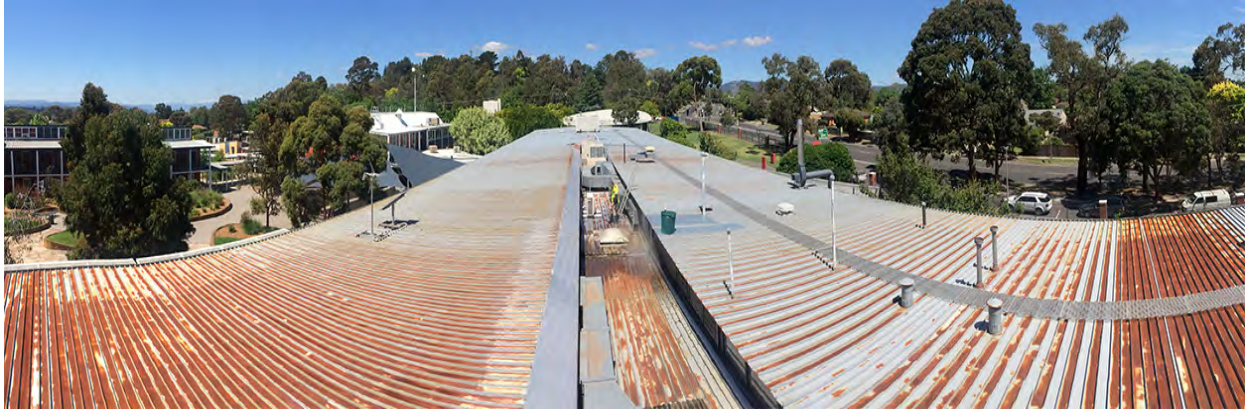
Before:

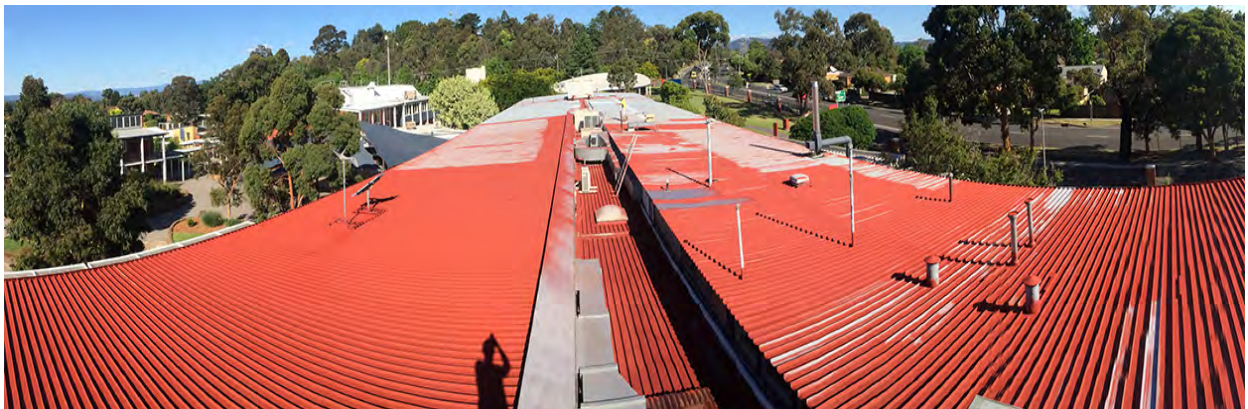
Rust Conversion:

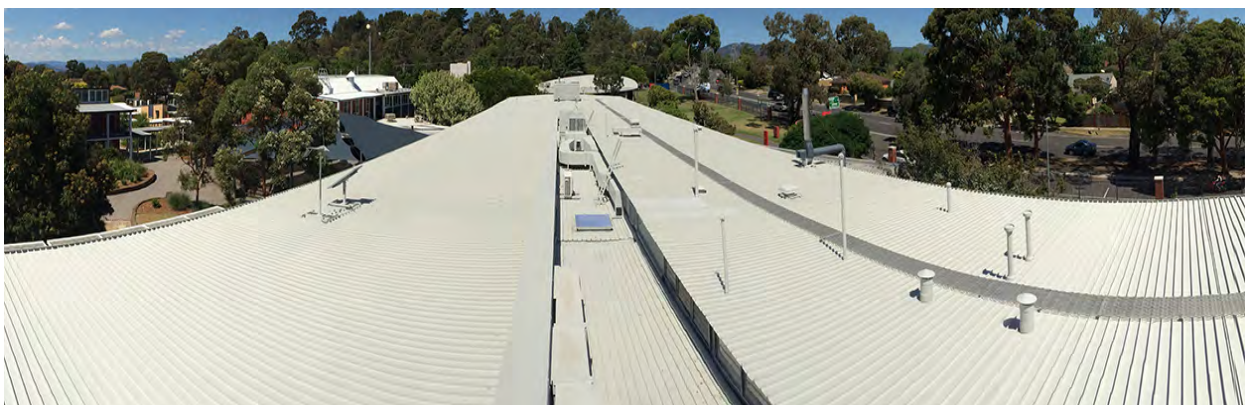
Completed coating system:

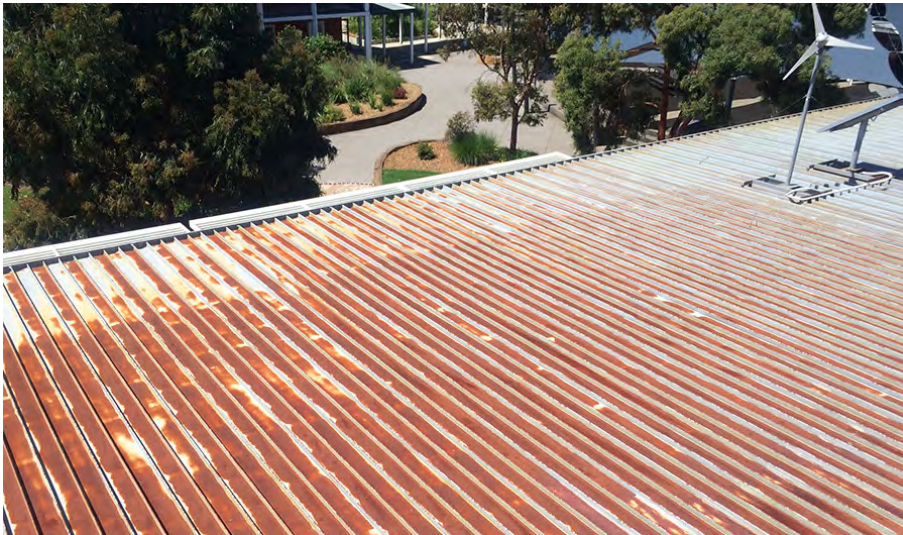
* **BEFORE** – original condition

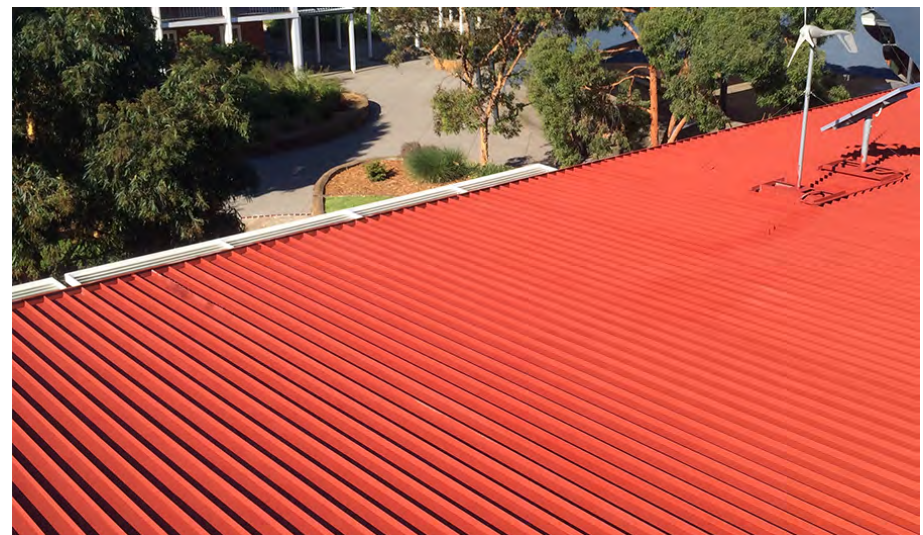
* **DURING** – after surface preparation, rust conversion coating

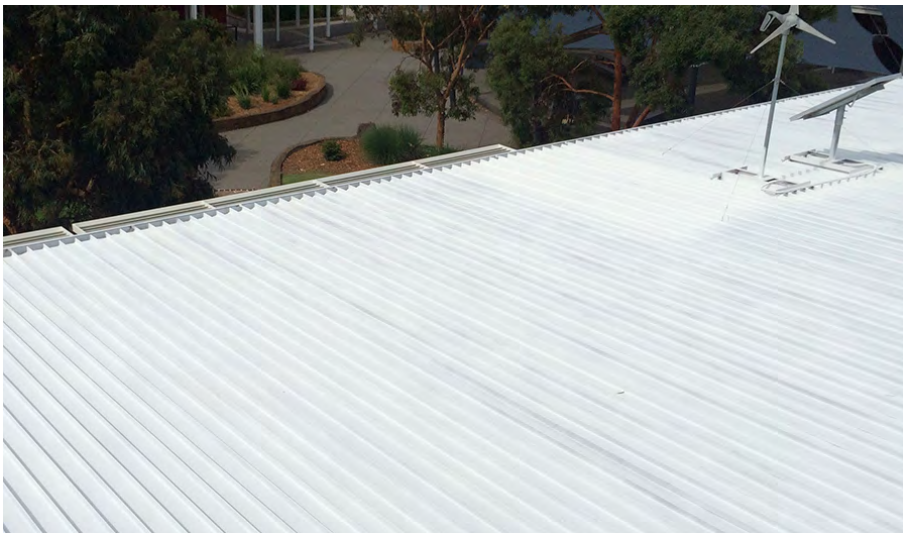
* **DURING** – First coat (White Thermoshield)

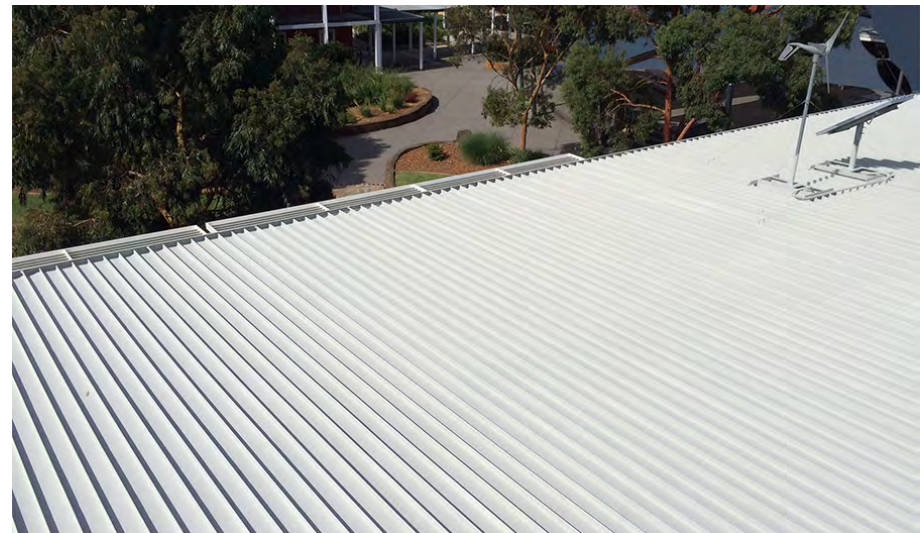
* **AFTER** – 1 coat white | 2 x shale grey coats

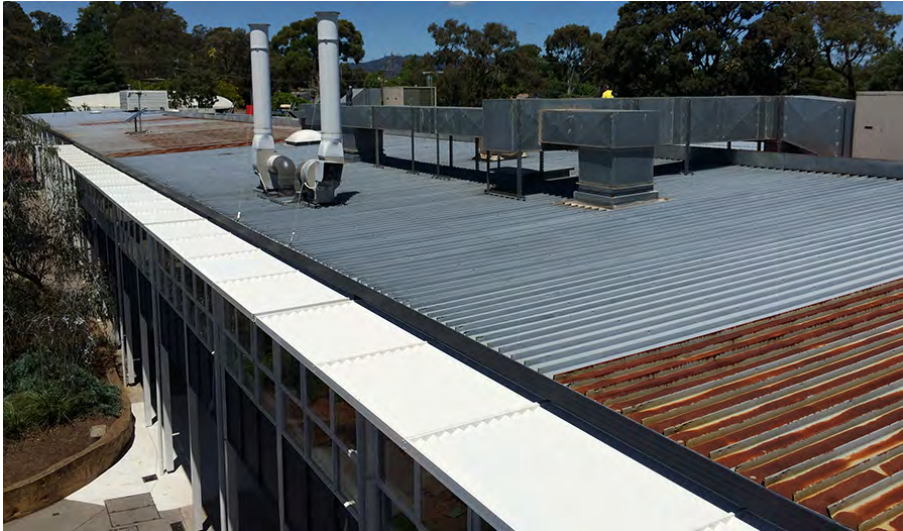
* **BEFORE** – original condition

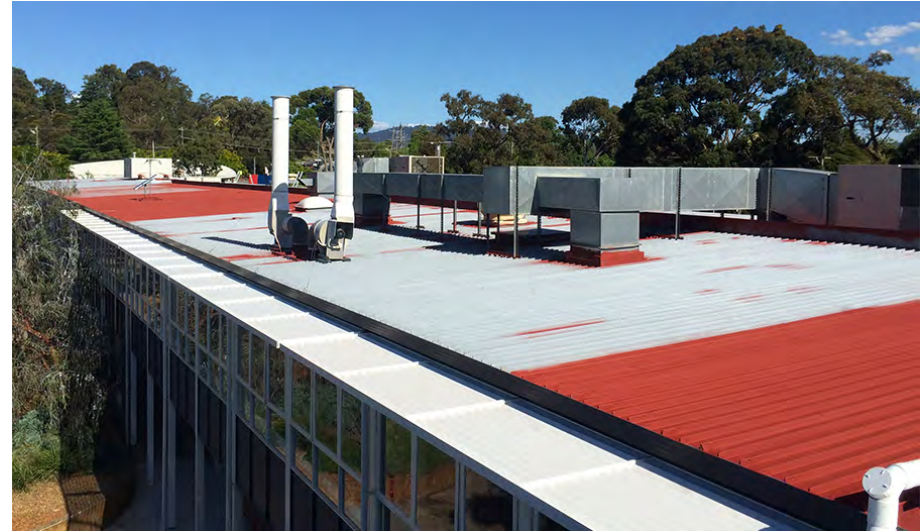
* **DURING** – after surface preparation, rust conversion coating

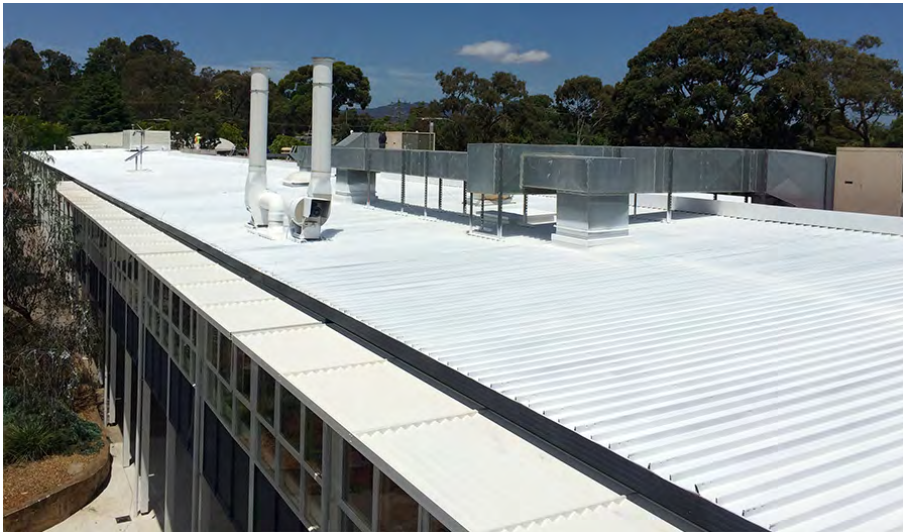
* **DURING** – First coat (White Thermoshield over rust converter)

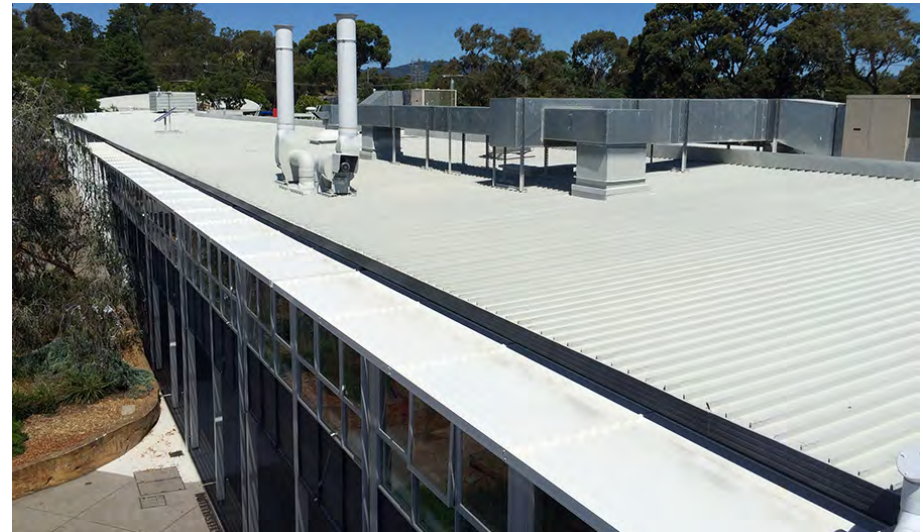
* **AFTER** – 1 coat white | 2 x shale grey coats

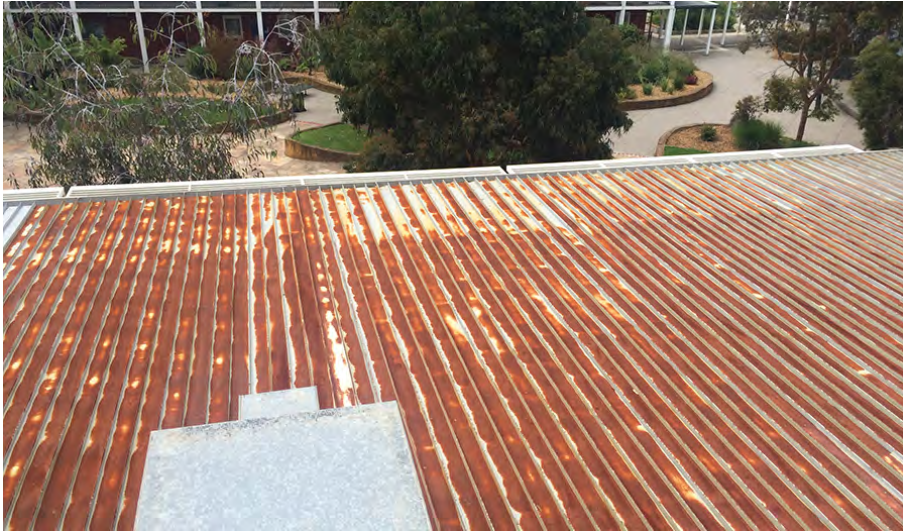
* **BEFORE** – original condition

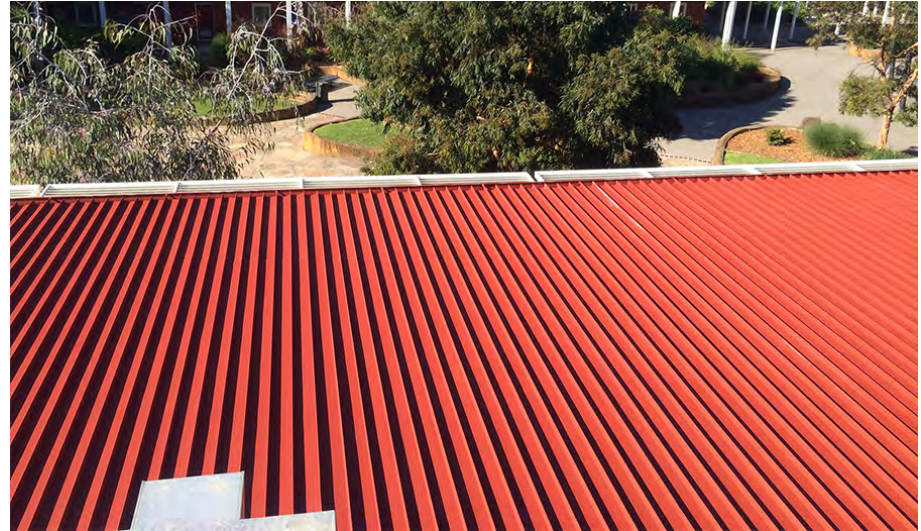
* **DURING** – after surface preparation, rust conversion coating

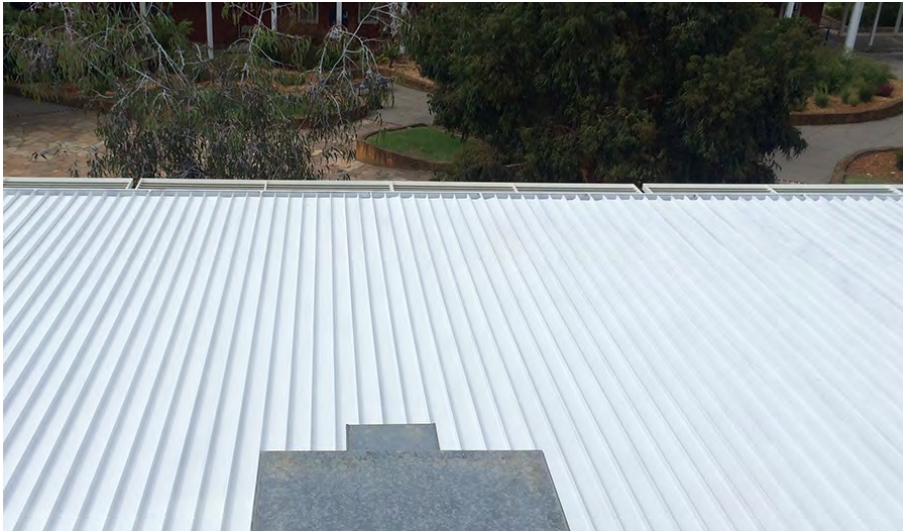
* **DURING** – First coat (White Thermoshield)

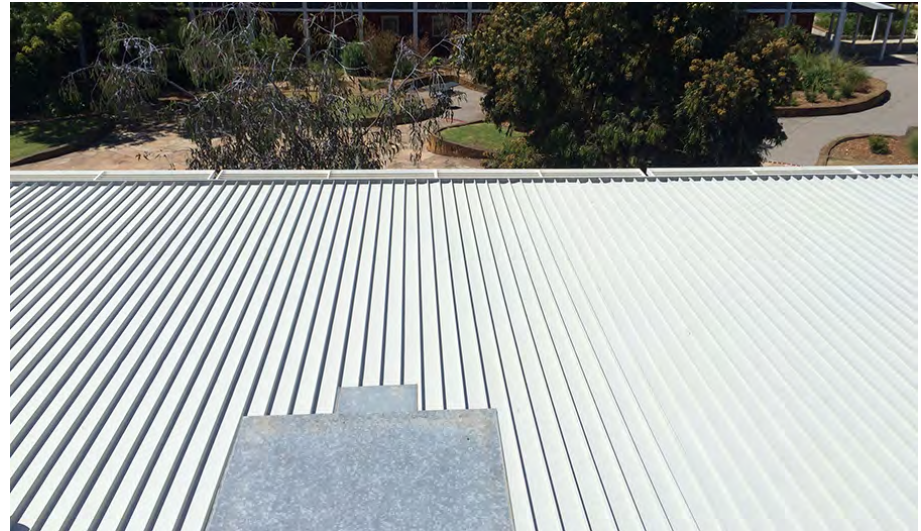
* **AFTER** – 1 coat white | 2 x shale grey coats

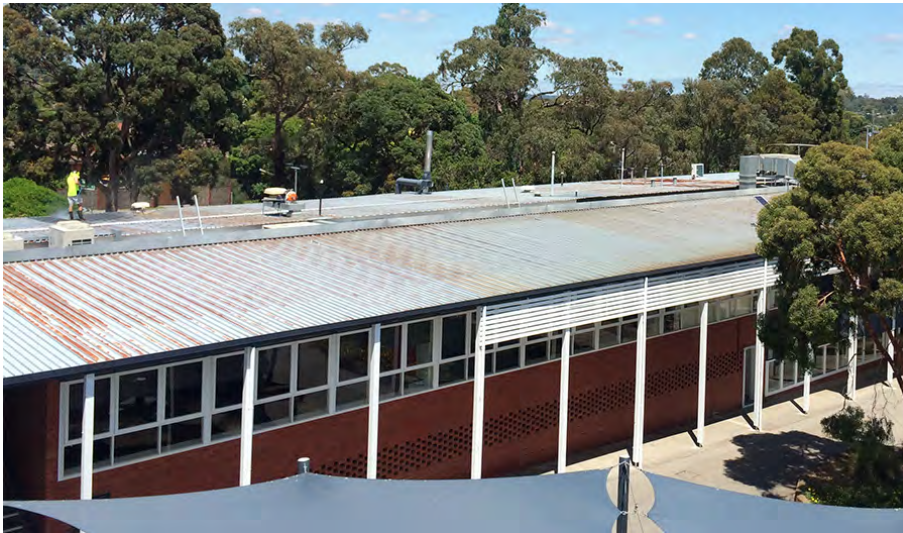
* **BEFORE** – original condition

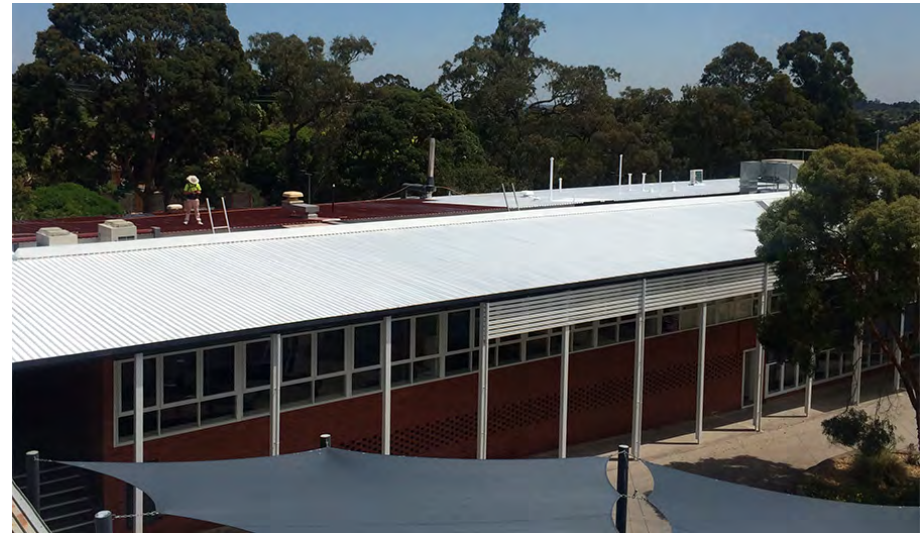
* **DURING** – post rust conversion, half way through 1st coat (white)

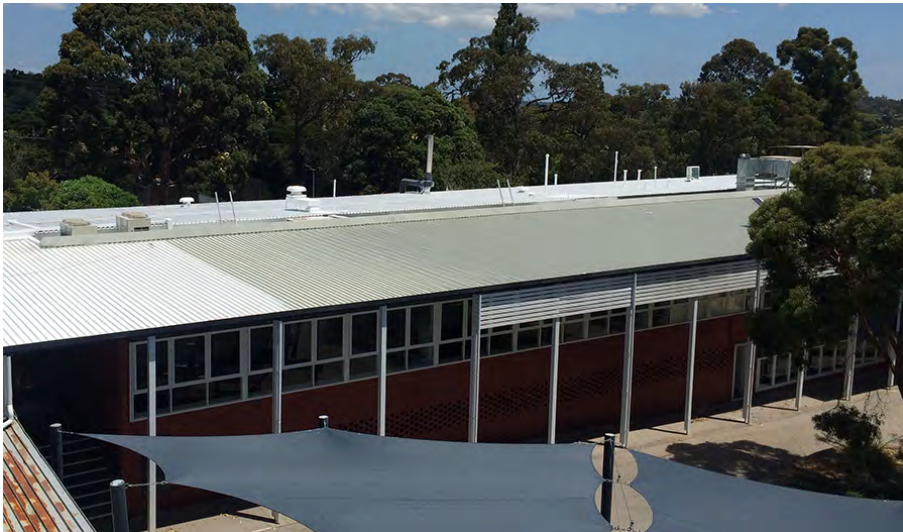
* **DURING** – Second coat (shale grey over white)

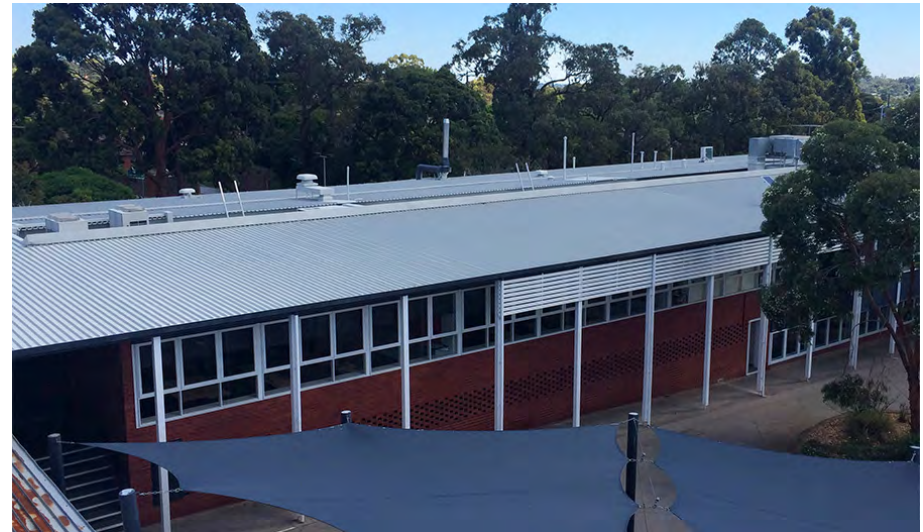
* **AFTER** – 1 coat white | 2 x shale grey coats

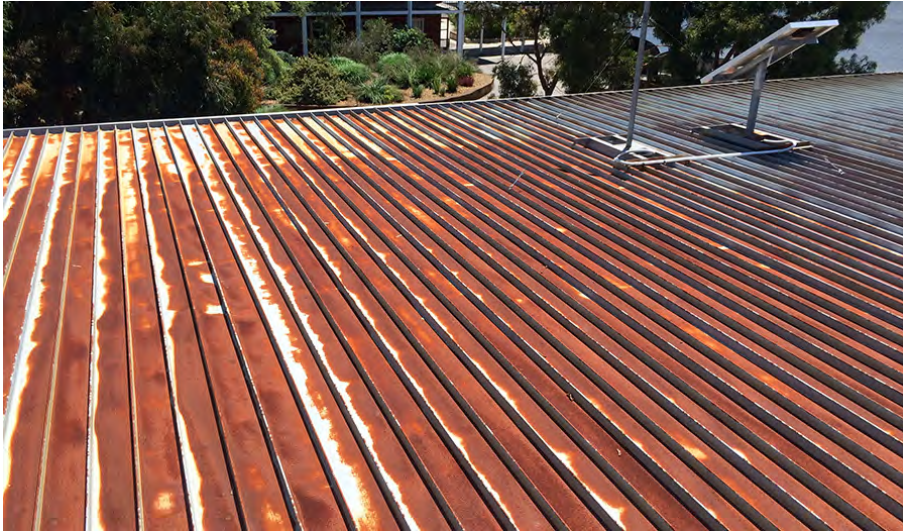
* **BEFORE** – original condition

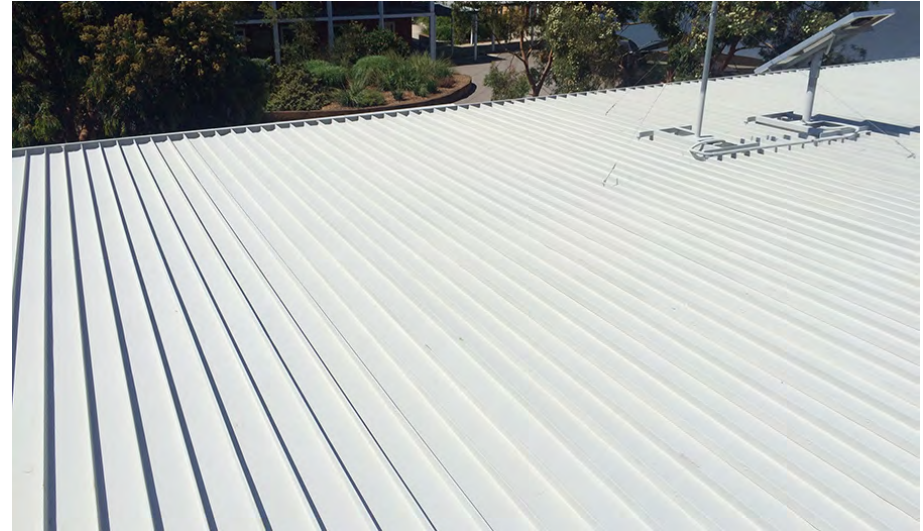
* **AFTER** – completed coating 'system'

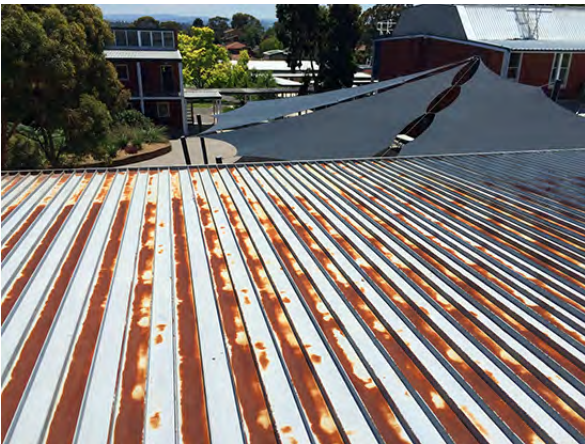
* 'Before' – prior to any work

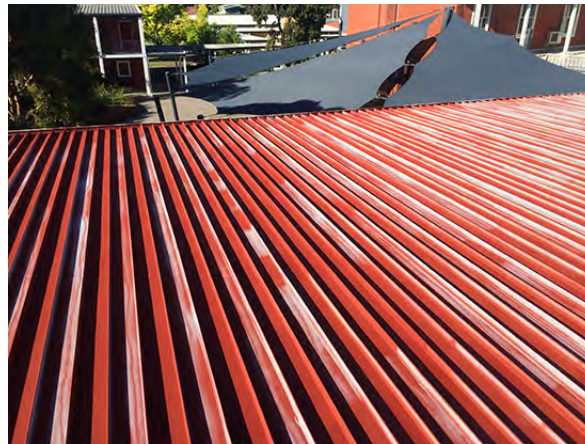
* 'During' – rust conversion

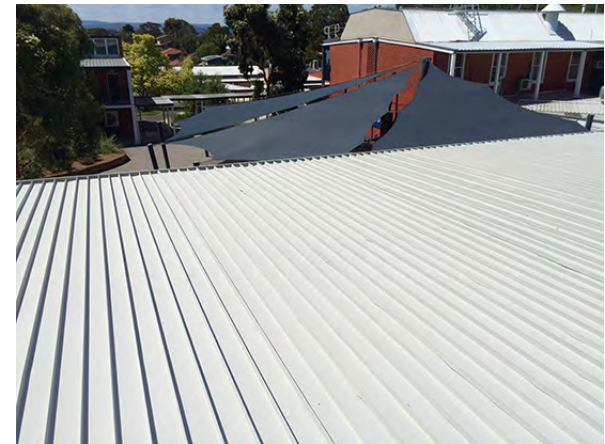
* 'After' – like new appearance

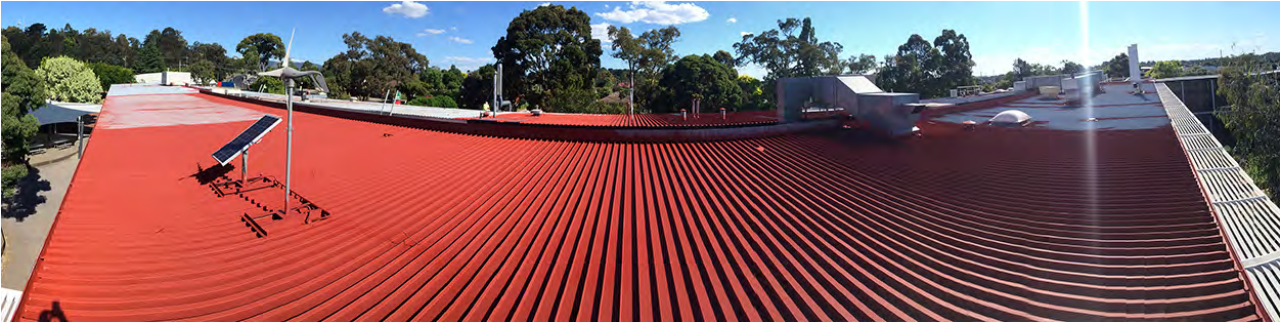
- Rust conversion:

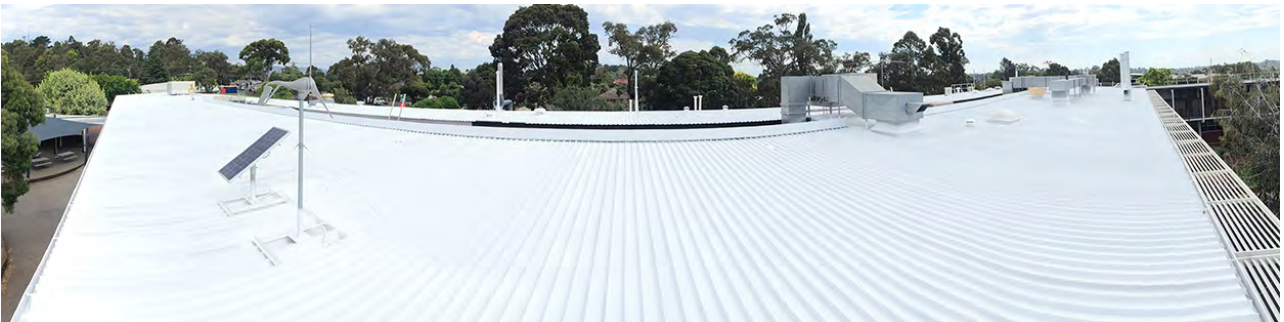
- First coat – Thermoshield WHITE:

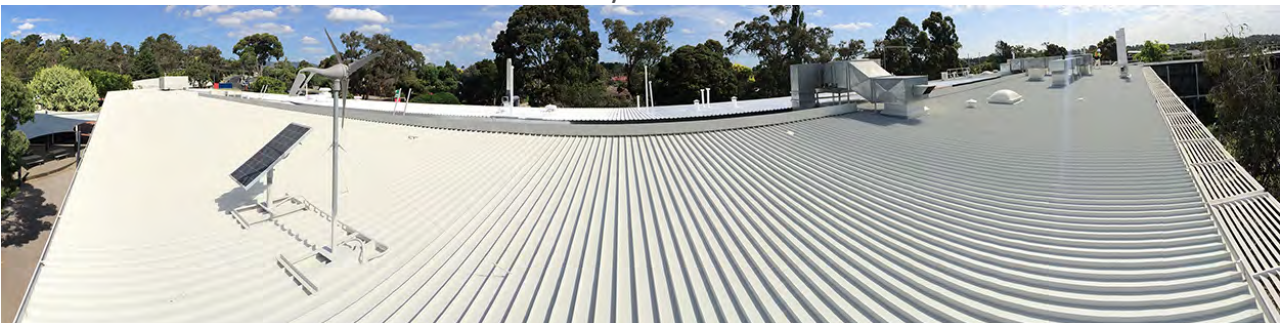
- Second Coat – Thermoshield 'Shale Grey':

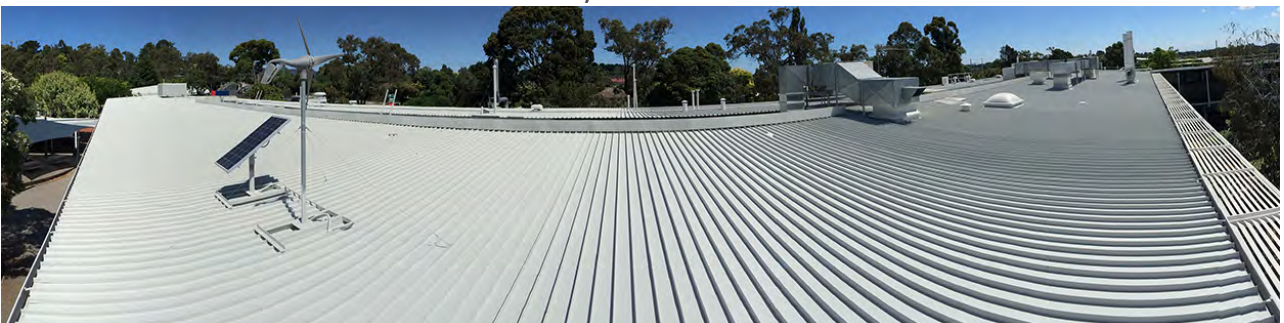
- Third Coat – Thermoshield 'Shale Grey'
