THE UNIVERSITY OF
MELBOURNE

McCoy Building - Earth Sciences Pre Solar PV installation - Roof Protective Coating Work

Heat Reduction | Future Proofing | Solar PV Efficiency

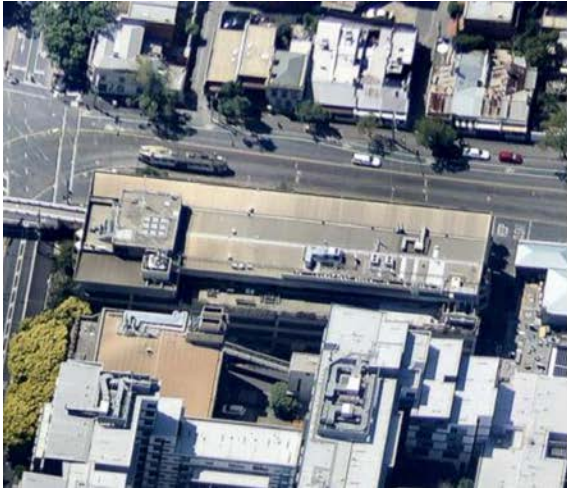
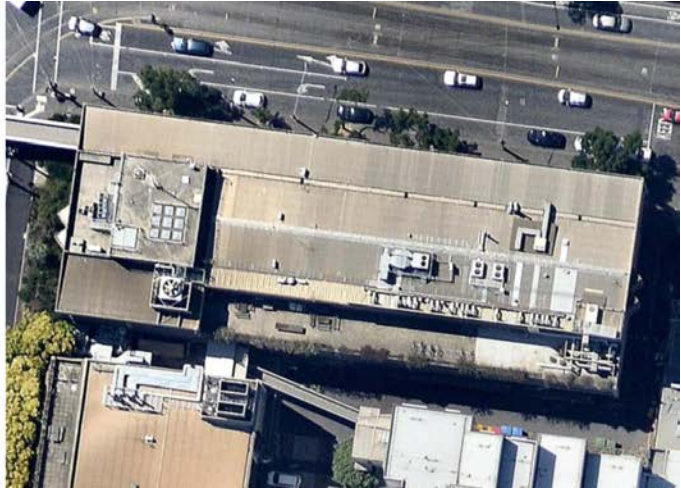
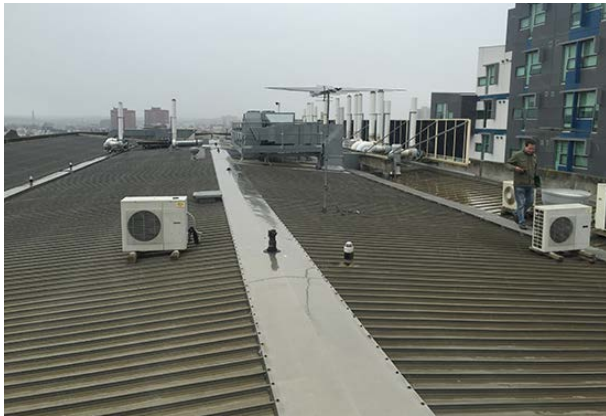
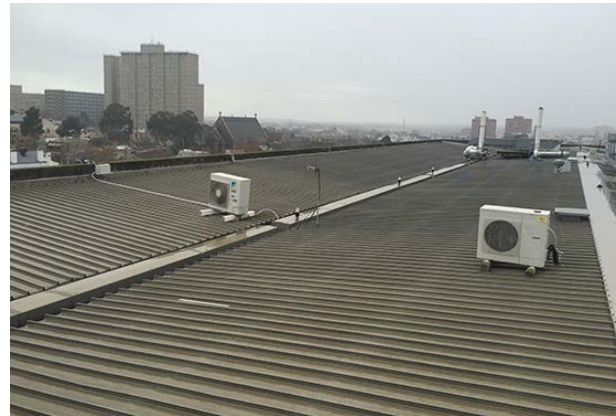
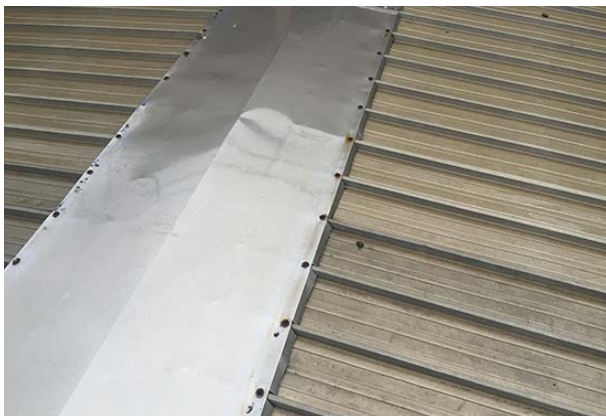
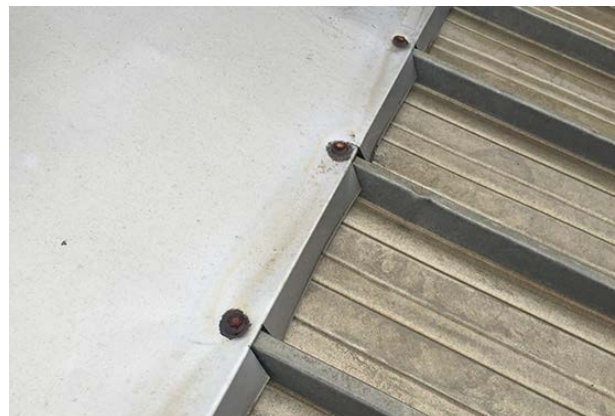
Section 1: **Original Condition:**

The McCoy building roof was ageing and showing signs of deterioration.

A very unique roof sheet (aluminum), the soft metal would suffer from expansion and contraction which would cause waterproofing issues.

Below aerial photos of the weathered, ageing roof:

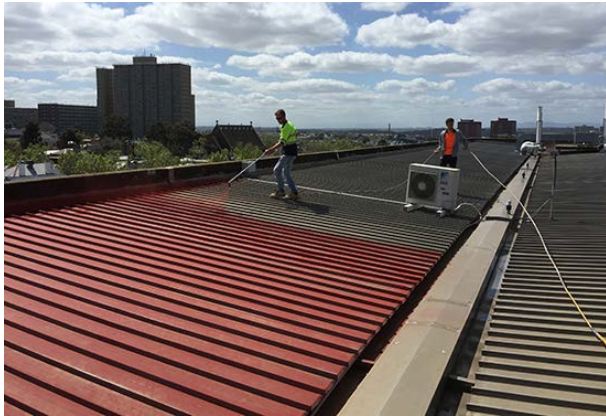
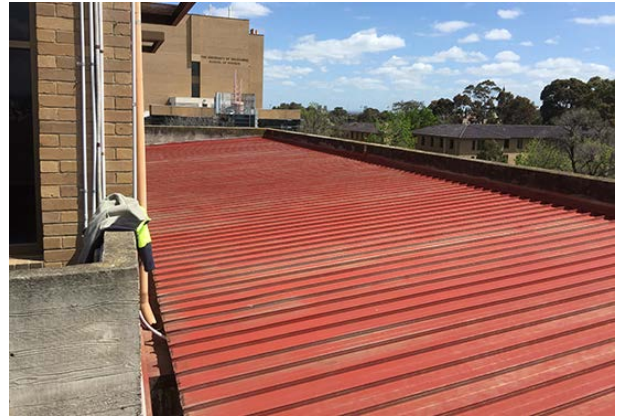
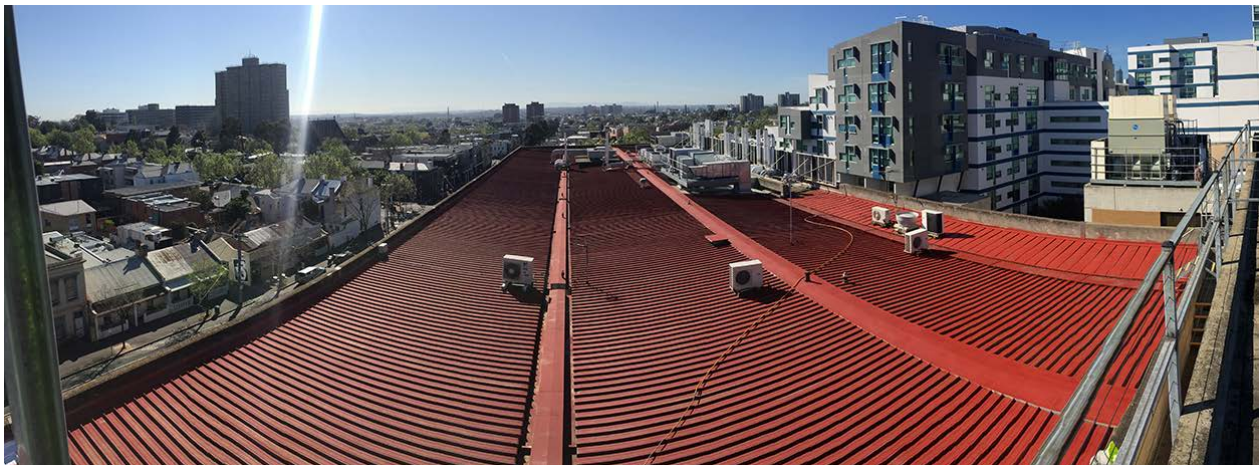
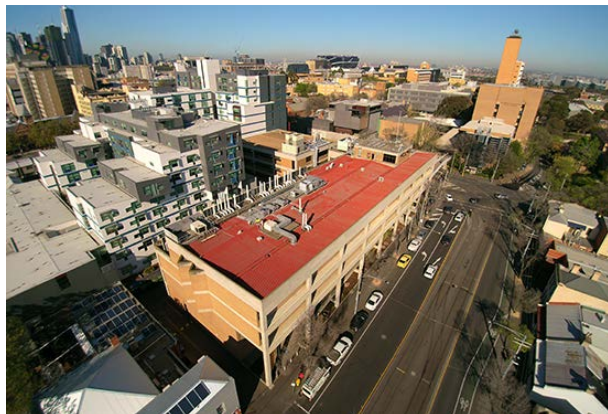
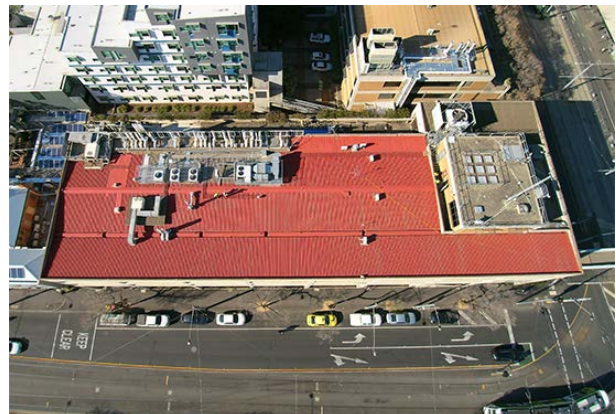
Section 3: **Etch primer coating (all areas):**

The etch primer is misted and is clear to see due its vivid red appearance:

Etch primer is then applied over all areas prior to the ceramic top coat. This particular etch primer ensures maximum adhesion to the ageing roof sheets.

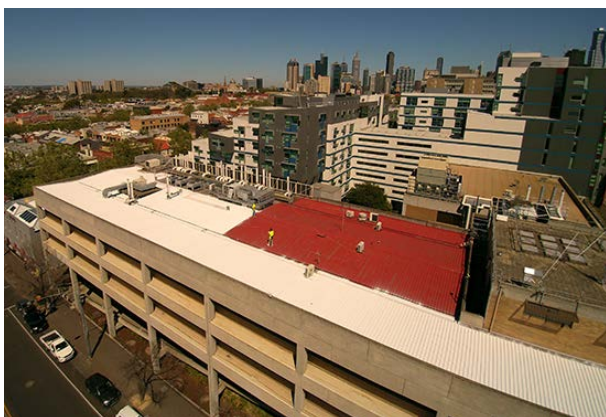
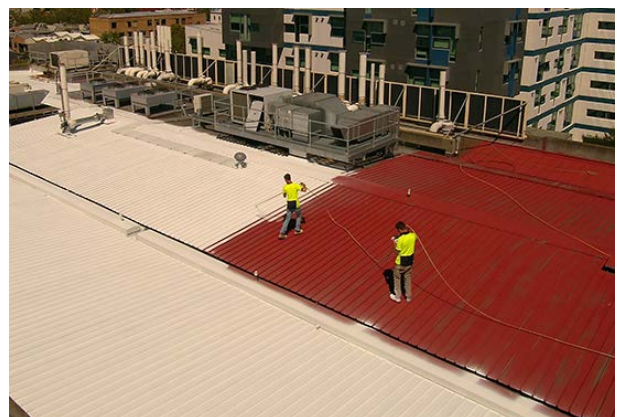
Section 4: Thermoshield coating – first coat:

The bright white of the Thermoshield coating over the vivid red of the etch primer ensures a complete coverage of the ceramic membrane.

Thermoshield thermal ceramic coating creates a thick, non-permeable membrane that acts to thermally insulate the roof sheeting & add a layer of waterproofing protection.

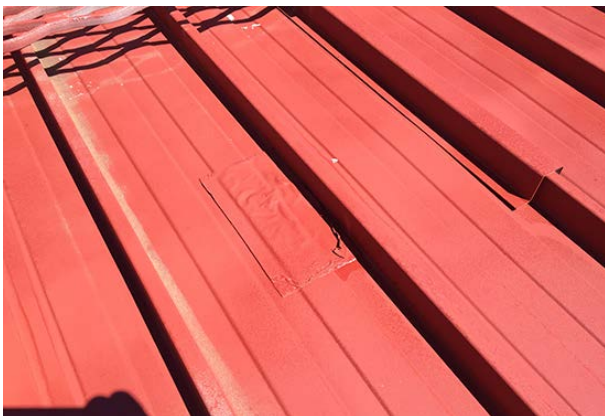
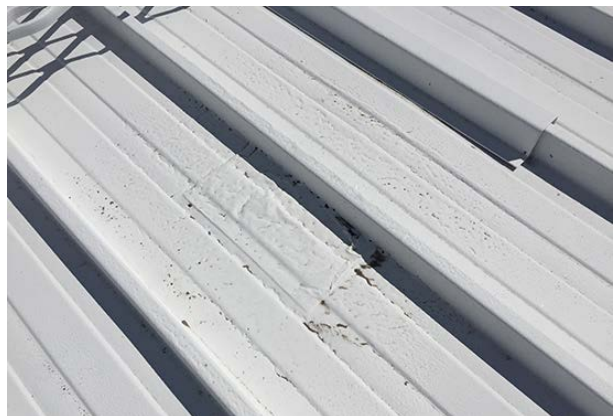
Section 5: **Waterproofing:**

Waterproof bandage application to damaged area of sheeting (left), followed by heavily sealed beneath the ceramic coating (right):

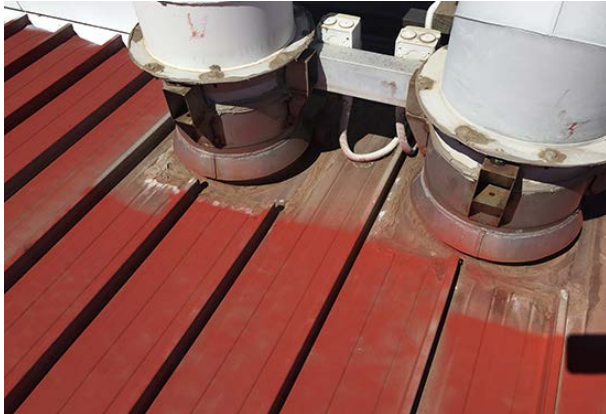
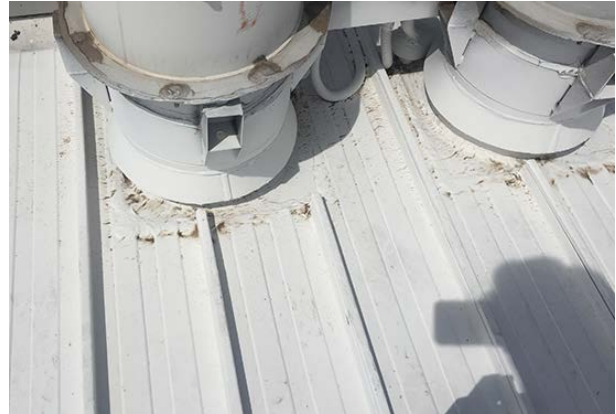
Prior to the coating works, reports from University staffers reported widespread leaking from the roof areas with HVAC penetrations. As a result, all areas of sheet overlap for the HVAC equipment we applied multiple passes of coating to really build up the protective thickness.

Below shows before and after of the waterproofing prone sheet overlaps:

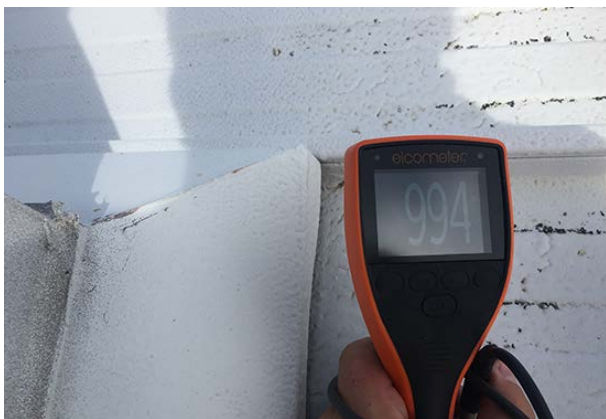
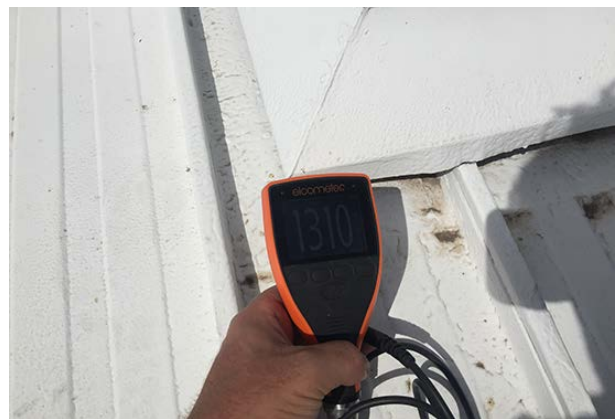
Below photos show this added thickness to these problematic areas specifically.

The coating is to be applied to yield a dry film thickness of 350 micron but on the areas of waterproofing concern, you can see the dry film thickness is between 900 micron and 1,300 microns as you can see from the below two photos:

Following roof coating and solar installations, we were informed there had not been any reports of roof leaking which was a great result.

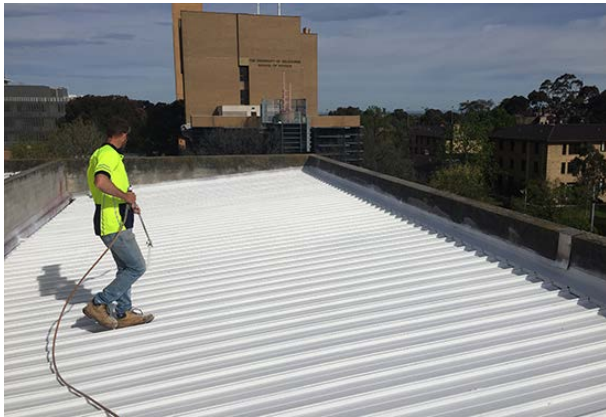
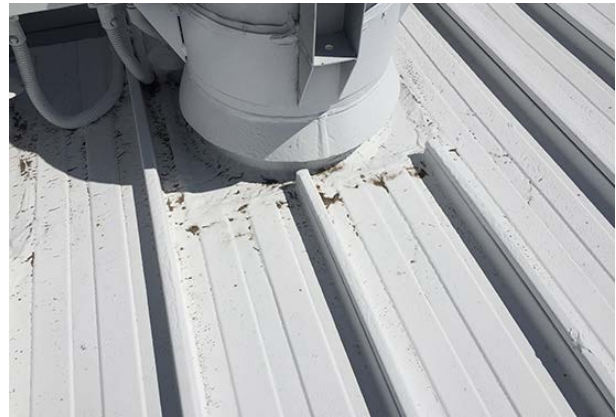
Section 6: Thermoshield – second coat:

Second coat commencing:

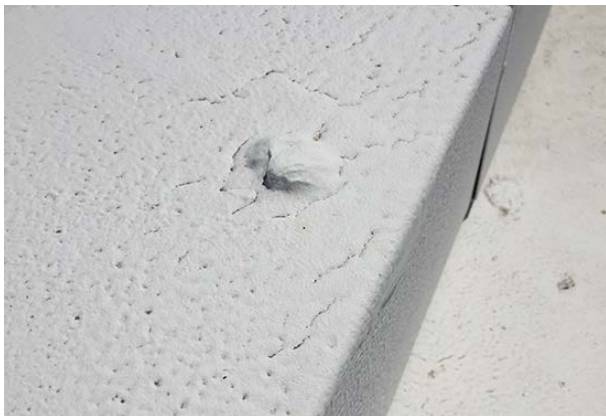
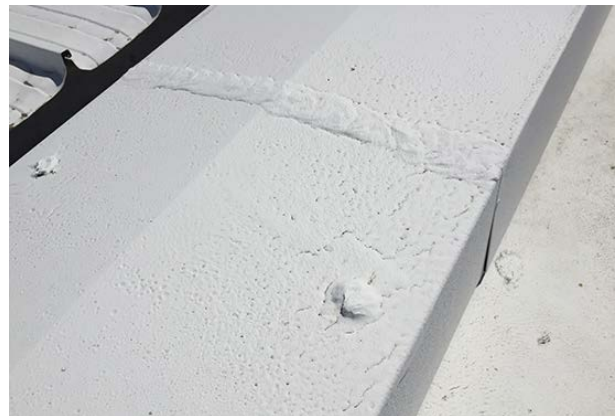
Below photos show the comprehensive sealing of sheet overlap and tech screw penetrations:

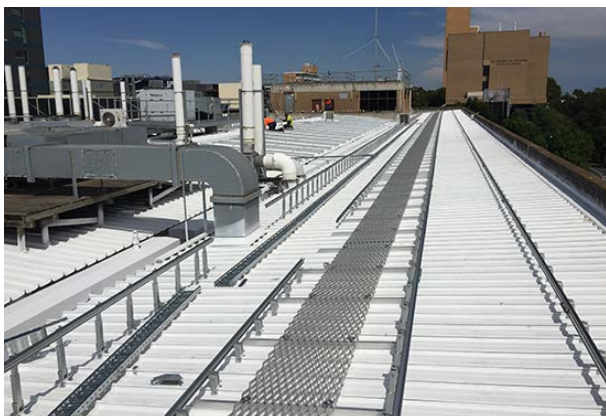
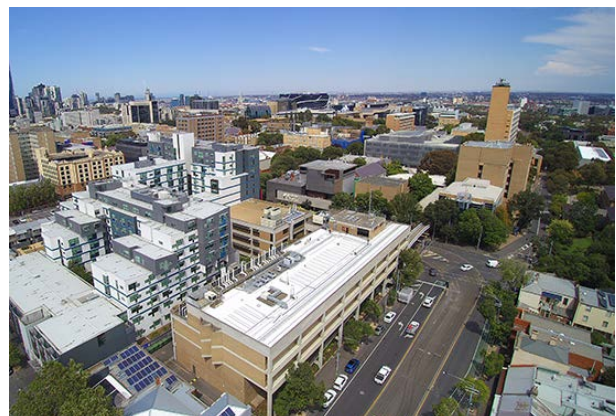
Section 7: Completed coating:

The ageing roof has been comprehensively sealed beneath a thick, ceramic thermal barrier.
