Muja Power Station

A/B Turbine - Rust conversion restoration coating system

Rust Conversion restoration coating system

Project Site: Muja Power Station | A&B Turbine – Boiler House roof

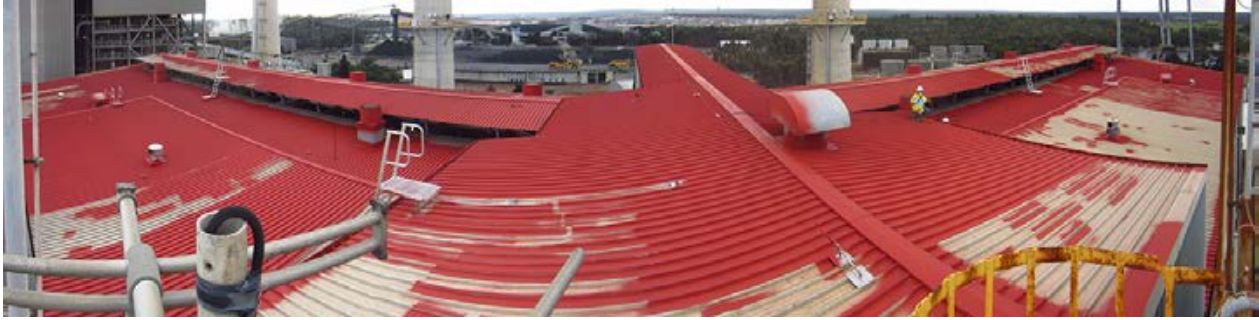
First coat | **RUST CONVERTER** – applied only to rusted metal:

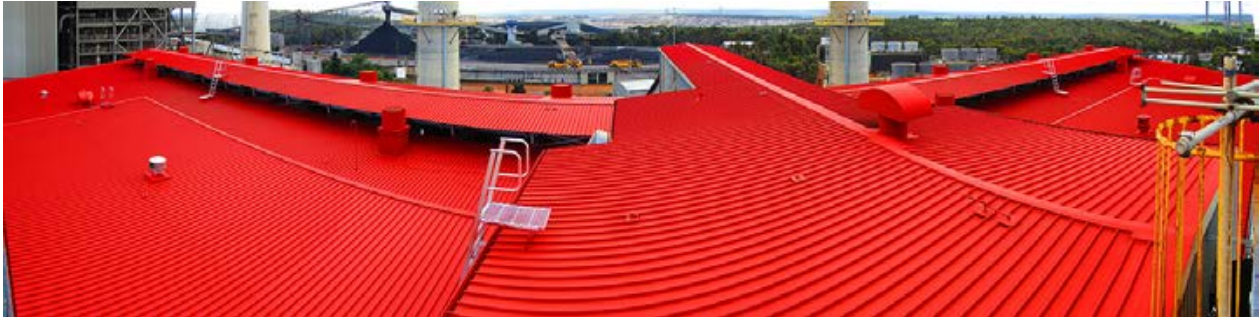
Second coat | **RUST INHIBITOR ETCH PRIMER** – applied to all areas:

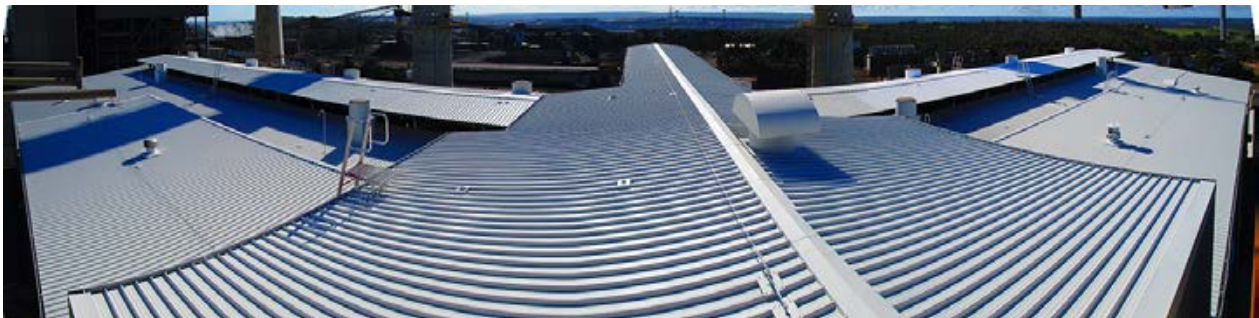
Fifth coat | **THERMOSHIELD** ceramic membrane – light grey 3rd coat:

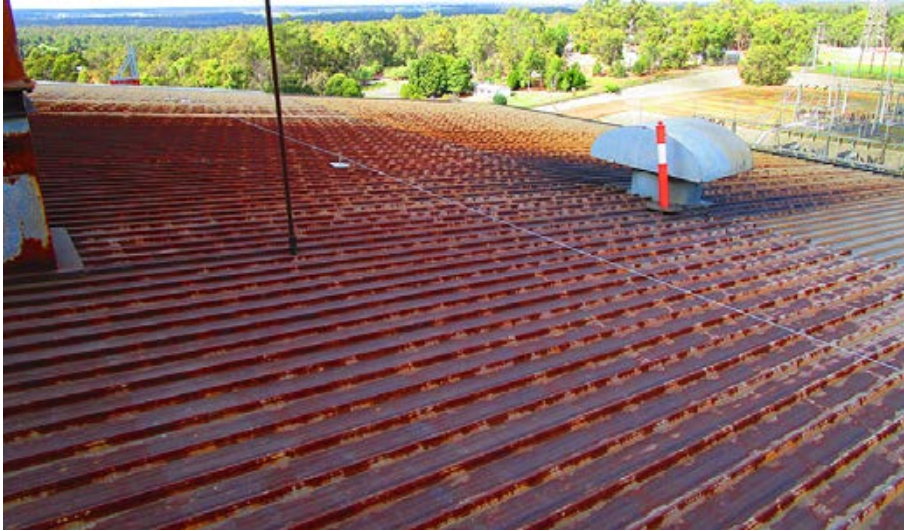
Original condition:

Completed coating system:

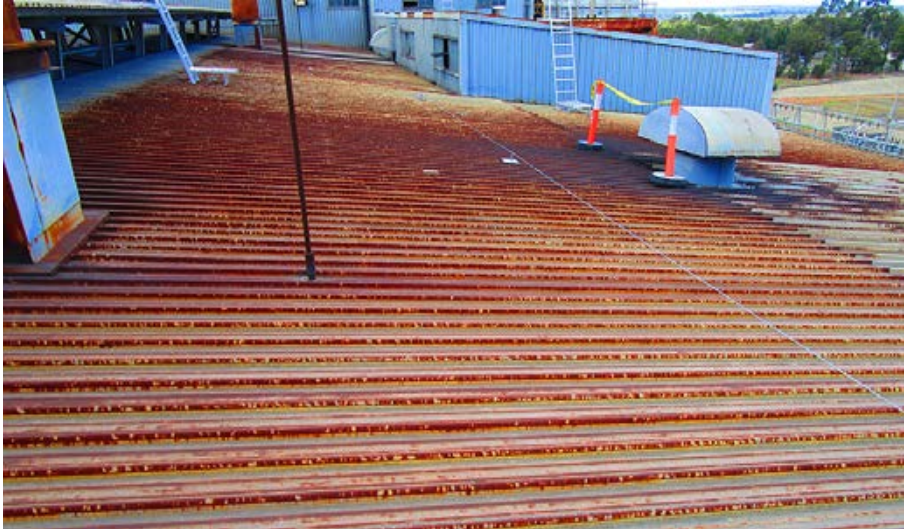
Original condition:

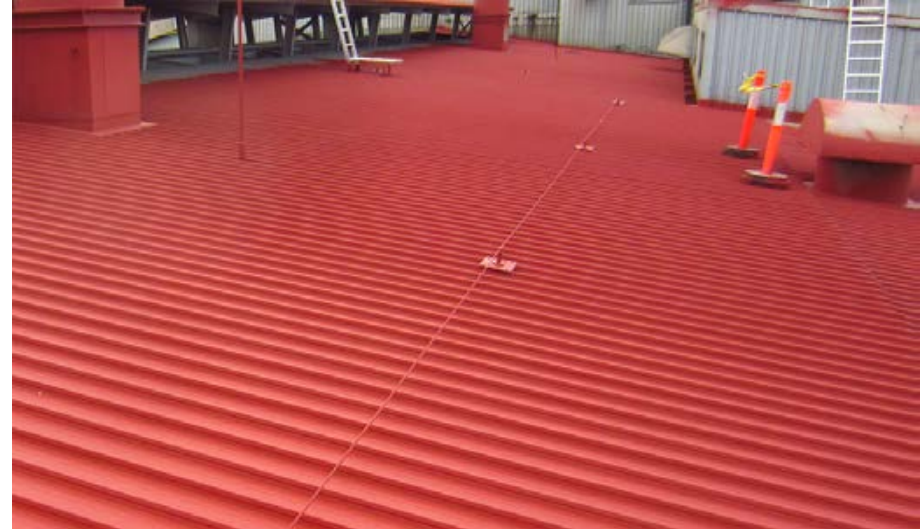
Rust converter applied:

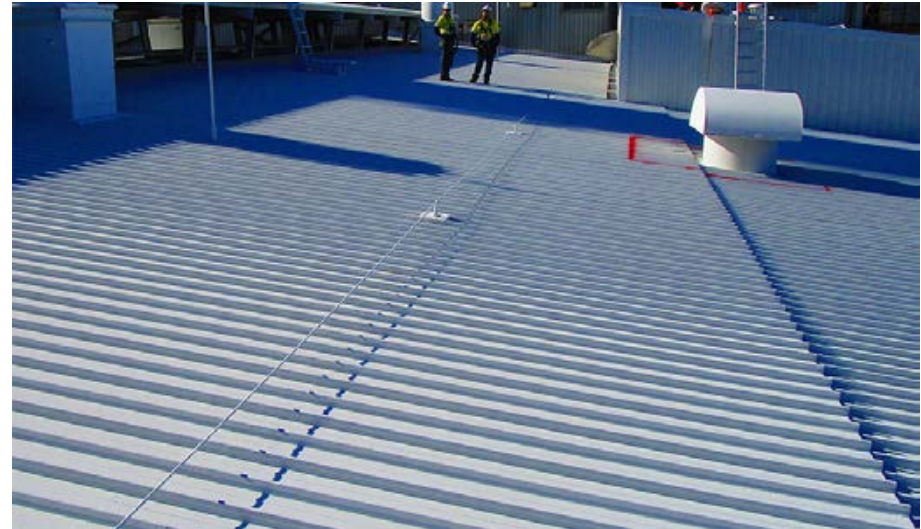
3 x Thermoshield coats | Completed coating system:

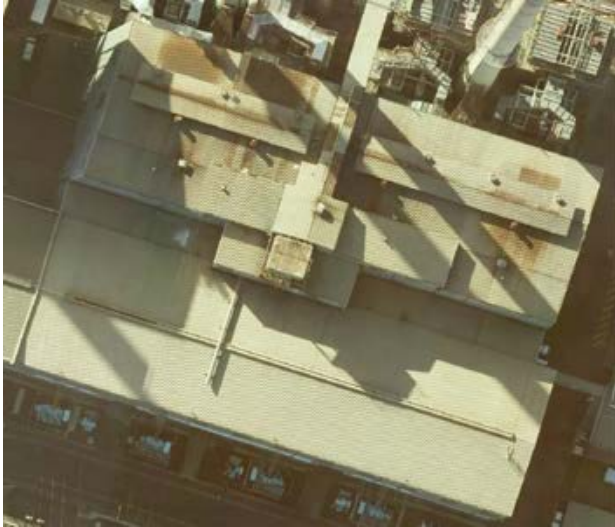
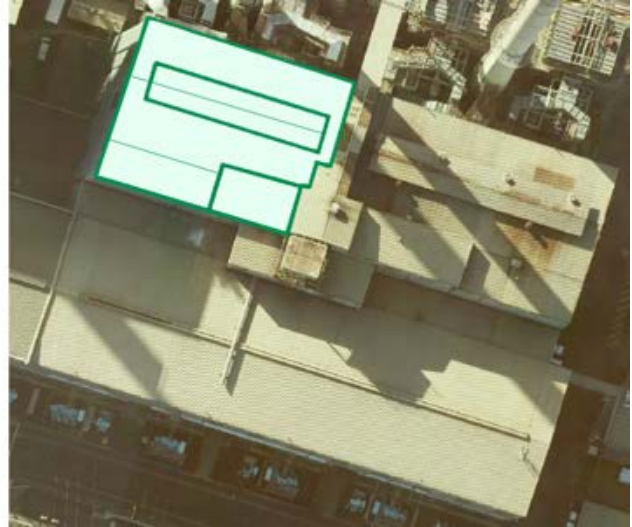
Below is a diagram of the boiler house roof:

The highlighted green area in the diagram above demonstrates the section of the roof the below “before” photos were taken from.

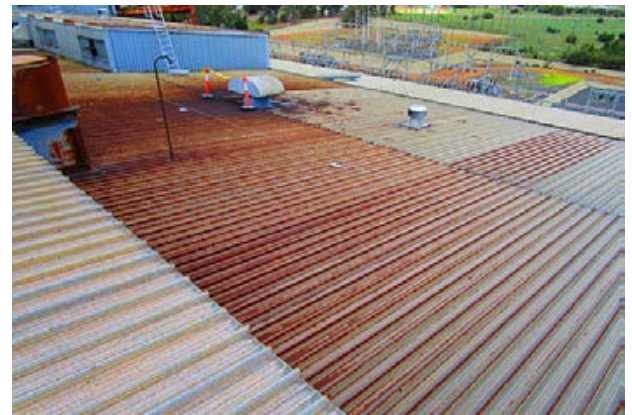
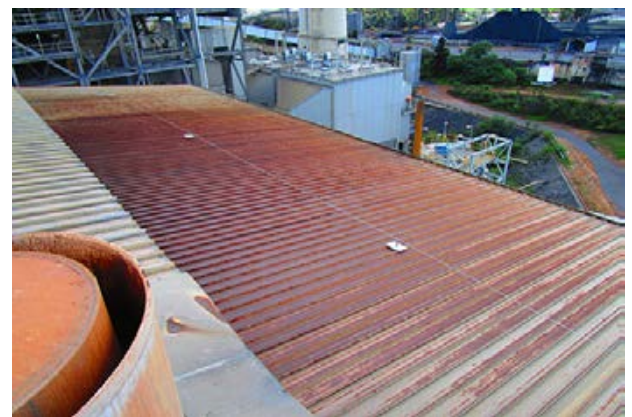
The boiler house roof was suffering from advanced, widespread surface rusting.

The below photos demonstrates the overall severity of the surface rust/corrosion:

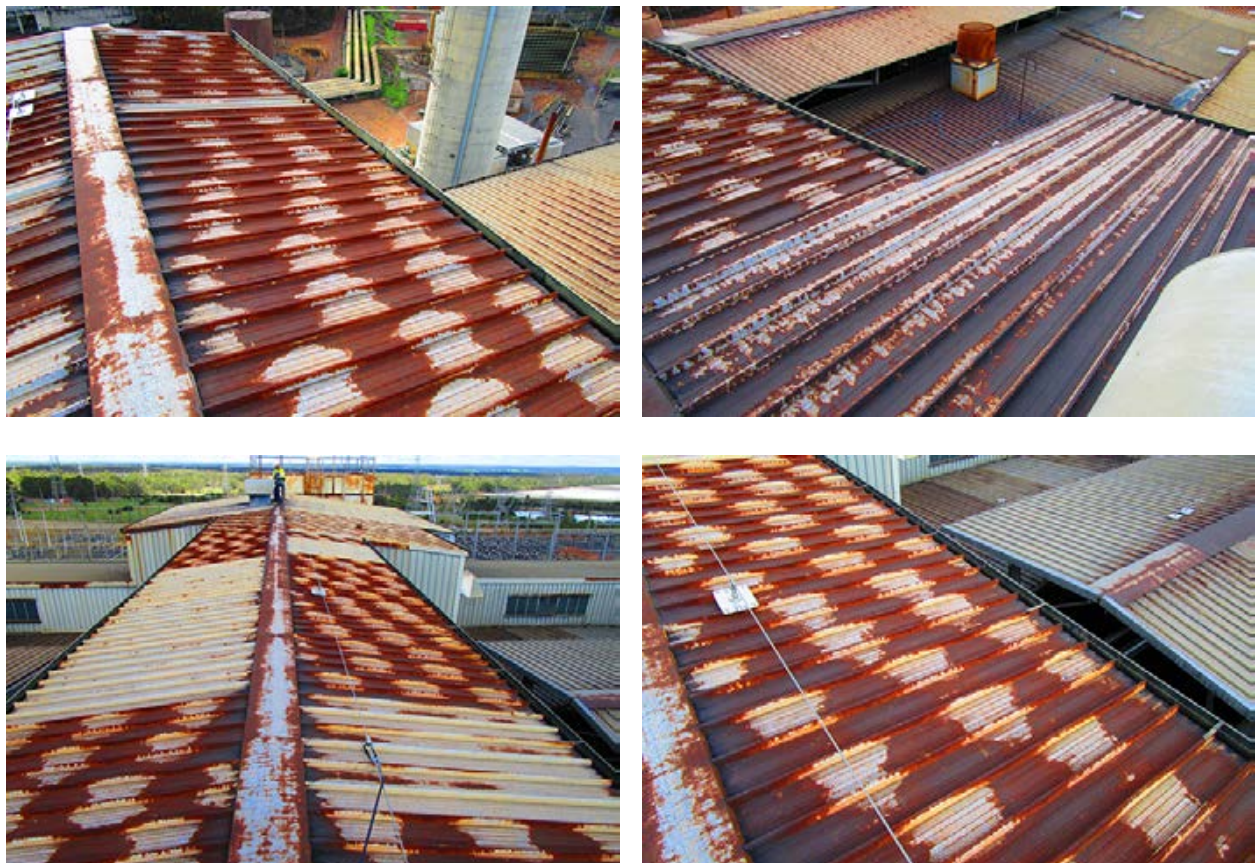
The below photos demonstrates the overall severity of the surface rust/corrosion from the middle, most upper roof of the A.B boiler house:

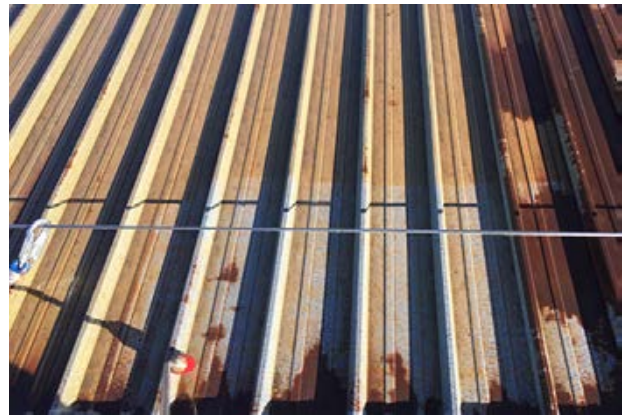
You can see from the below photos there is a clear line showing whereby the dirt/grime layer has been removed and bare metal is exposed:

All grime, coal & rust flakes were removed under high pressure water to ensure the rust converter made contact to the rust itself, not rust flakes or a layer of dirt.

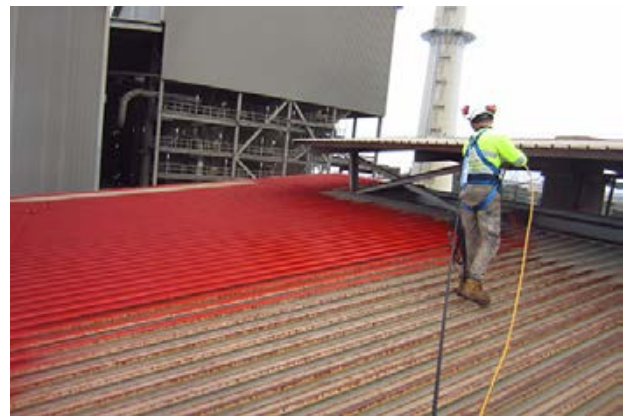
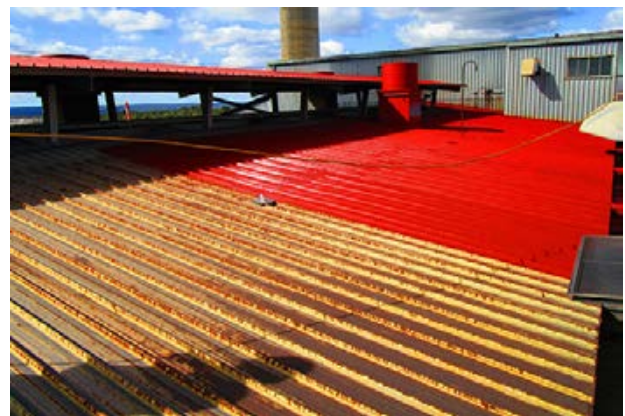
The rust converting etch primer is applied to rusted steel only and not clean steel.

Our rust converting primer of choice has a lower pH and this enables it to be applied directly over rusted steel, where the converting action turns all the rust (namely, the mixed iron oxides and hydrated oxides) into a stable metal phosphate, whilst simultaneously forming a tough protective coating over the converted steel.

This is an irreversible reaction, which leads to a permanent rust conversion - if correct surface preparation and application occurs.

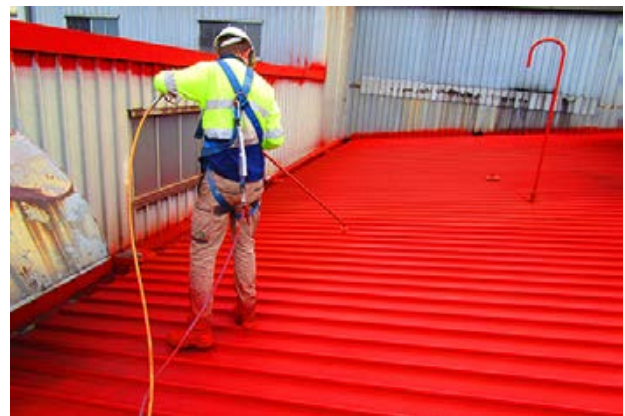
Primer coating commencement to eastern roof side:

The rust inhibitor primer is also vivid red in colour, like the rust converter. It is slightly brighter which helps ensure you know where you’re spraying.

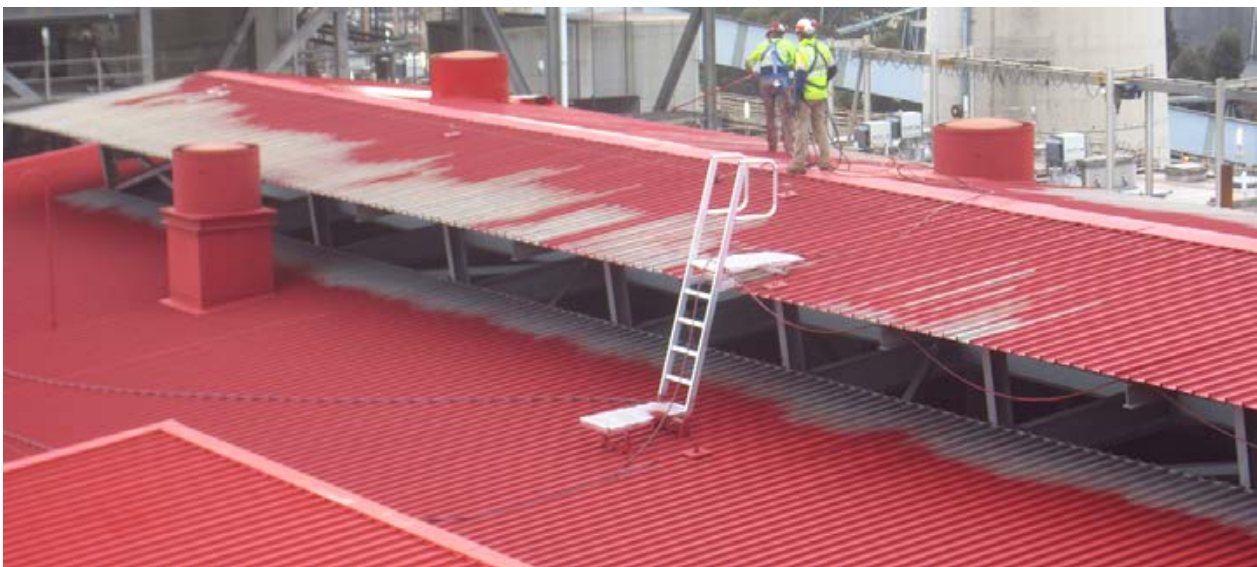
Primer coating in full swing on the western roof side:

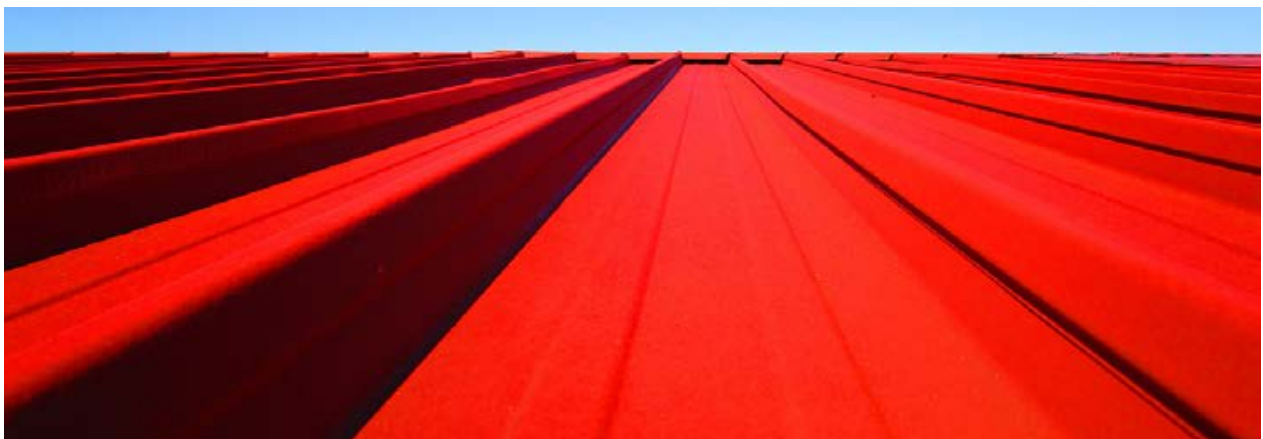
This technique ensures no rust is hidden from coating beneath the shadows of the profile ribs. The bottom of the sheet troughs essentially gets 2 x coats each passing.

Below photos demonstrates the comprehensive result of this technique:

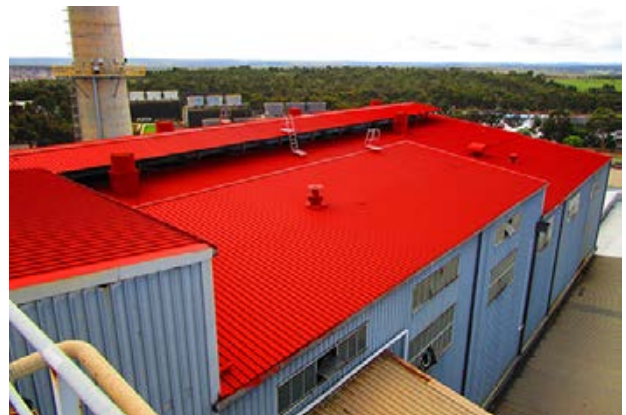
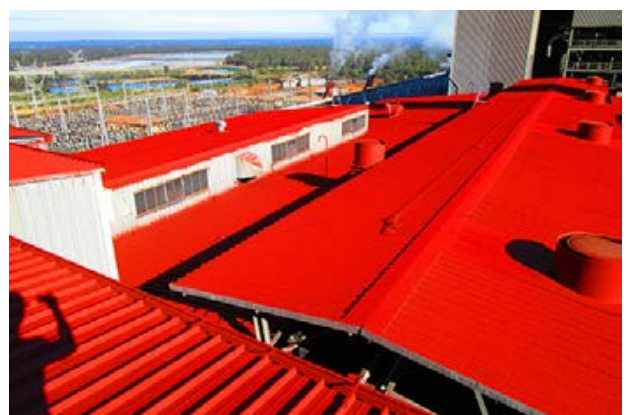
Completed rust inhibitor etch primer coating:

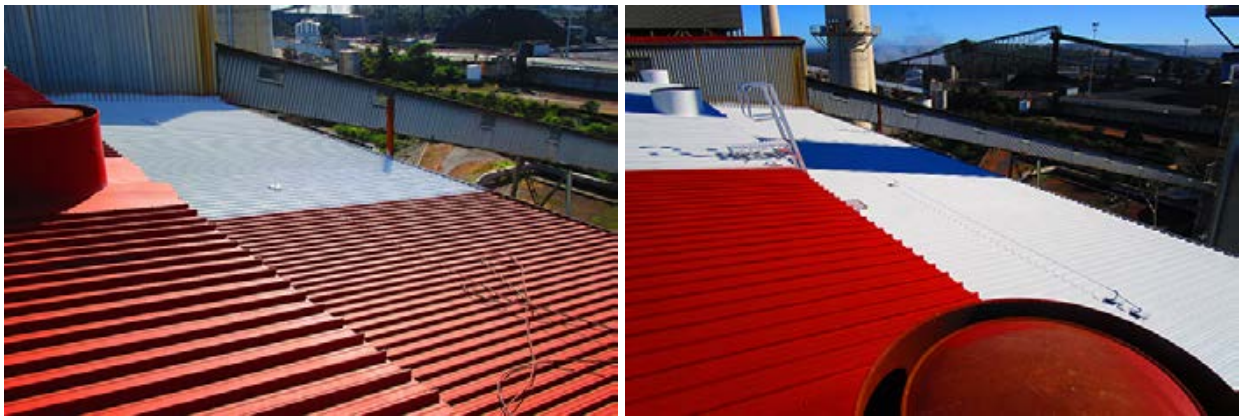
First coat of Thermoshield (light grey):

Coating over the vivid red with a high contrasting colour ensures that no spots are missed.

If you spray to lightly, the red will show through. Full red elimination ensures a thick, uninterrupted blanket coverage

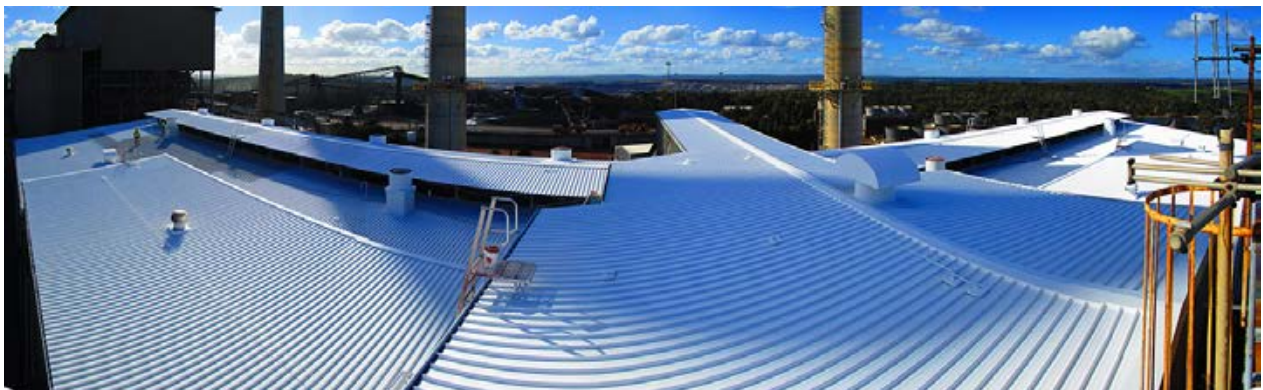
Completed second coat in white Thermoshield:

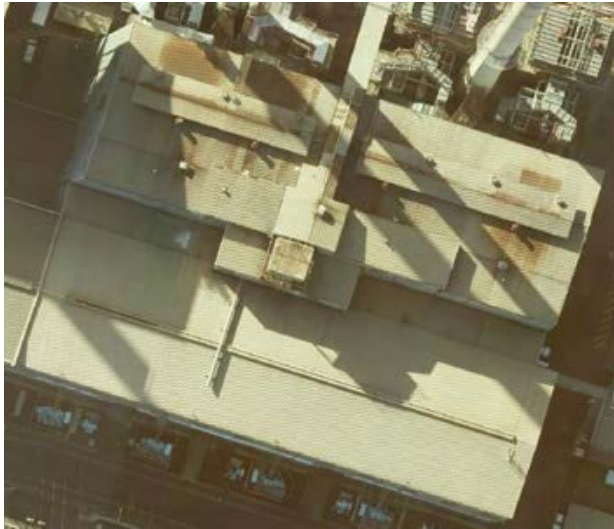
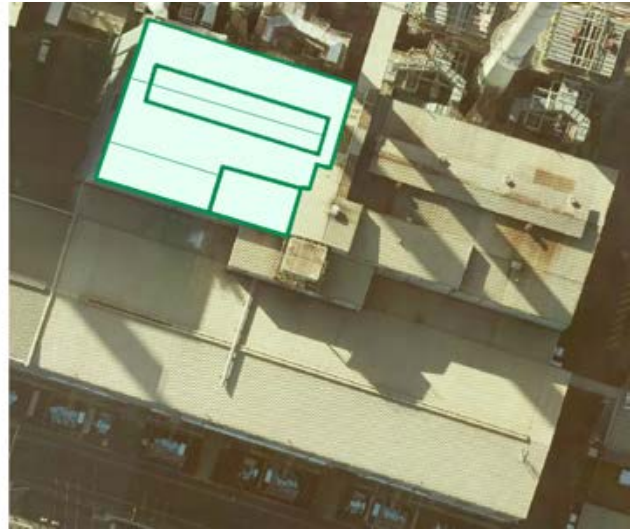
Below series of completed photos are of the western half of the boiler house roof, highlighted green in the below diagram:

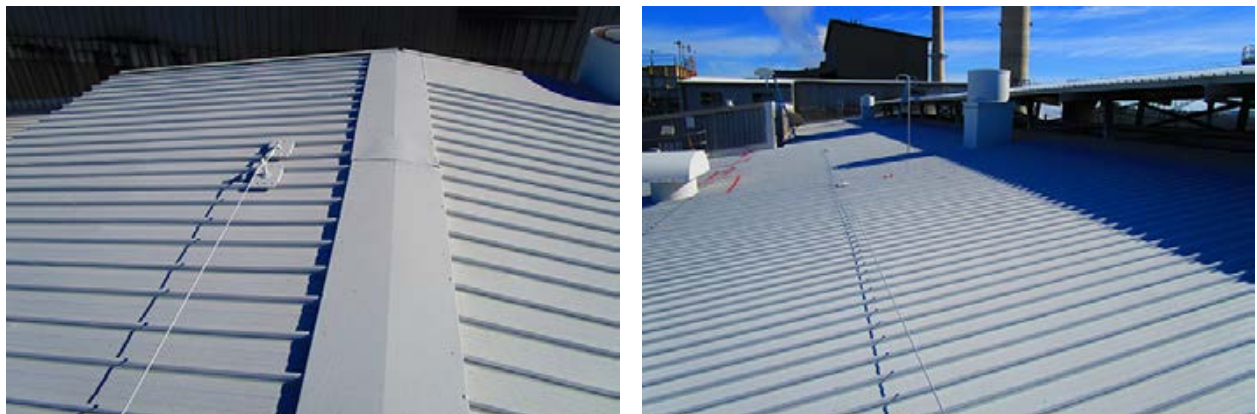
Third & final coat applied in a light grey (shale grey):

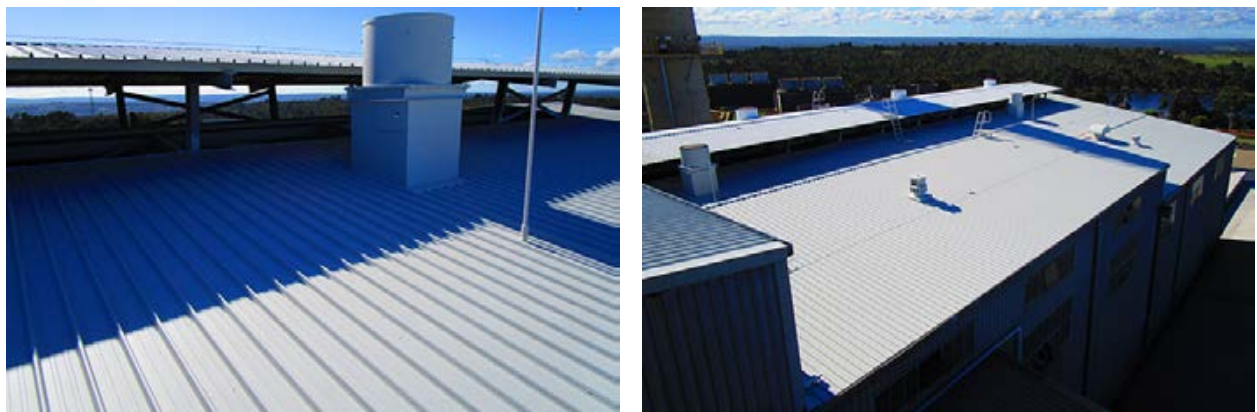
The rust conversion process is permanent & irreversible.

Once the rust converter & rust inhibitor primer have cured, the thick ceramic membrane creates a non permeable protective 'blanket' shielding the metal from all environmental & chemical exposure (such as coal ash deposited on roof sheet from chimney stacks).

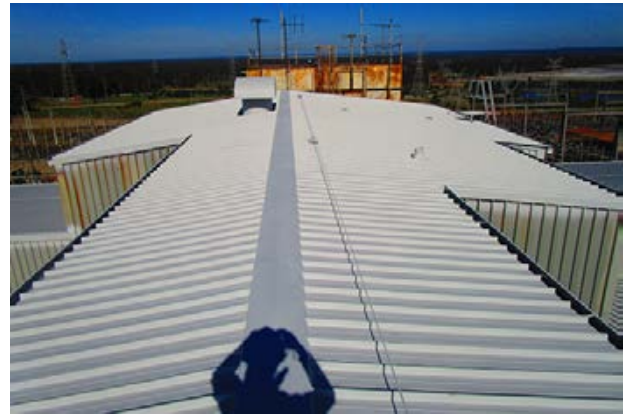
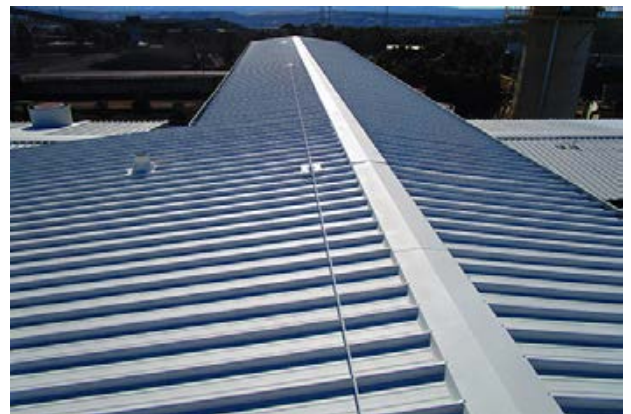
Third & final coat applied in a light grey (shale grey):

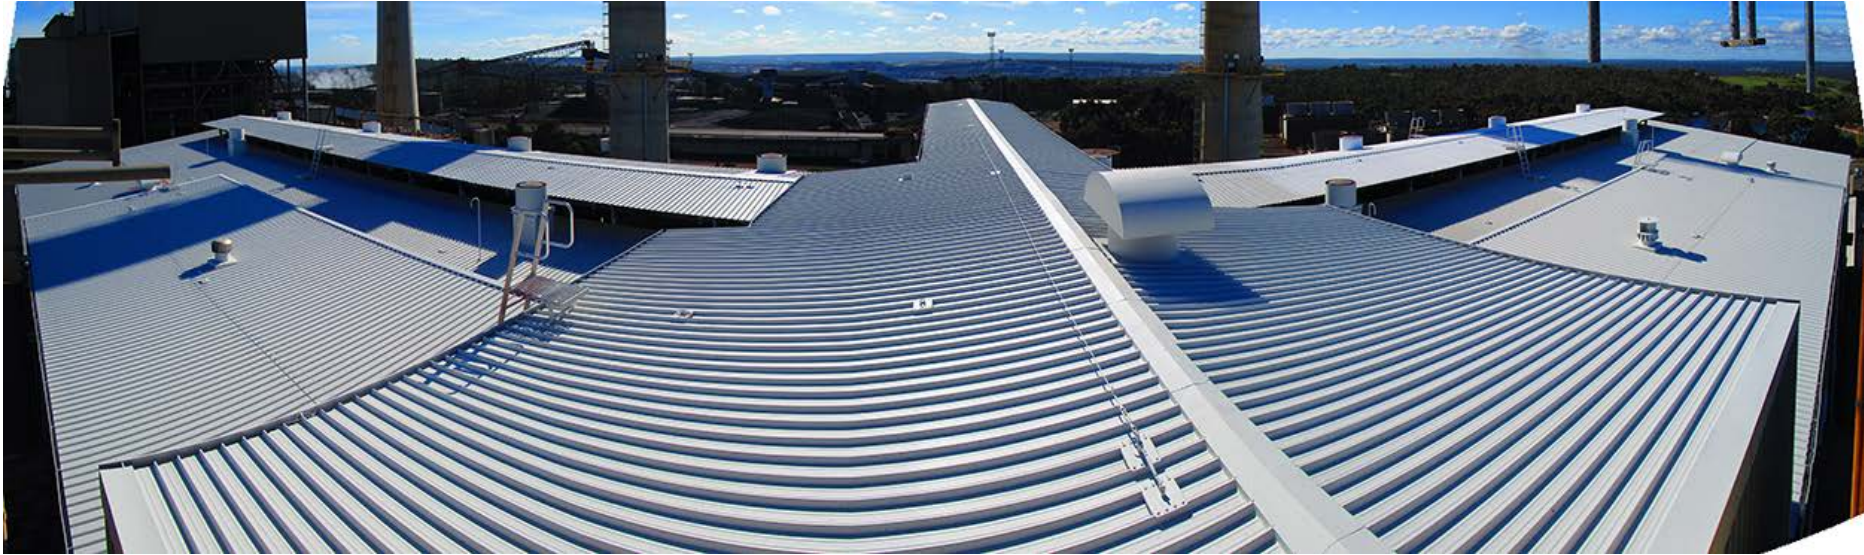
After a grueling month comprising of a thorough surface preparation and 5 separate coats - the below panoramic photo demonstrates the completed rust conversion restoration coating system. Complete with 10 year warranty:
