THERMO SHIELD®

Residential Restoration
Mould Removal | Rust Conversion | Thermal Insulation

ROOF RESTORATION - Mould removal | Rust conversion | Thermal ceramic coating

This report takes you through the process of the various stages undertaken on restoring a heavily weathered, aging roof suffering from widespread surface rusting - due to the incorrect use of dissimilar metals between roof sheeting & tech screws, causing galvanic corrosion.

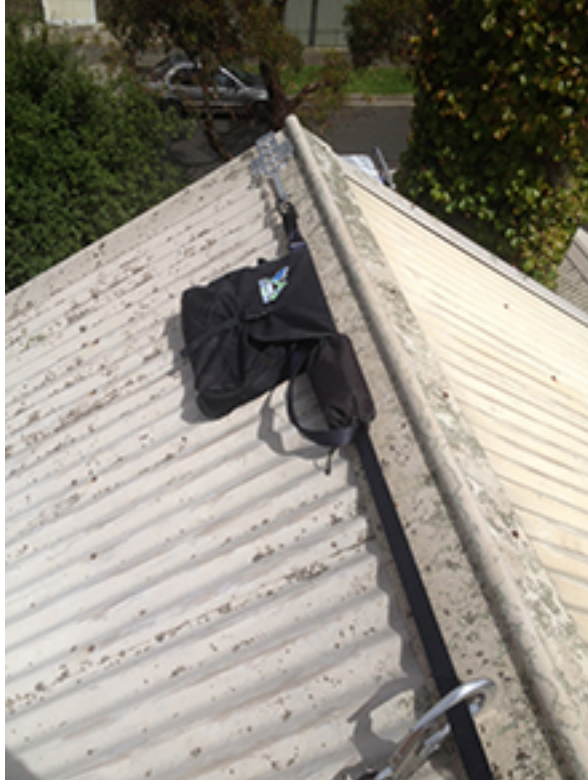
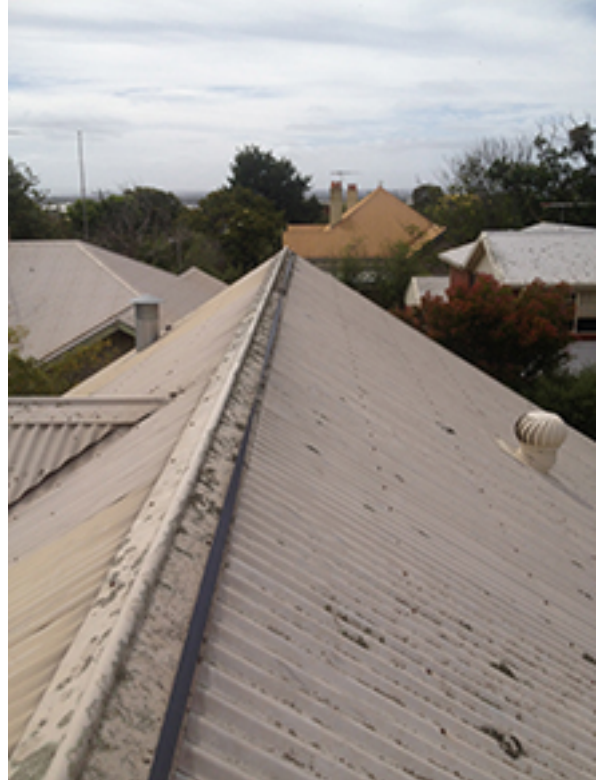
Prior to works commencing, a permanent static line (or 'lifeline') was installed in order to work on a very steep pitched roof. The photos also doubles for roof condition prior to work:

The roof is visible from road level and you can see the roof has become highly unsightly due to the build up of moss & mould.

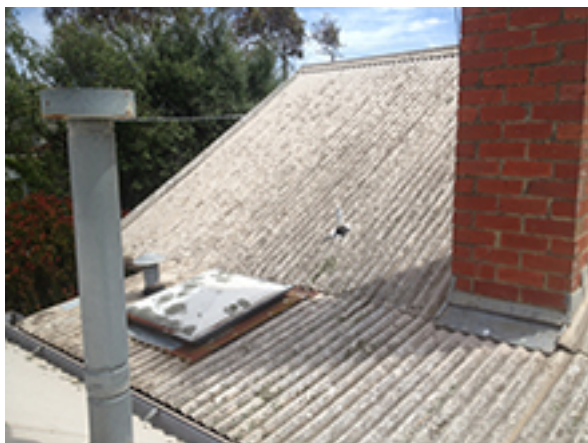
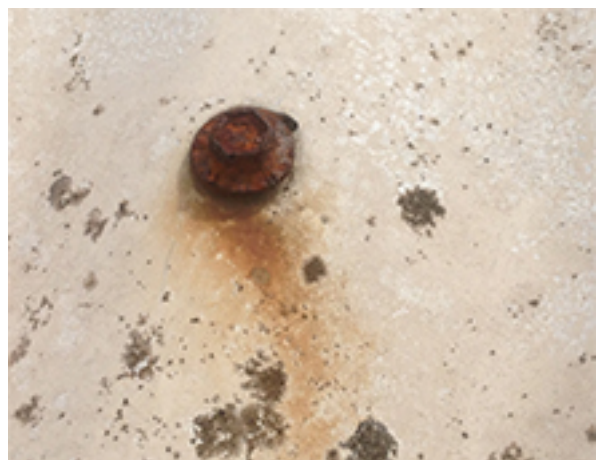
On closer inspection – the roof had far greater issues than its appearance in that heavily rusted tech screws had caused the rust to spread onto the roof sheeting itself:

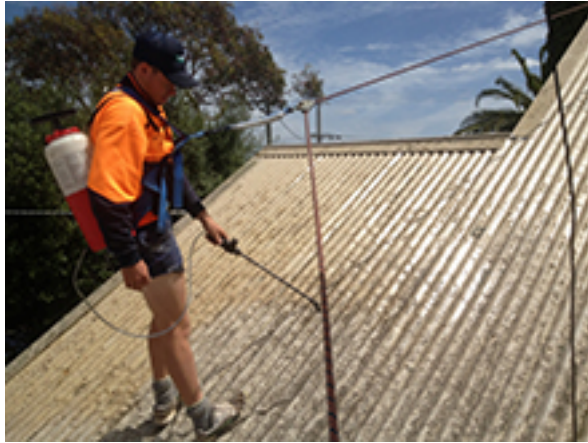
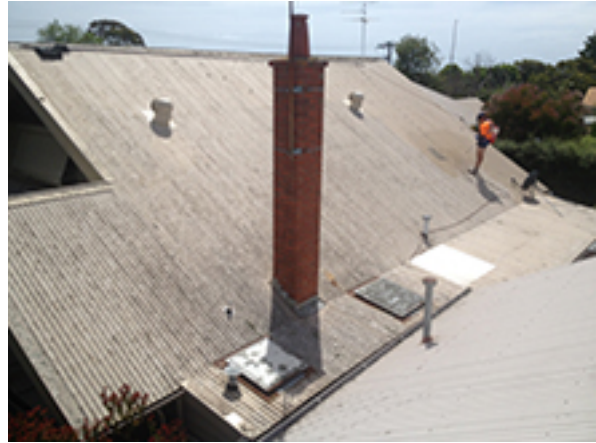
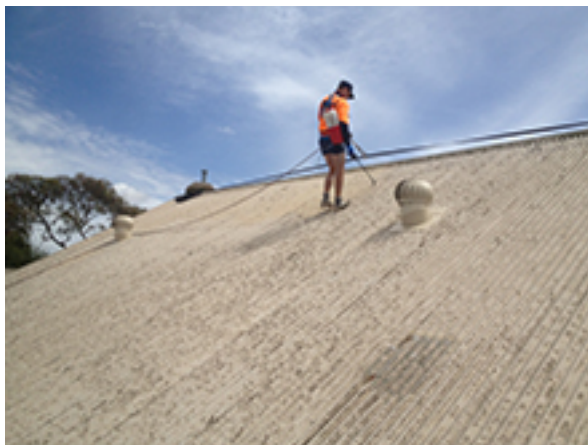
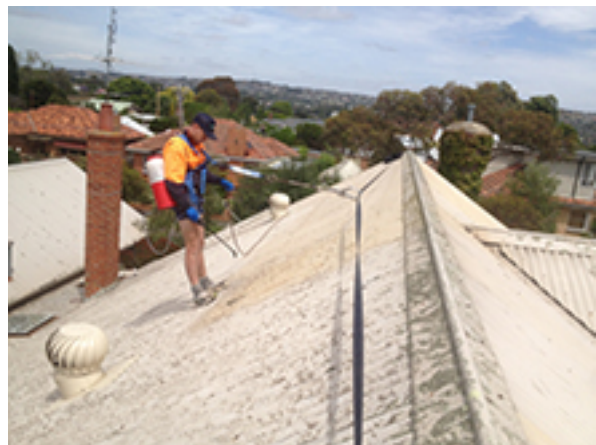
Below photos shows the applicator applying a very low pressure chlorine mist in order to greatly assist in completely removing all mould, moss & grime from the roof sheets.

Without this process, the risk of product not making ideal 'contact' to the metal increases. Again, the photos also double as 'before' shots of the roof:

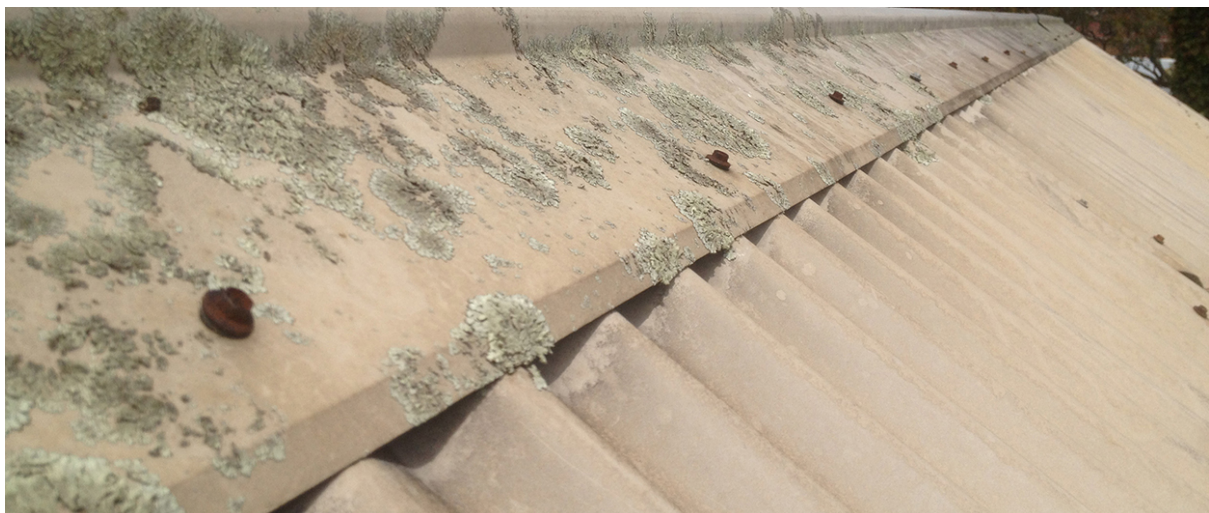
Again, you can see from below the in amongst the moss & mould, each & every tech screw roof connection are on their "last legs" – which was beginning to cause roof sheet corrosion:

In our experience, when advanced tech screw rusting spreads to the roof sheet itself, in 2-3 years the areas around the penetration corrode through which causes widespread waterproofing issues – which ultimately leads to roof replacement.

Heavy tech screw corrosion, coupled with the damaging effects of roof expansion & contraction - leads to screws breaking &/or becoming dislodged creating prominent openings for water ingress.

In addition, the high rust content water run off also causes accelerated wear on roof channels, sheet troughs & gutters – significantly reducing their expected life.

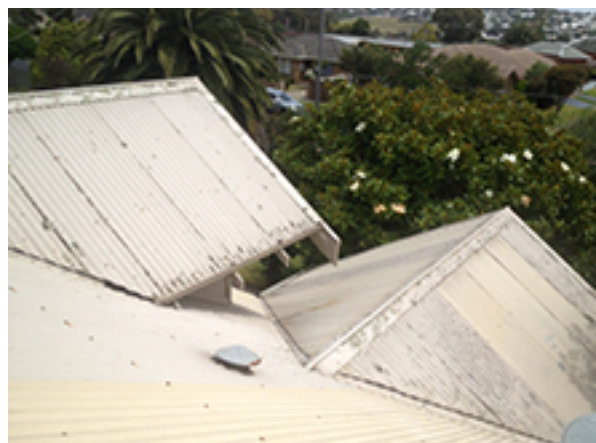
What appeared to have been simply an unsightly mould issue – in reality was also a potentially very expensive corrosion issue.

If left untreated, the roof could well have found itself on its “last legs” in the very near future, which would have resulted in a major cost & inconvenience to replace it

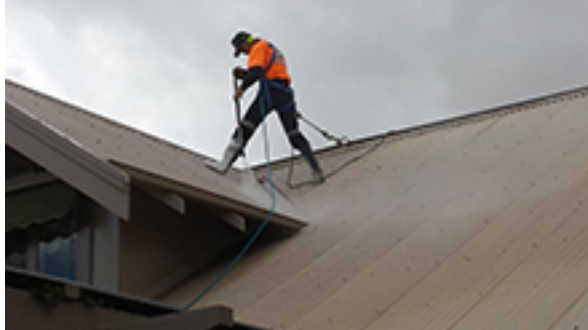
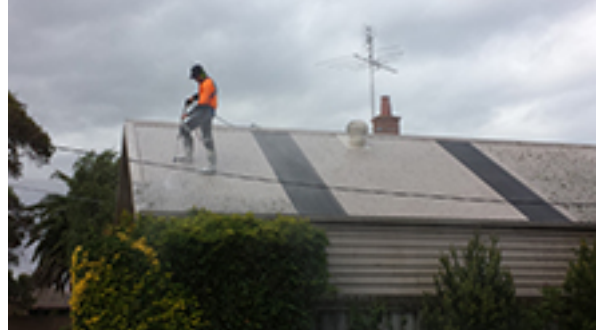
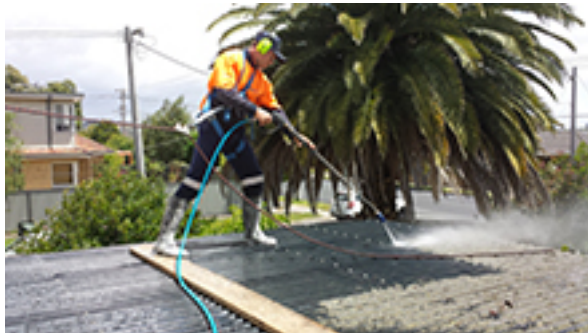
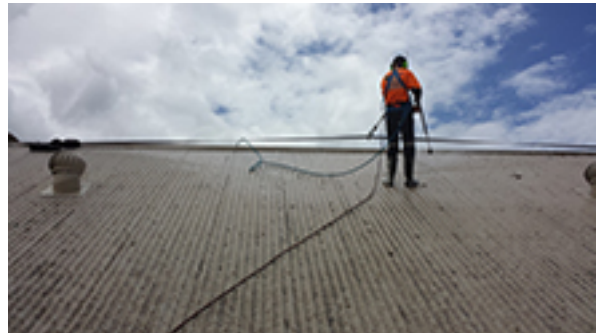
Fairly self explanatory – however the point to stress is that minimum of 3,000psi is required. High-pressure washers bought from hardware stores or DIY kits, are manifestly inadequate.

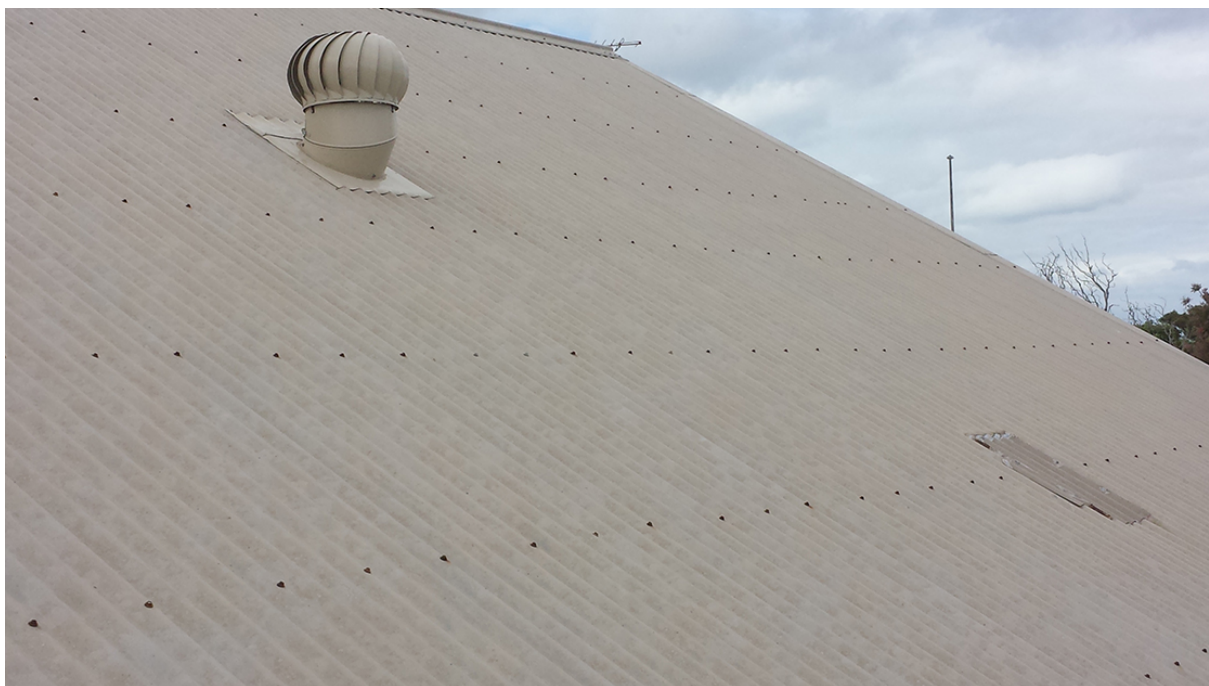
You can see from the below photos the difference following the mould and grime removal. Once cleaned, it highlights how corroded the tech screws have become:

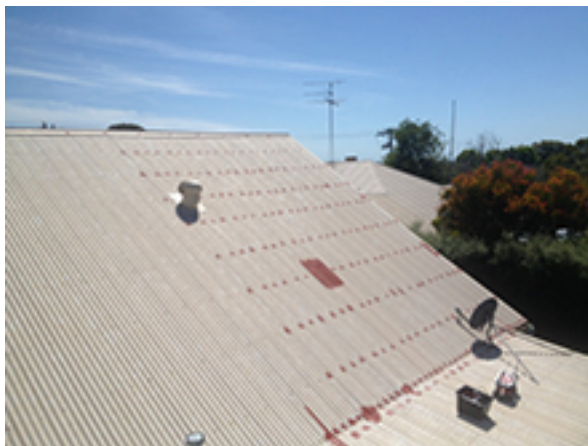
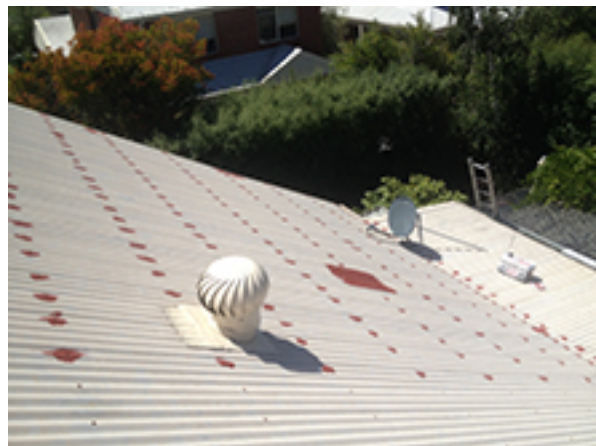
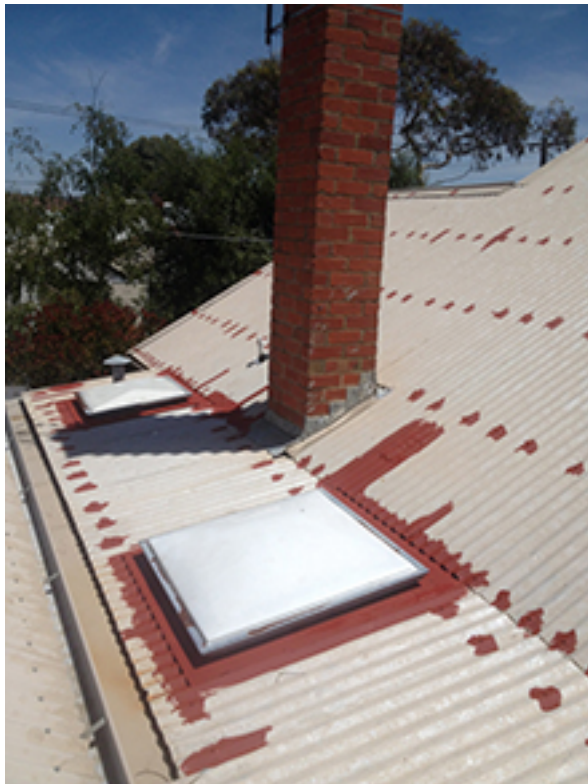
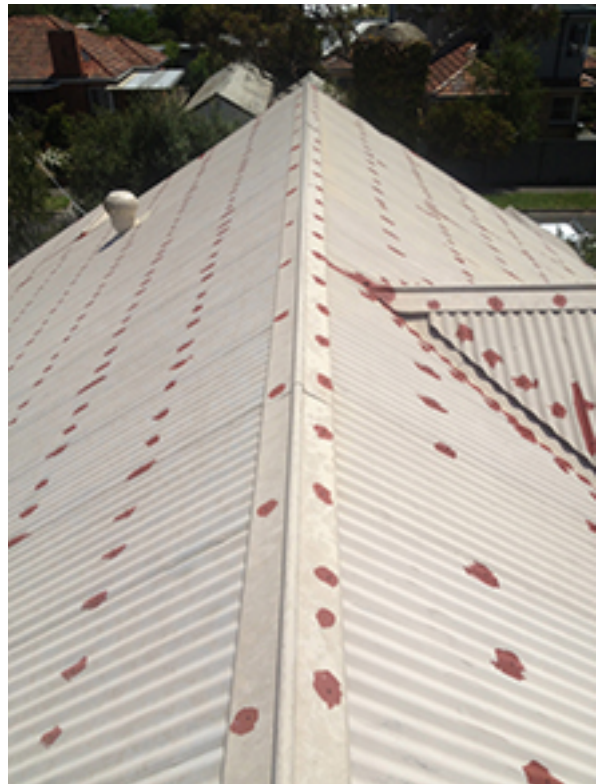
In order for rust to not re-surface through the coating, a dedicated rust converter is applied to convert the rust into a stable metal phosphate & simultaneously forms a protective abrasion resistant skin.

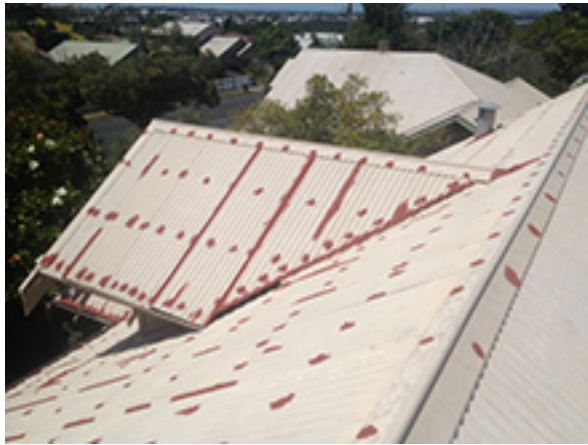
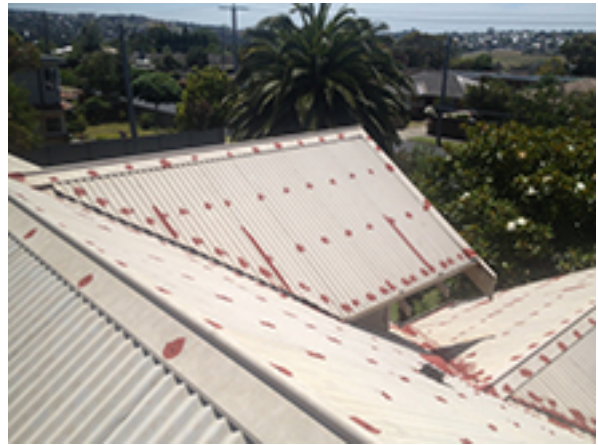
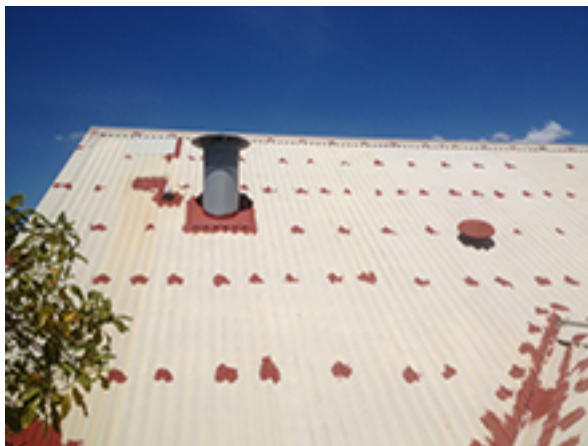
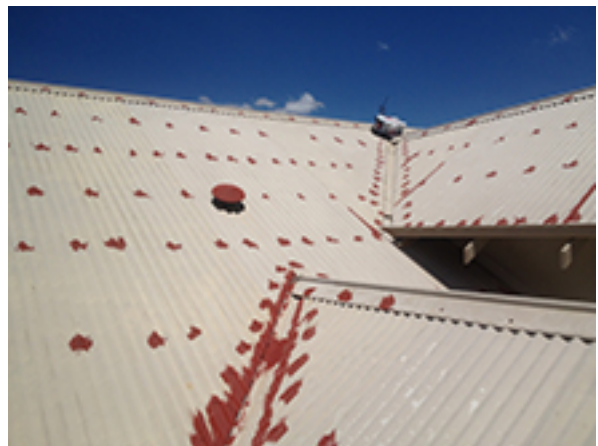
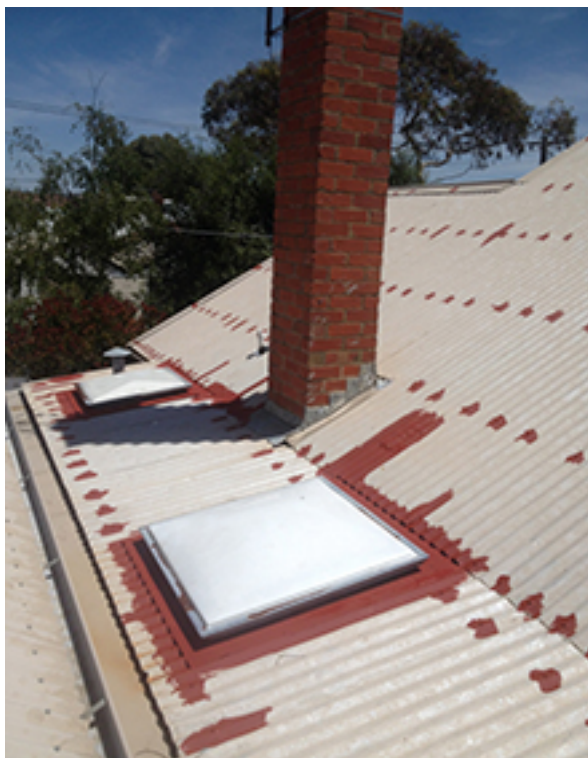
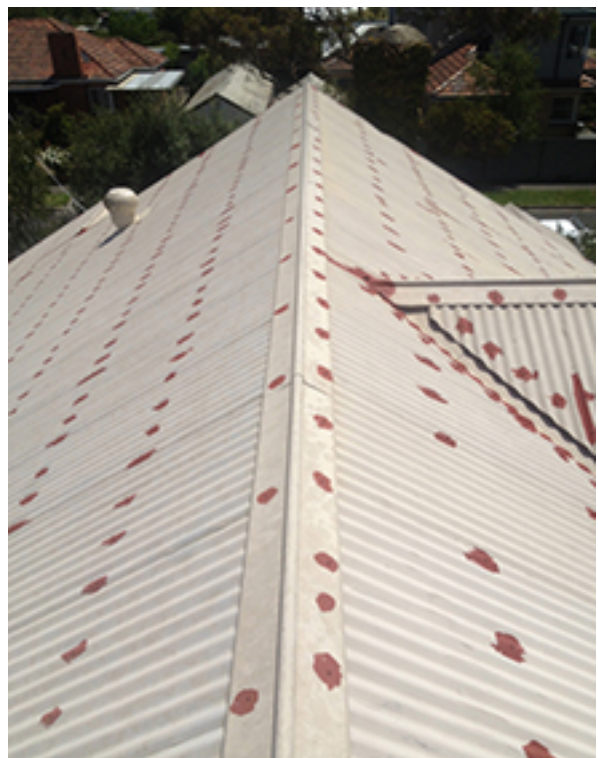
The 'polka dot' contrast of the roof sheet to rust converter highlights how widespread corrosion & rust rusting had become underneath the moss & mould coverage:

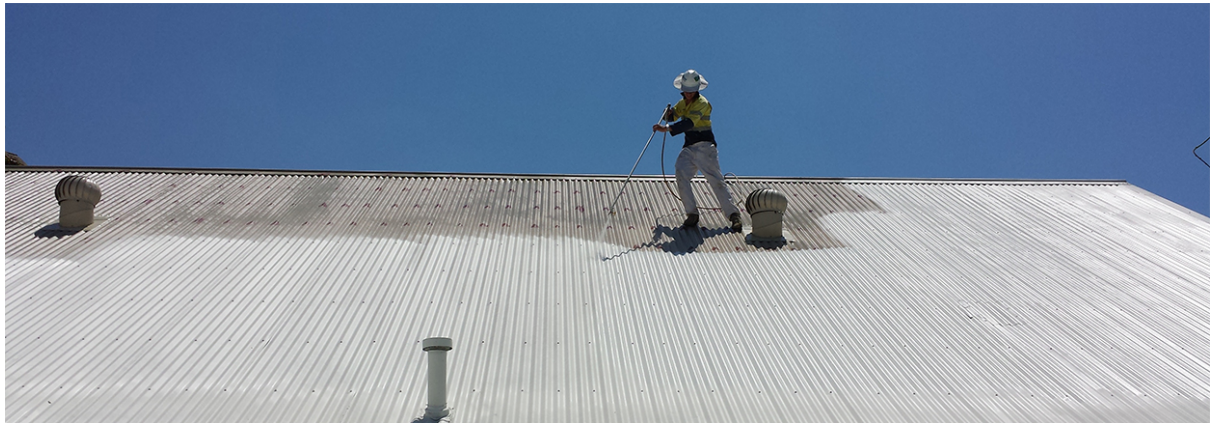
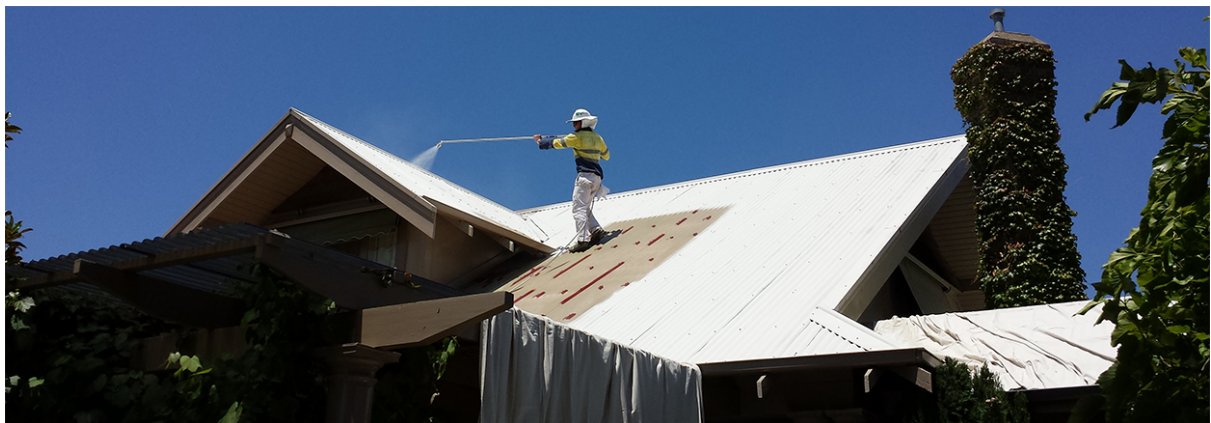
Significant amount of care was taken to remove the potential for overspray to damage surrounding areas such as plant life, decking & house walls.

We estimate that the colour 'surf mist' would result in approximately 70% of the thermal performance efficiency, compared to the standard pure white coating.

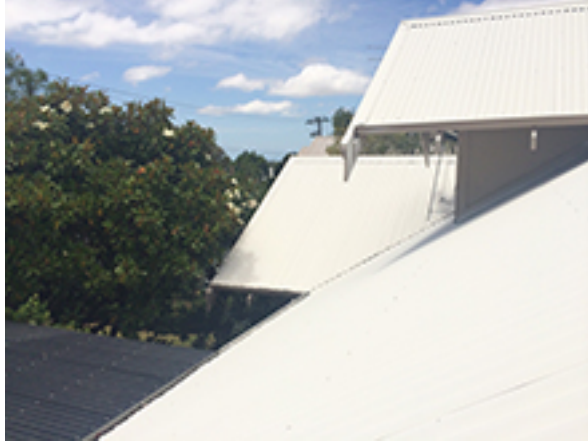
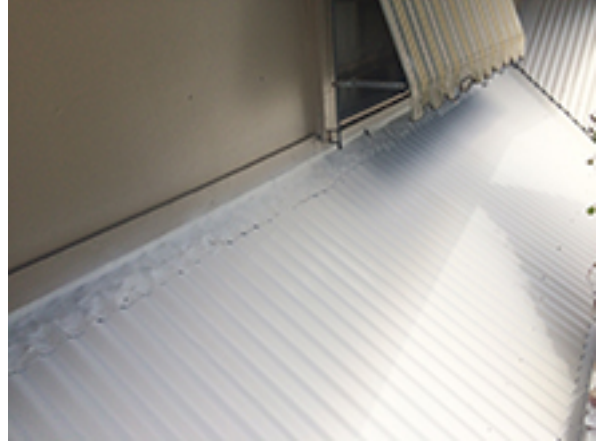
You can see from the below two photos how much care was taken to avoid over spray. You can see the tree was protected & any edges were cut in by hand:

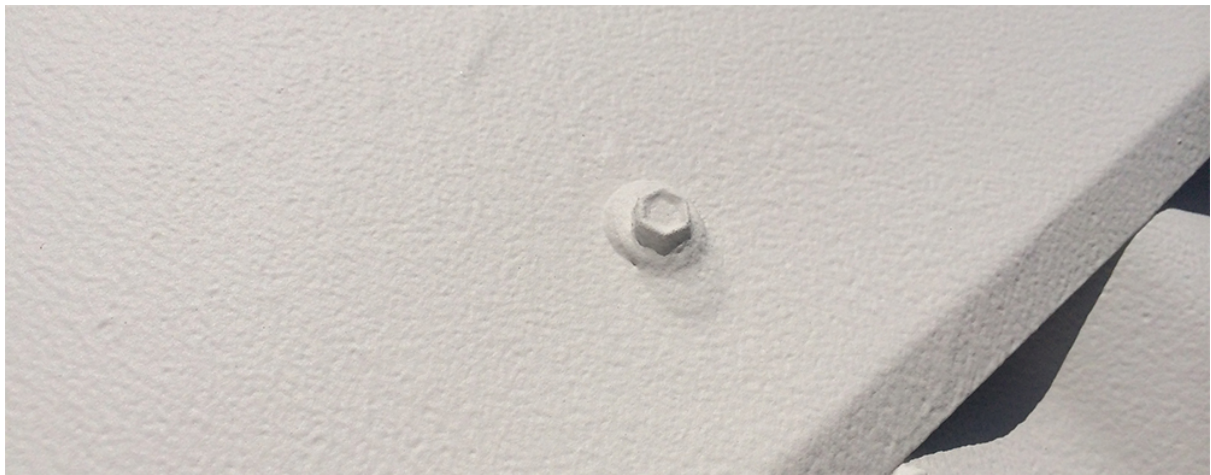
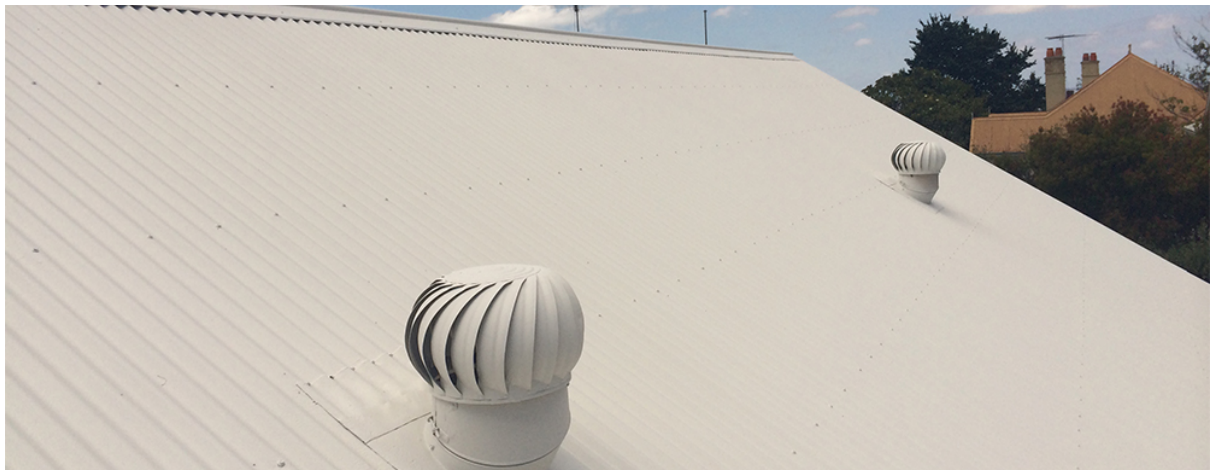
You can see from the below photo how the tech screws have been well sealed beneath the ceramic coating. If the problematic screws are not able to come into contact with water or oxygen, then they are deprived of essential elements to cause further corrosion.
