Victorian College of the Arts  
Pre Solar PV installation - Roof Protective Coating Work

### **Roof protection coating system**

**Project Site:** Victorian College of the Arts

**Site address:** 234 St Kilda Road, Southbank VIC 3006

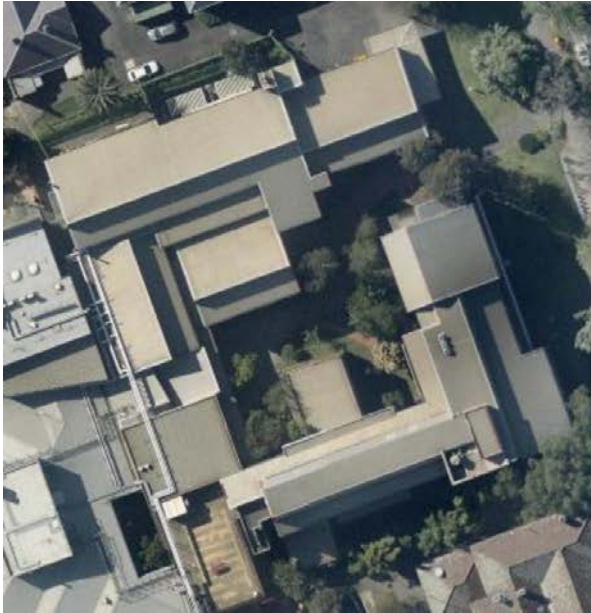
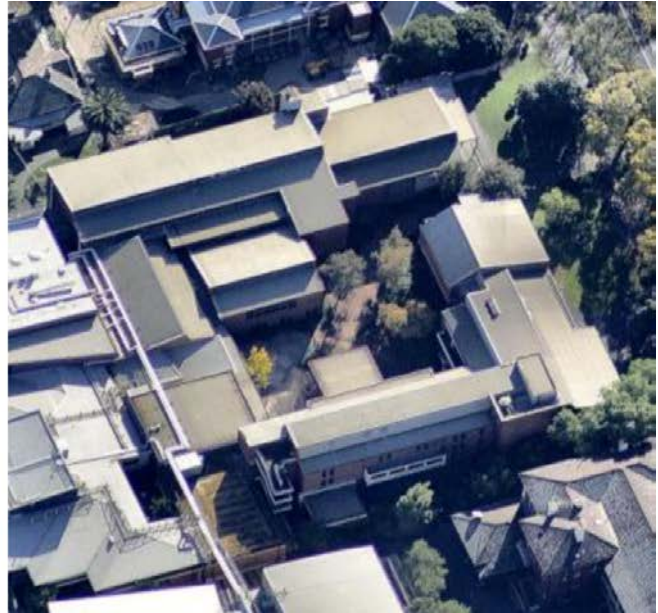
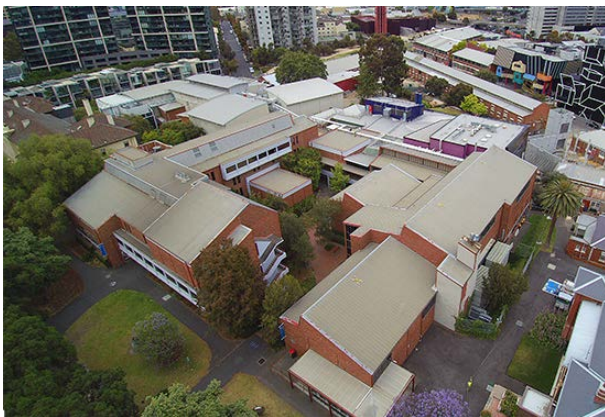
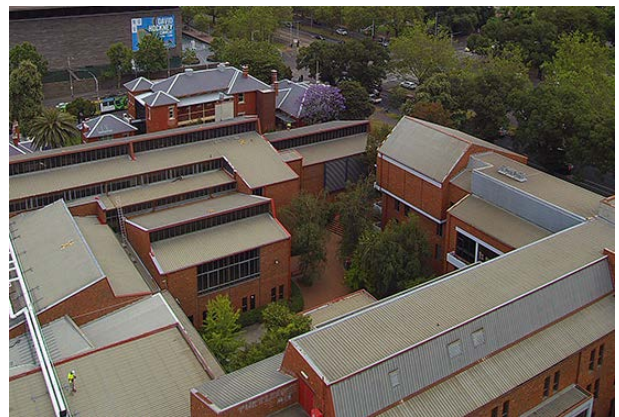
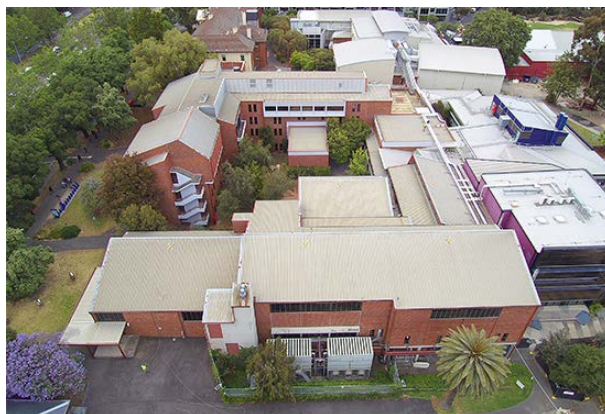
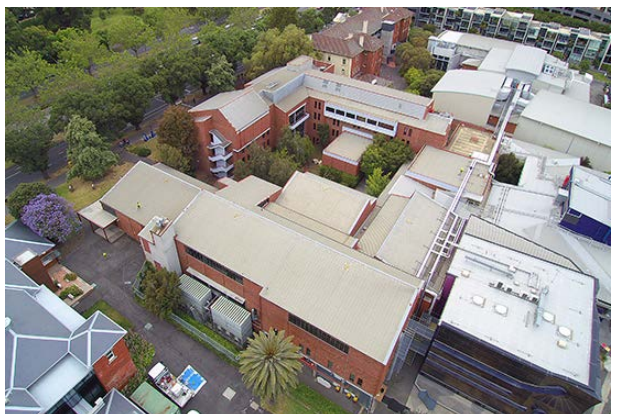
The VCA roof was heavily ageing and showing widespread signs of deterioration.

Below aerial photos of the weathered, ageing roof:

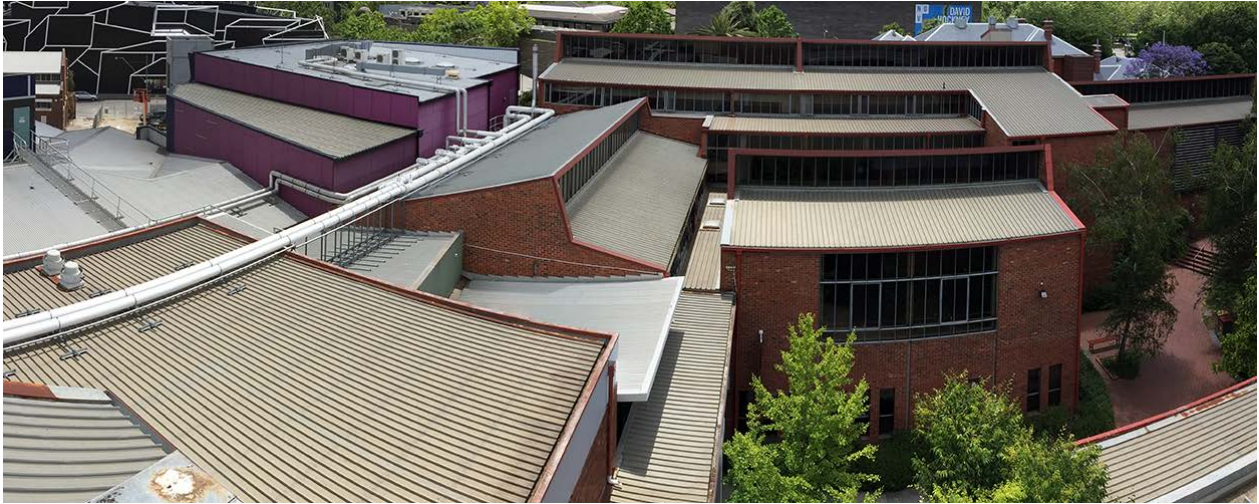
Wider angle photo of the unique roof design:

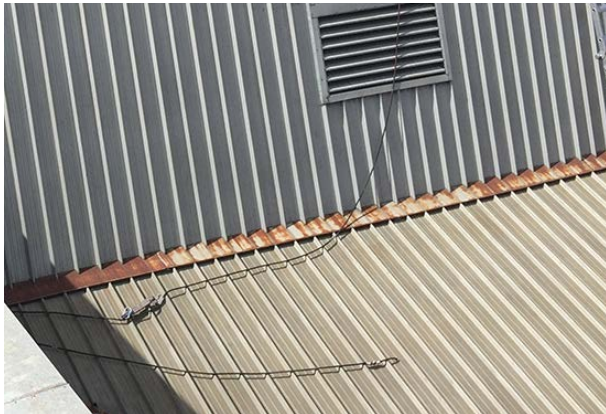
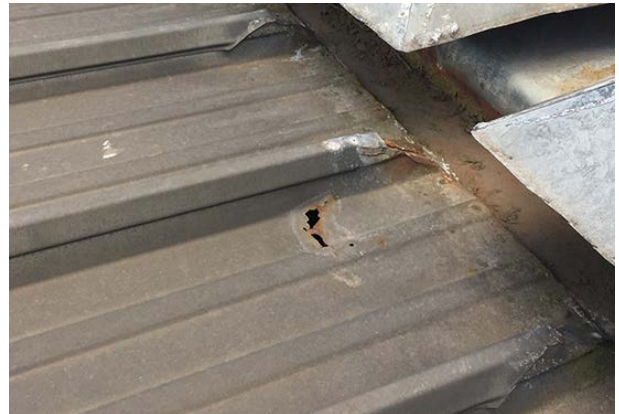
Heavy surface rusting along flashings as well as spot corrosion:

Many of the flashings were suffering from surface rusting. Rust conversion was not in the original scope however prior to coating works, we felt it was necessary to treat the rusted flashing to ensure longevity:

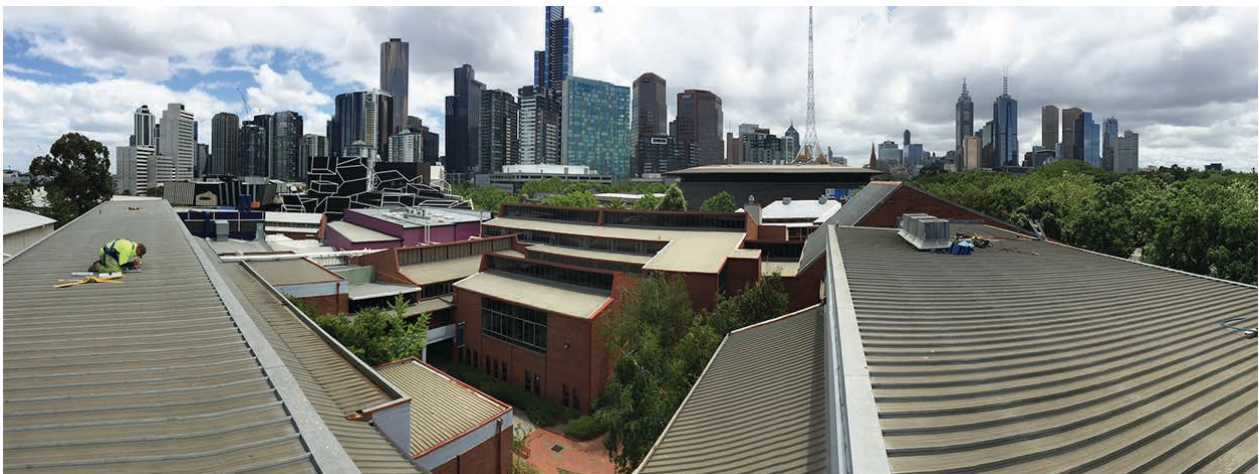
Wider angle image of various VCA roofs, as well as roof safety anchors being installed:

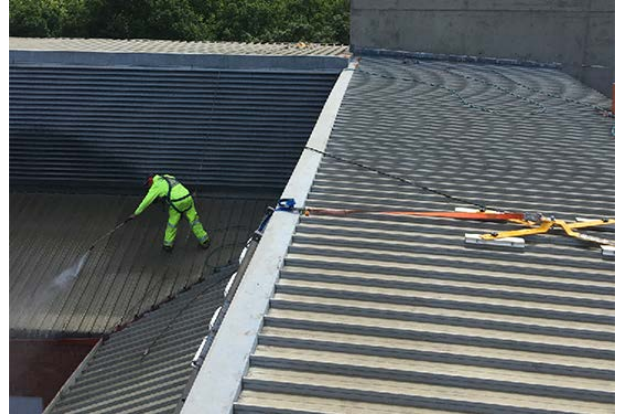
All surfaces cleaned under high pressure water prior to coating works:

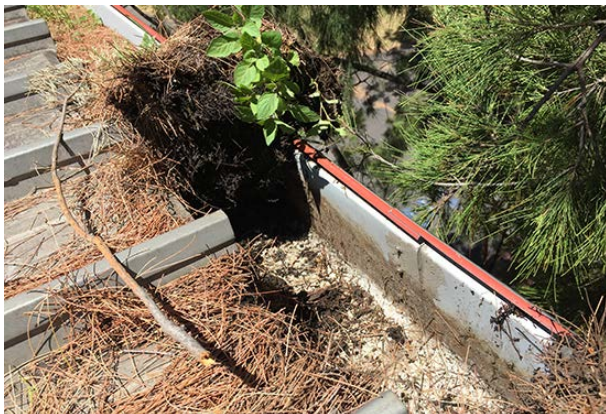
In addition to the roof sheets, gutters that were completely filled with debris were cleaned and power washed:

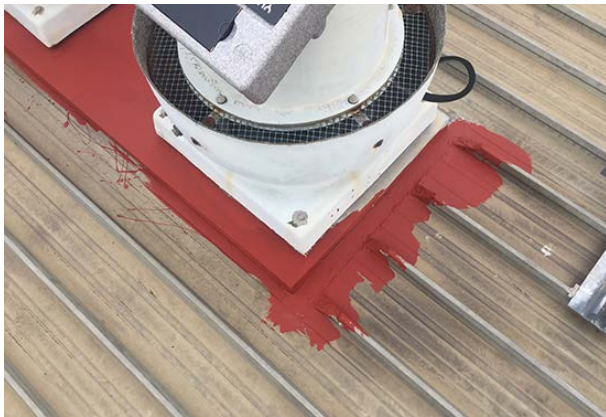
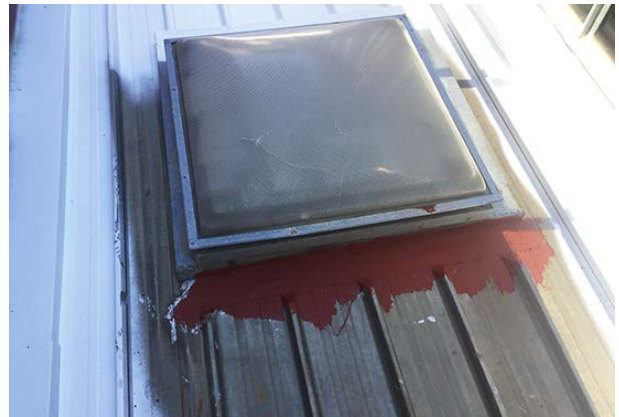
Water pooling around penetrations caused surface rusting:

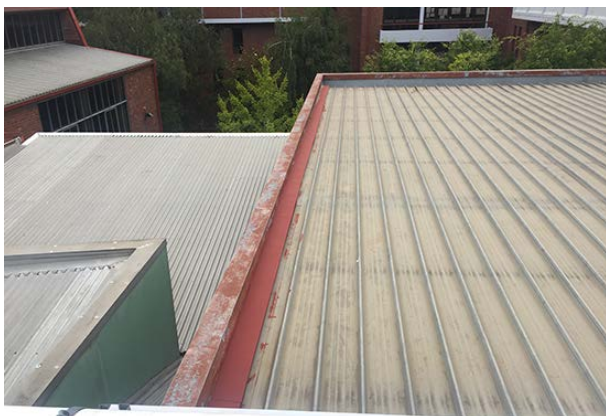
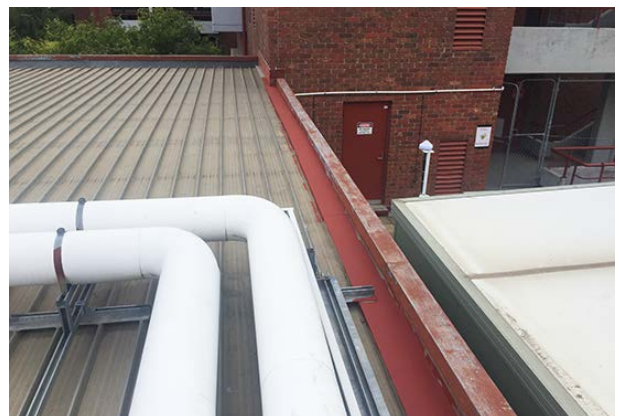
Most flashings were/are galvanised steel whereas the roof sheeting is zincalume. The electrical mismatch in the dissimilar metals resulting in accelerated corrosion of the flashings:

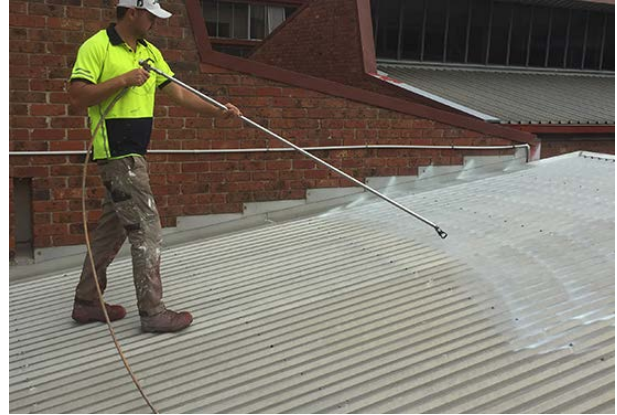
Etch primer is then applied over all areas prior to the ceramic top coat. This particular etch primer ensures maximum adhesion to the ageing roof sheets.

The etch primer is misted on fairly indiscriminately as it dries clear.

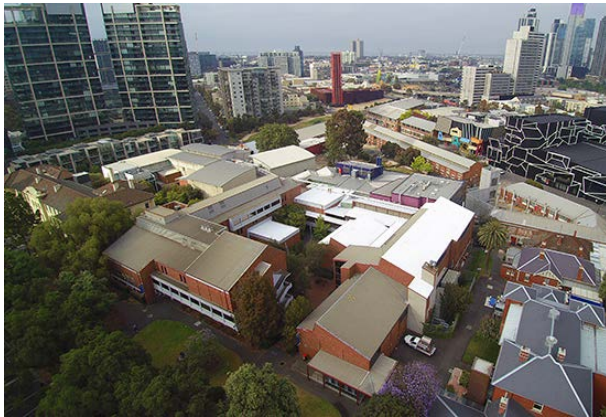
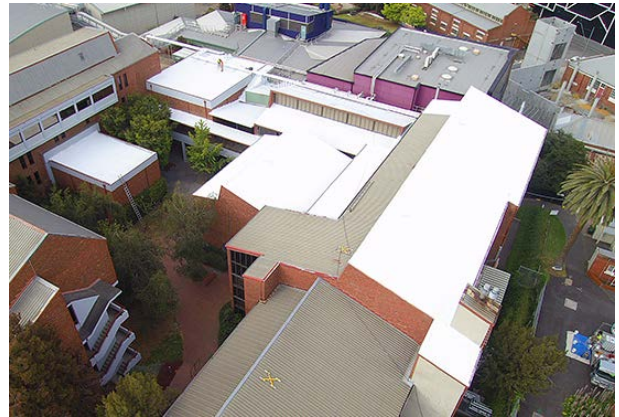
The first coat commenced (stage 1) in basic white Thermoshield:

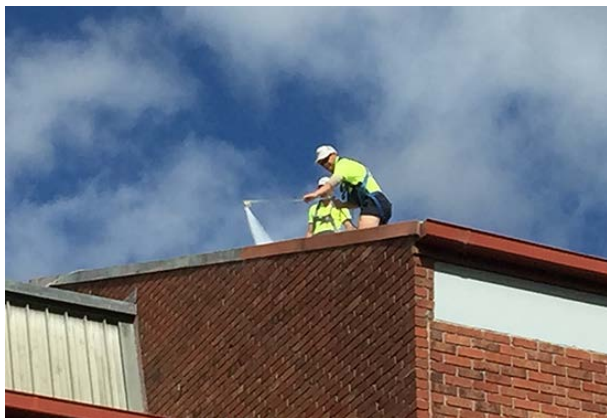
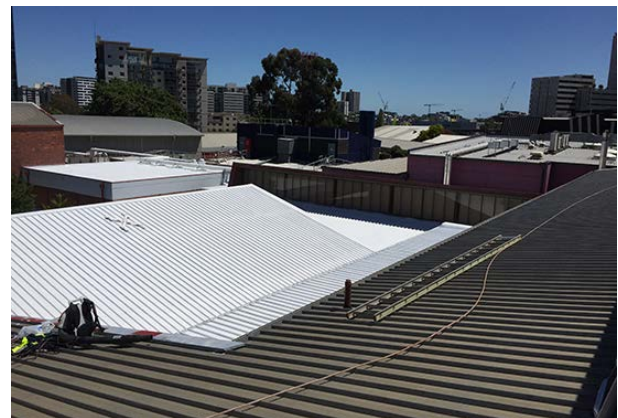
Below (left) shows application near live edge. You can see harnesses in use for both sprayer and spotter. Below (right) shows eye level progress shot:

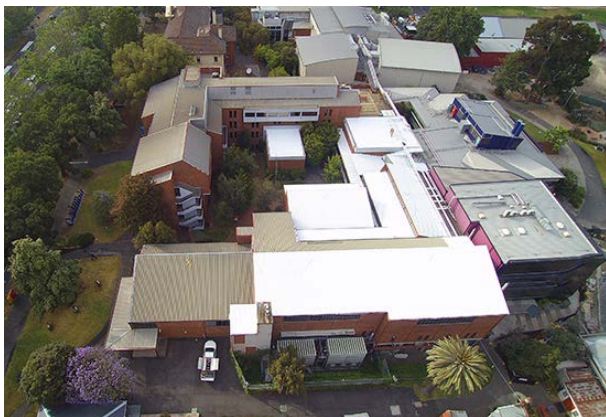
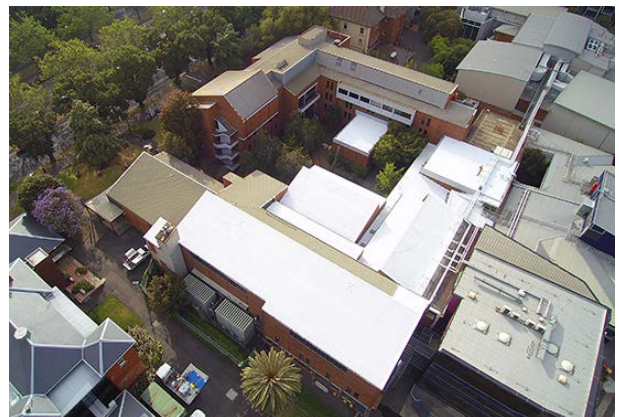
Aerial photos showing the vivid white of the Thermoshield coating:

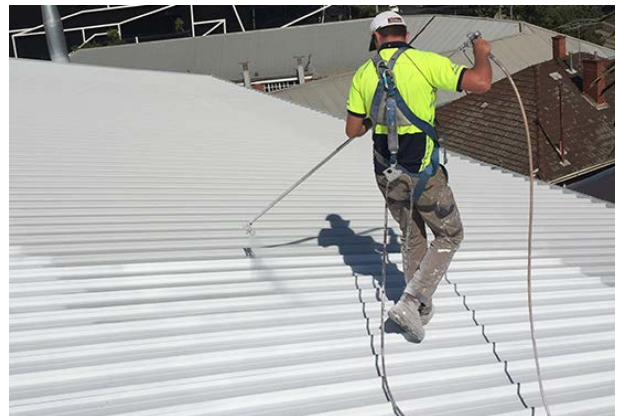
The second (top coat) was completed in infrared pigment shale grey. The infrared pigment reflects greater amounts of UV radiation, therefore increasing the thermal performance of the ceramic membrane compared with regular tinting.

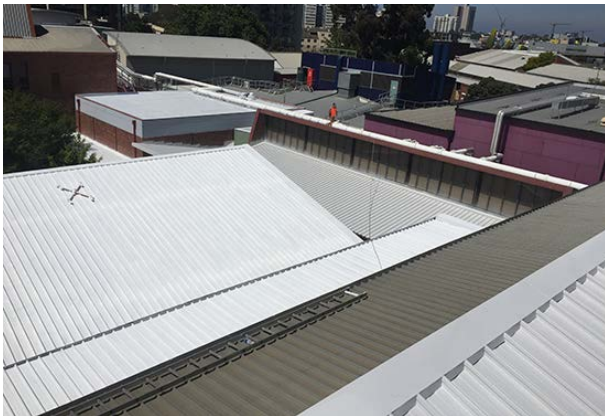
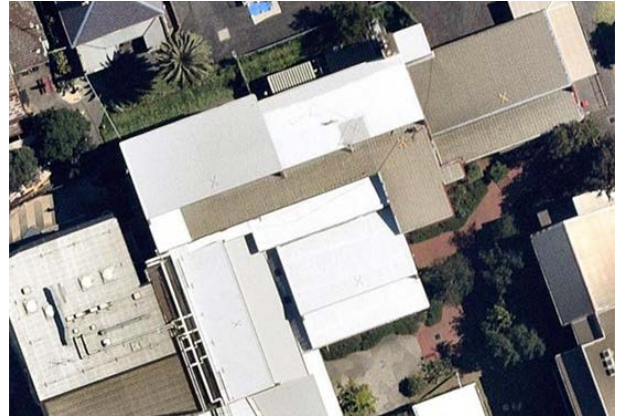
Contrast between white first coat and shale grey second coat:

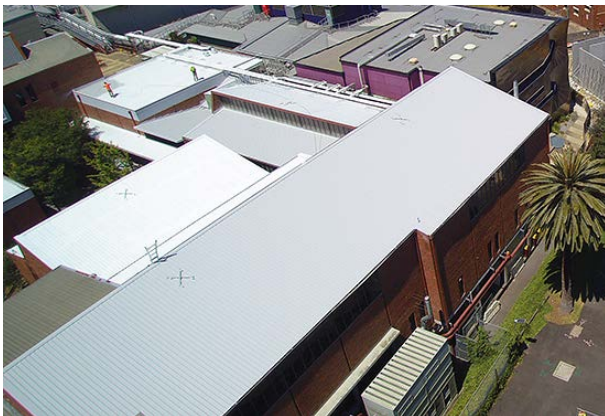
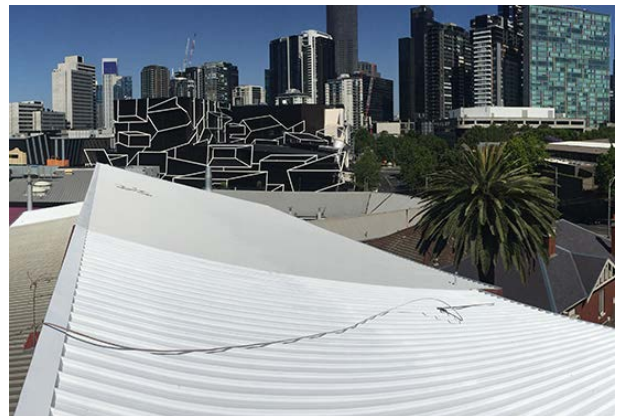
Aerial photo of colour contrast as well as wide angle eye level demonstration:

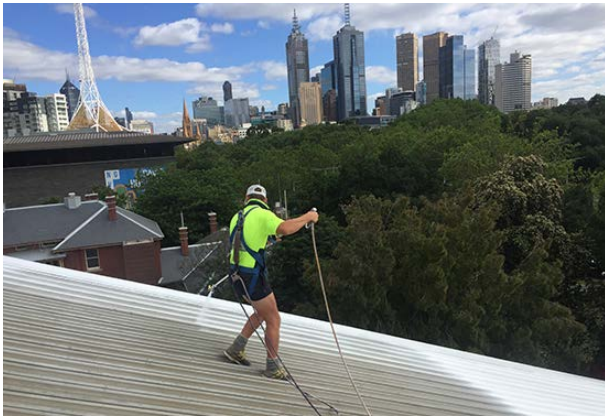
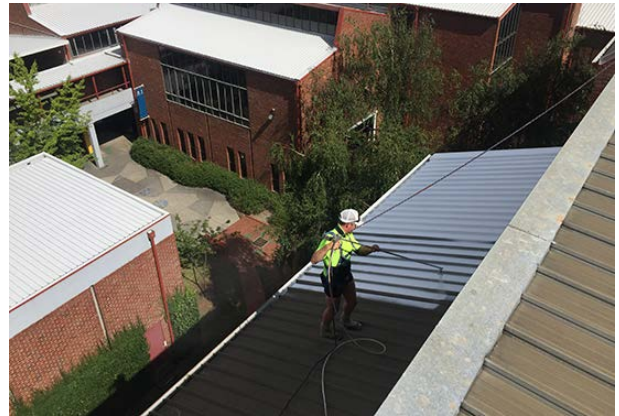
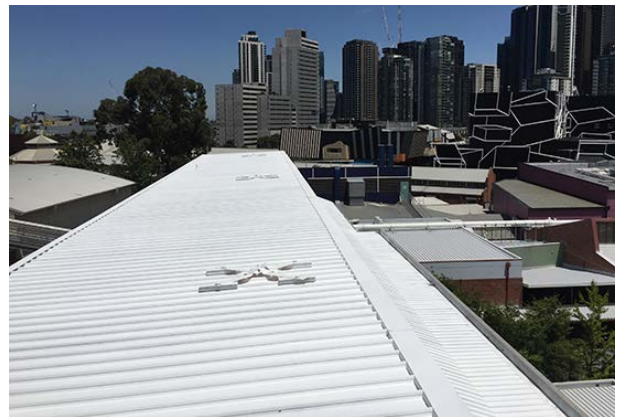
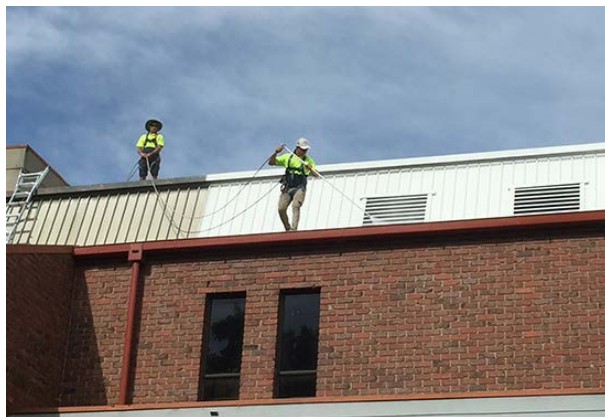
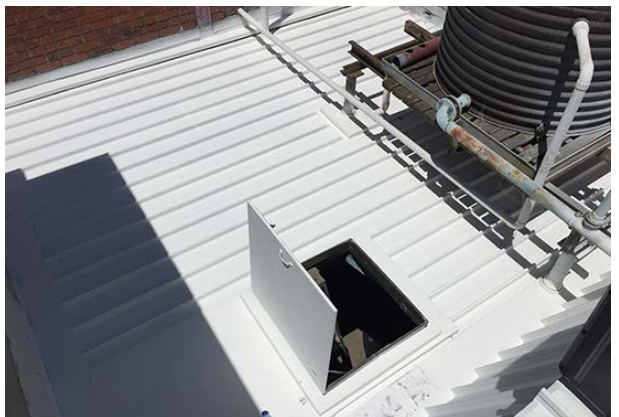
Stage 2 – First coat in basic white Thermoshield commencement:

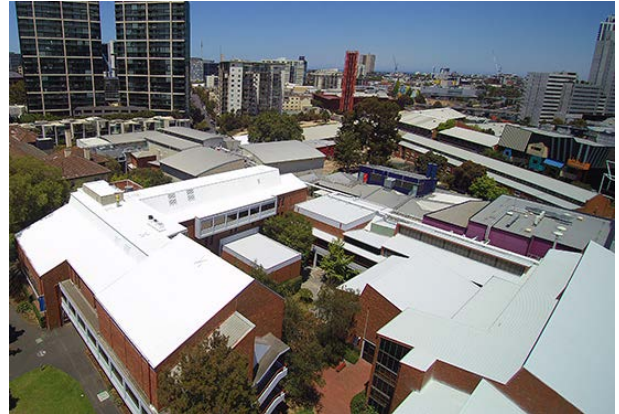
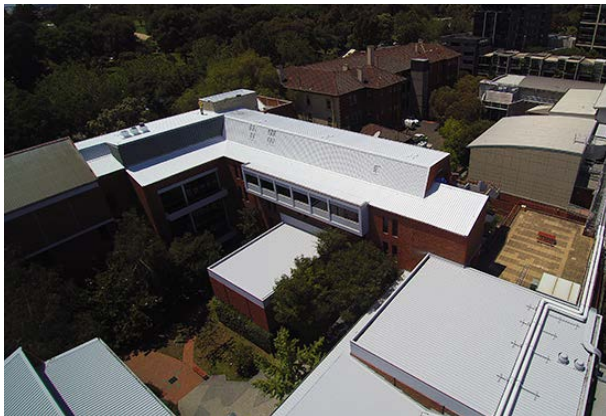
Arial photos demonstrating the differences between the white (first coat) applied to stage 2 areas as well as shale grey (second coat) Thermoshield applied to stage 1:

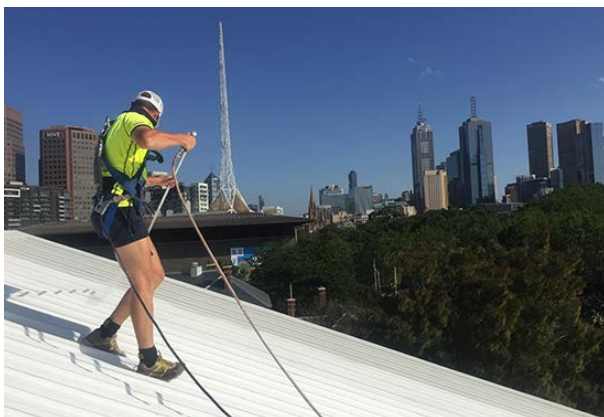
Second coat in shale grey, applied over the white first coat:

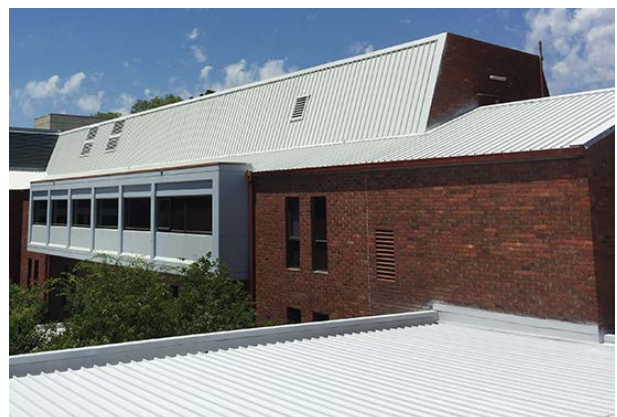
Final passes to complete stage 2 and overall coating:
