Rio Tinto Hope Downs 4
True ceramic coating drives Scope 1
reductions at Hope Downs 4

Facility: Mess / dining & commercial kitchen

Product credential: Thermoshield — Australian-made, true ceramic insulation coating (a genuine insulator, not a reflective paint)

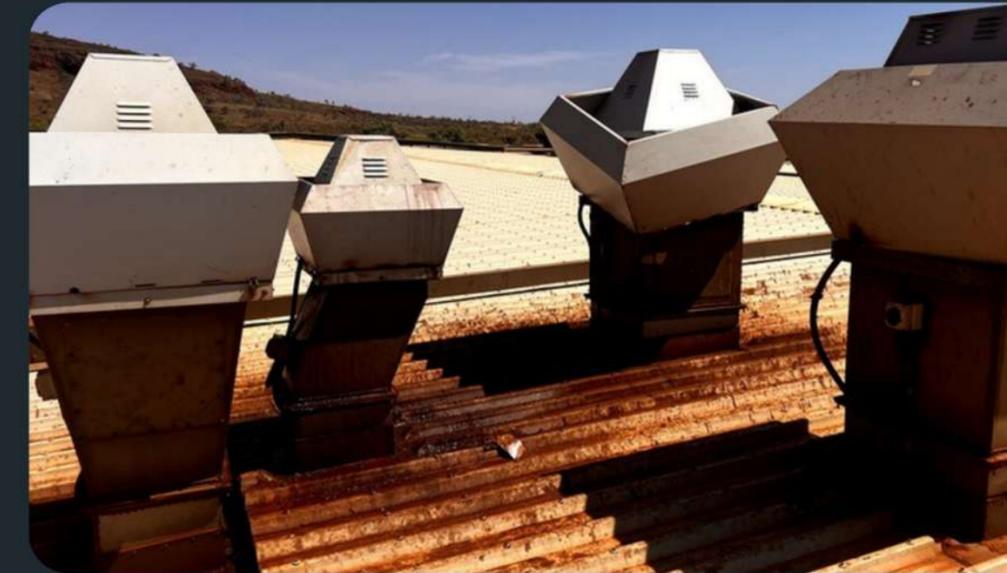
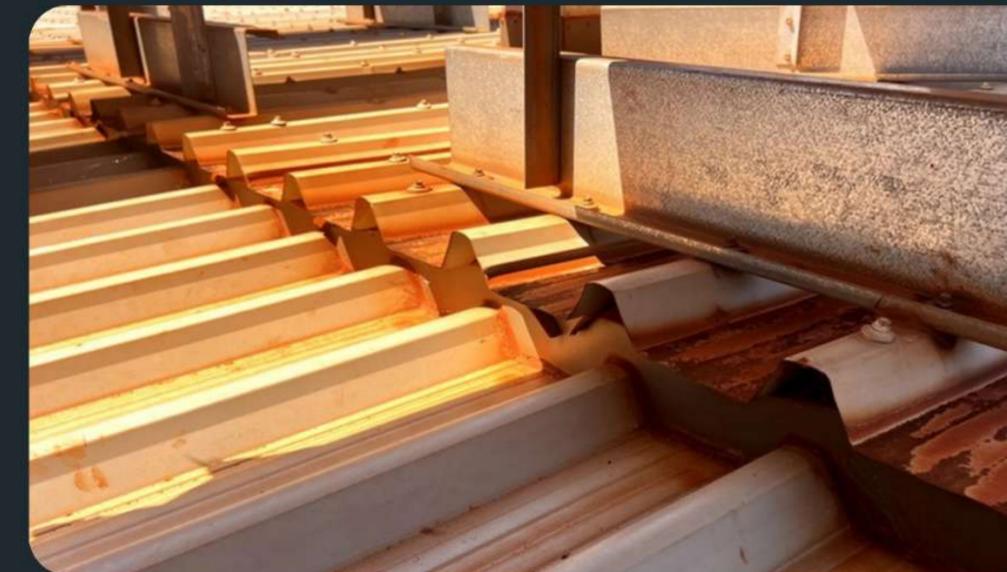
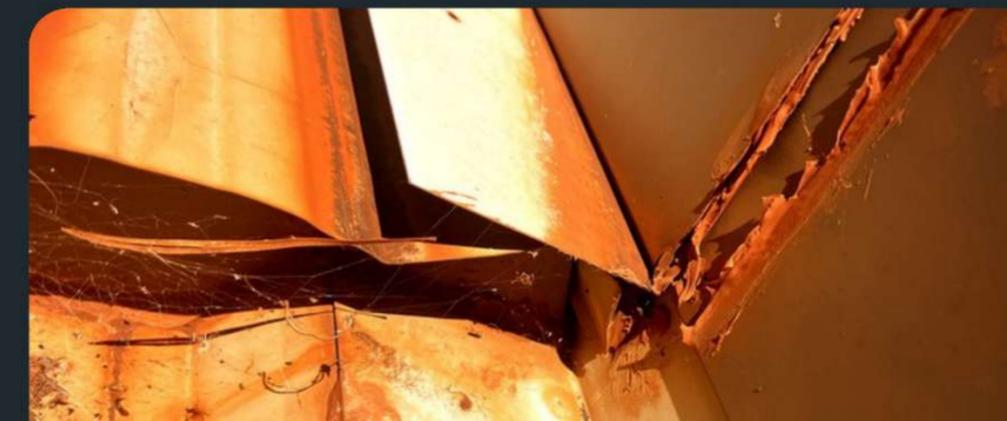
- Brutal ambient + solar load: Metal roof temperatures routinely exceeded 60 °C, driving heat into the roof assembly and dining areas during peak service.

- Water ingress & corrosion: Wind-driven rain and capillary action at sheet laps, penetrations and degraded sealants were causing leaks during summer storms. Repeated wetting accelerated corrosion at fasteners and joints, threatening structural integrity, electrical safety and food-service hygiene (mould risk). Thermal cycling widened gaps, compounding ingress and rust.

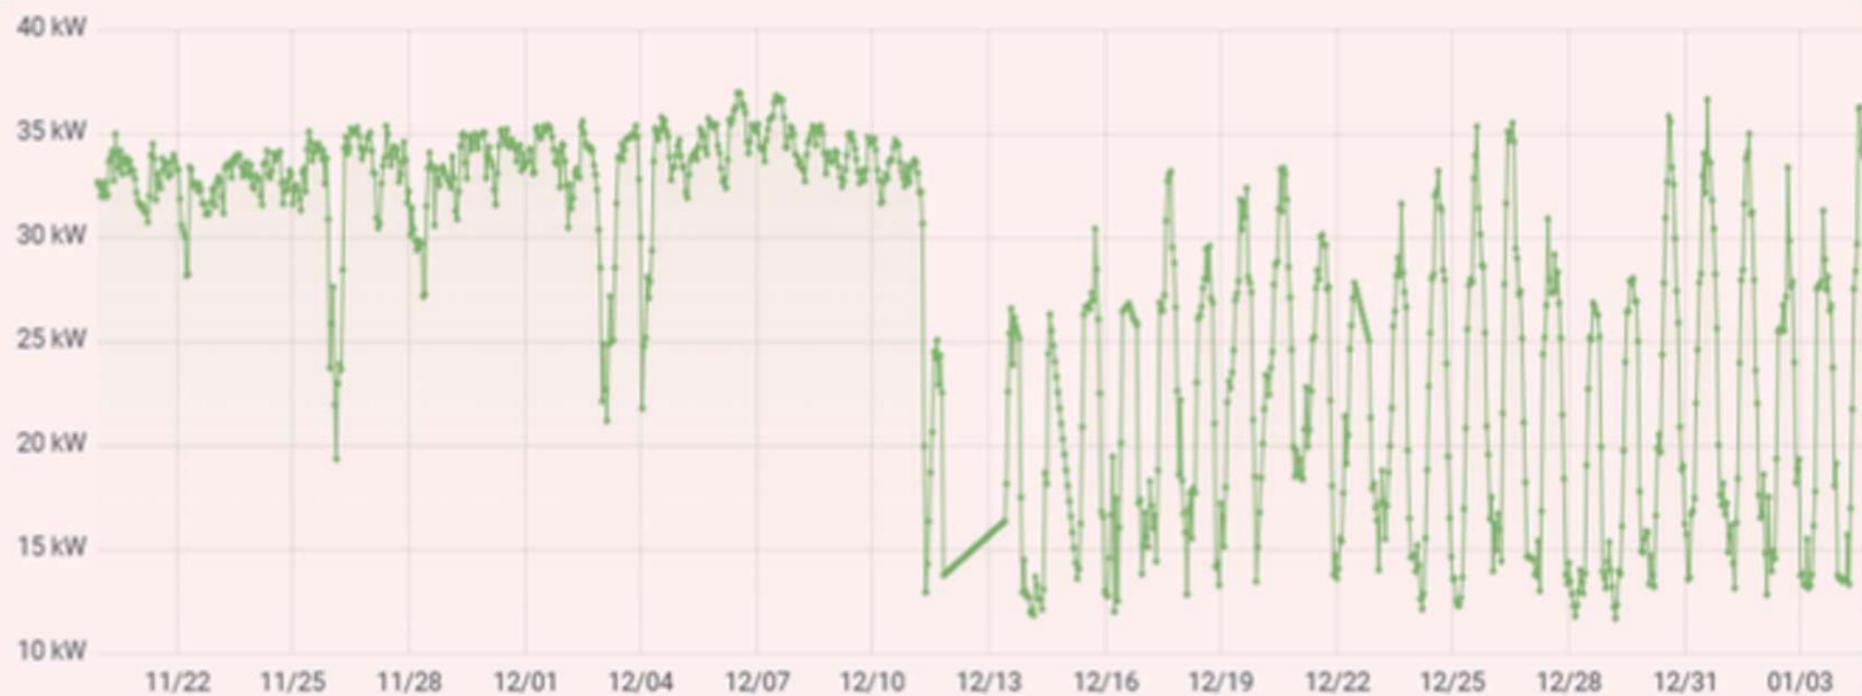
- 37% reduction in energy consumption measured on monitored distribution boards
- 558 kW drop in daily energy use across the monitored circuits
- Max roof surface temperature reduced from 62.8 °C → 44.8 °C (-18 °C)
- 137 t CO₂-e/yr avoided (monitored scope) — equal to ≈2,264 trees
- Immediate storm test passed post-install: no leaks or water ingress
- Safer access for maintenance: hot-surface burn risk substantially reduced

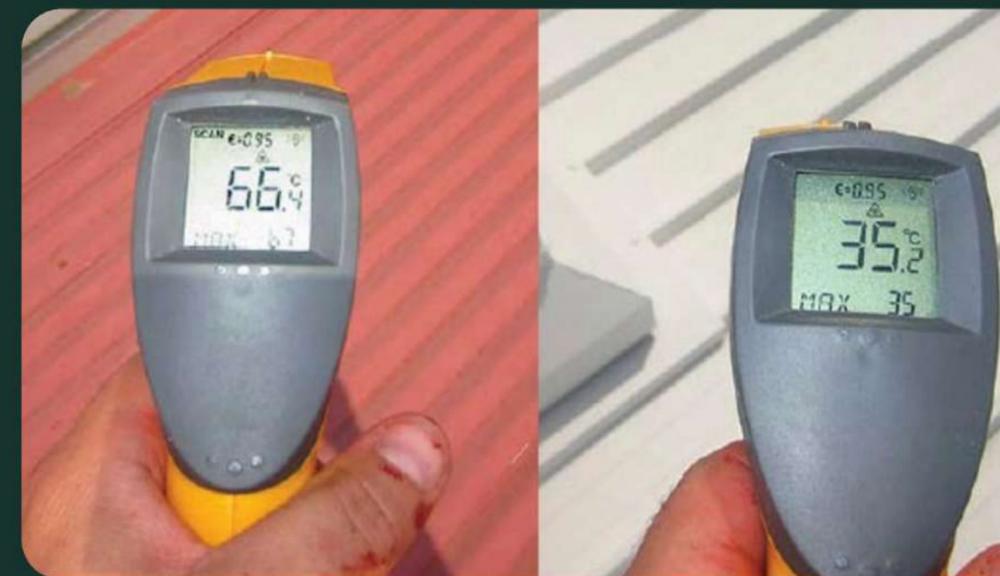
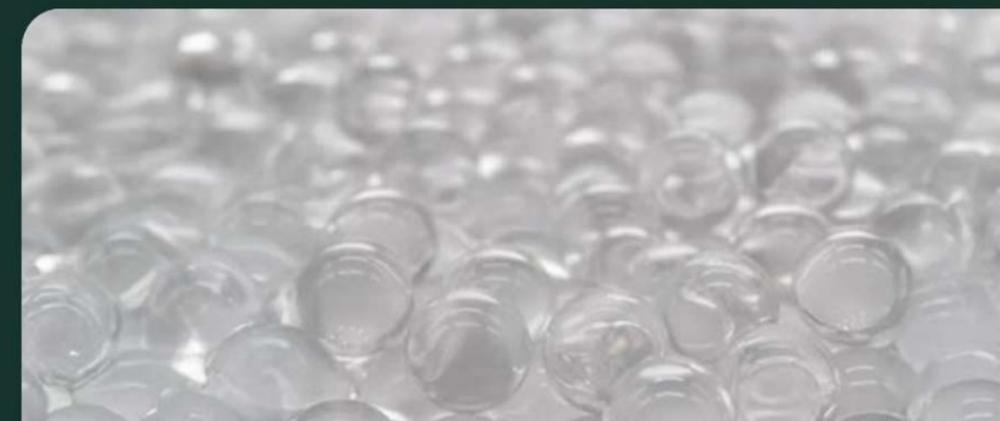
Within days of application, the insulated roof assembly showed a sharp drop in surface temperatures and heat flux. By impeding conductive and radiative heat transfer through the metal sheet, compressor runtime and fan energy use were cut materially. Lower roof and plenum temperatures also reduced heat soak into exposed ductwork, improving supply-air stability and further lowering compressor cycling.

The waterproofing program targeted the primary leak paths — laps, fasteners, penetrations and gutters — eliminating known ingress points and converting active rust. After significant storms in December, the mess reported no leaks. By isolating metal from oxygen and moisture, corrosion progression was arrested, extending service life and reducing unplanned repairs. Lower peak surface temperatures also minimise thermal expansion and contraction cycles, protecting fixings and sheeting. The cooler surface further removes burn hazards for technicians.
