# THERMO SHIELD®

Rio Tinto ammonium nitrate  
storage facility corrosion control

## **AMMONIUM NITRATE FACILITY BEFORE REFURBISHMENT – SITE INSPECTION**

## 6 MONTH INSPECTION OUTCOMES

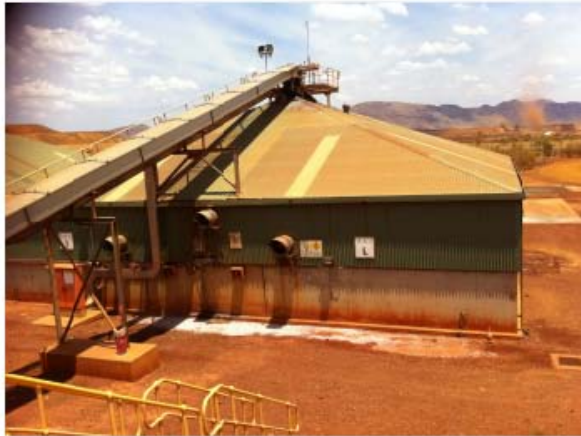
\* A shot of the sheds - from a distance:

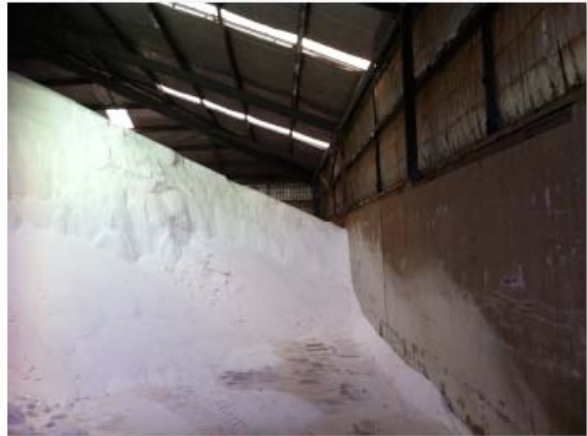
\*An indication of the volumes of explosives stored

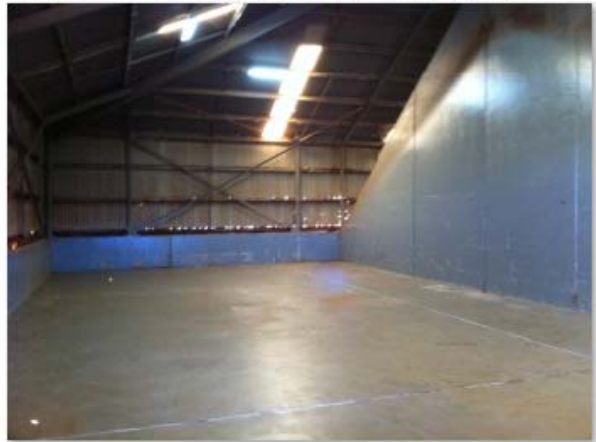
\*Visible holes through sheeting from long distance

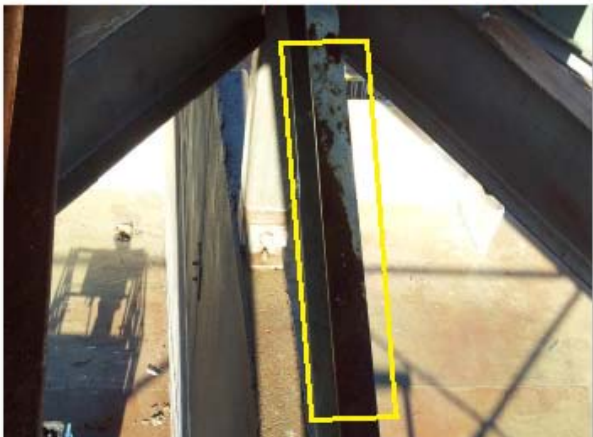
\*Thermoshield applied directly on to moderate rust

The few areas of framework that had maintained structural integrity yet had been still effected by corrosion, were able to be kept and directly coated with Thermoshield.

Thermoshield contains very strong corrosion inhibitors, to eliminate any further rusting. Once applied, the ceramic coating converts rust to iron phosphate.

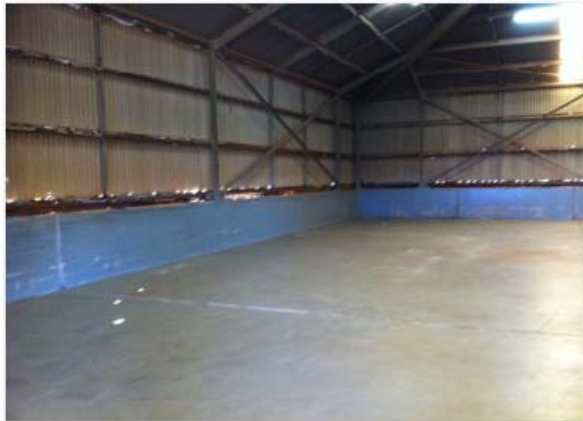
\*SHED 1 - BEFORE

Both sheds had become highly unsafe, structural integrity had been compromised and the sheds were incapable of their primary function of keeping the AN unexposed to environmental elements.

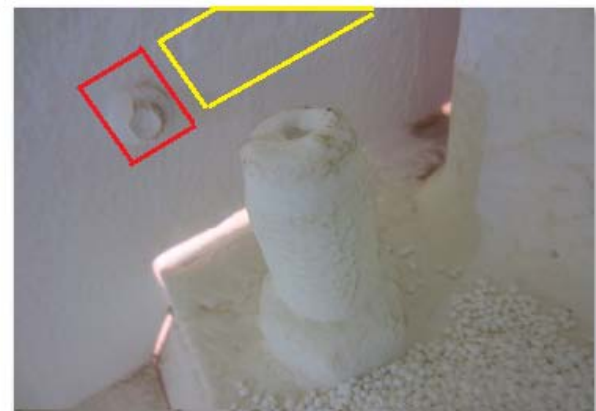
\*Sheet joins, penetrations & screw/bolt thread sealed

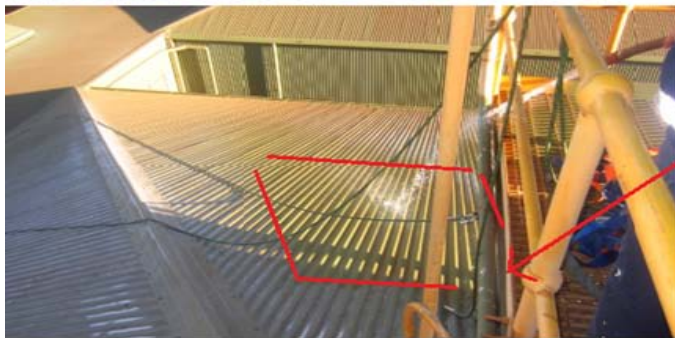
3 months of 'caked on' ammonium nitrate as a result of spillage upon delivery

AN heaped to as much as 2 inches at various points

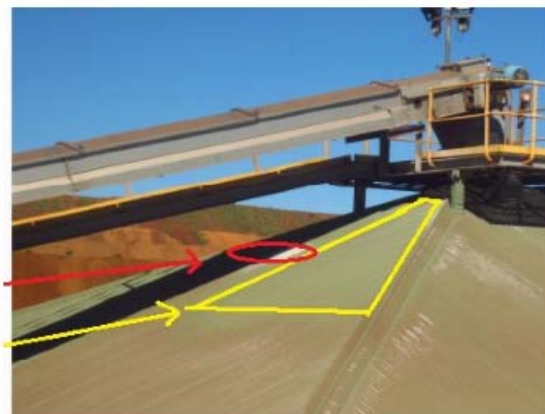
The AN hasn't damaged the coating in any way under the harshest of tests

3 inch thick AN build up removed in seconds

Hosed area in isolation as a basis for comparison

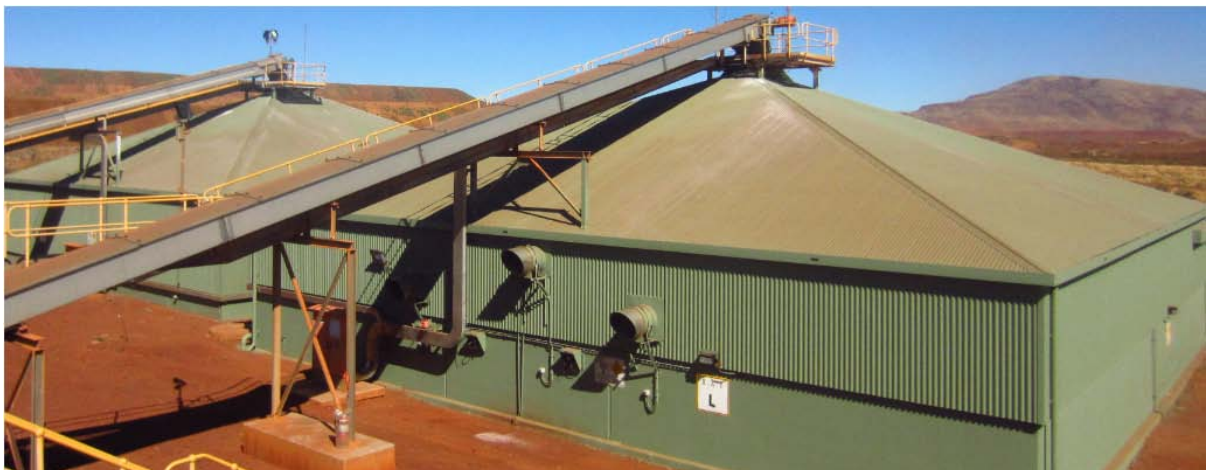
Overall, 3 months in – we at Thermoshield couldn't be happier with the current condition:

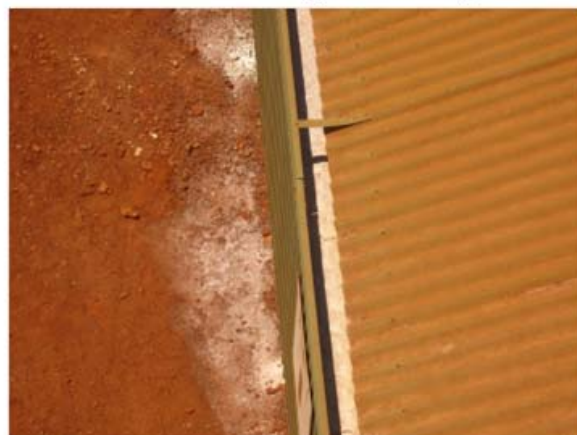
We can see that any AN overflow is failing to bind to the ceramic coating. This is shown by the below photos where any AN had run off the sheets and collected in the gutters – (which also haven't shown any signs of deterioration)

\* AN has ran down the sheeting - to collect in gutters

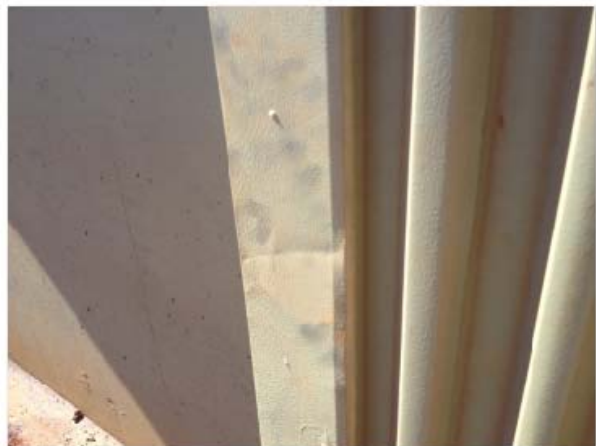
\* Flexible membrane has withstood many knocks/bumps

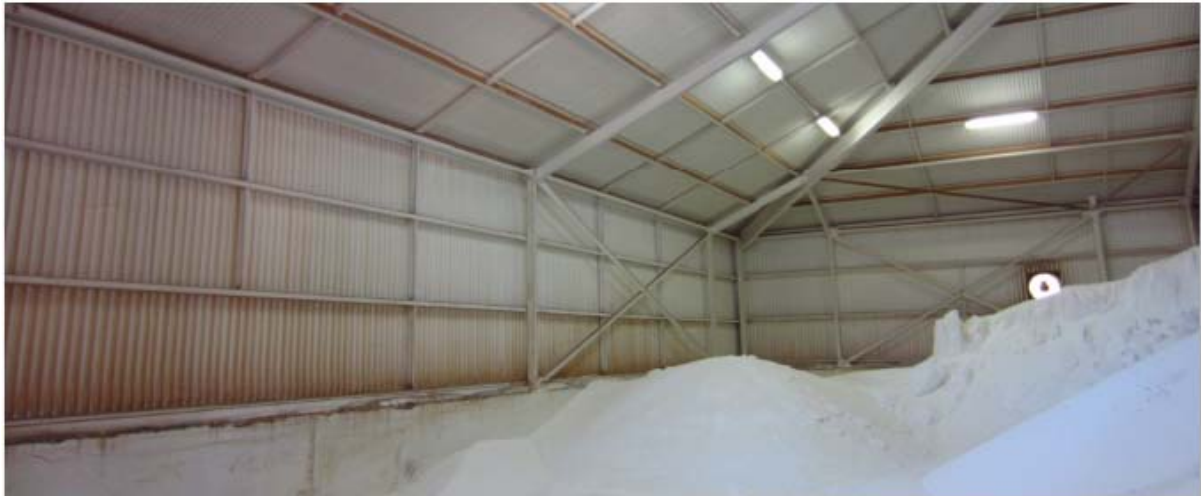
Shed 1:

Following on from the external examples – below is a wider angle view of the sheds internally, followed by some close up examples of how the ‘seal’ has been maintained:
