Woolworths
Australia's fresh food people

Claremont, Tasmania

Stage 2

Roof Restoration | Corrosion Control | Waterproofing

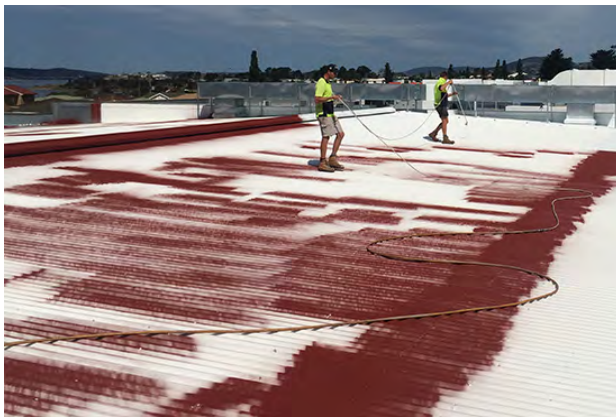
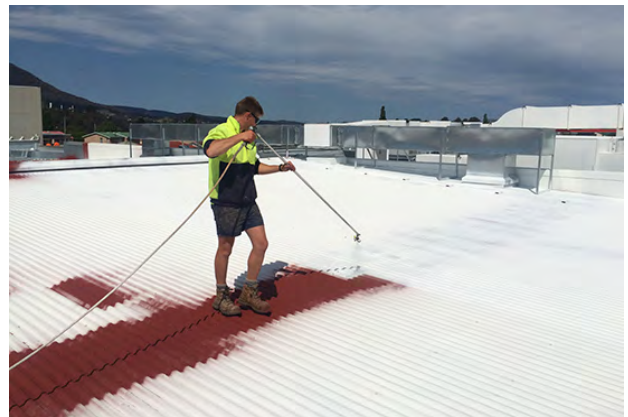
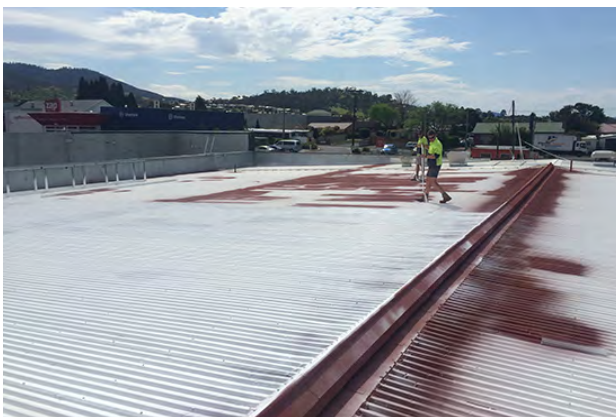
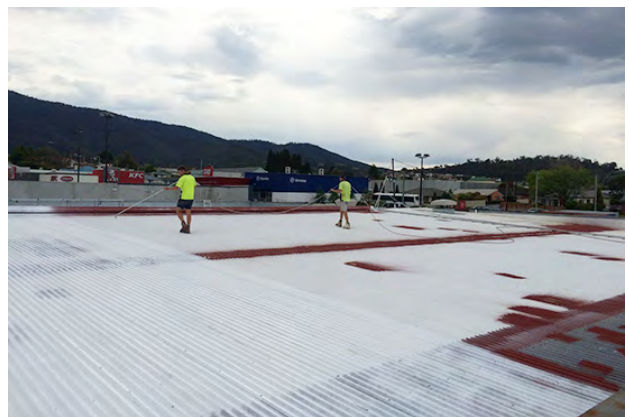
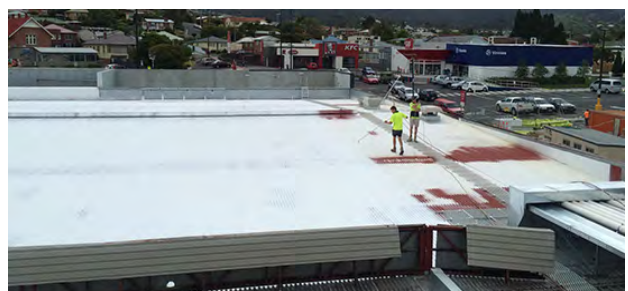
There was excess roof traffic on the finished coating. The installation of HVAC duct work, roof safety walkways, various vents & roof flashing all contributed to the wear. The major damage to the coating was the metal filings left on the roof that formed minor rust on the surface of the Thermoshield coating in isolated areas.

Below are the photos of the first coat to complete the repairs to damaged stage 1:

Following power washing (to remove metal filings, general grime & any product flaking), rust inhibitor etch primer was applied due to the minor rust from metal filings.

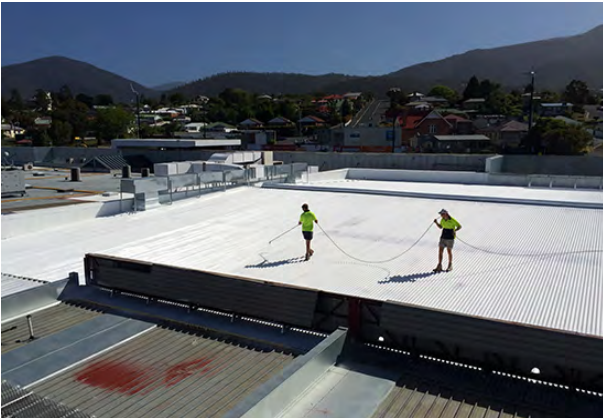
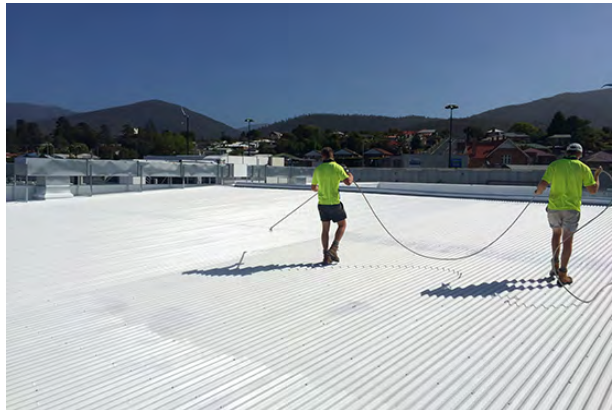
Below series of photos demonstrate the second coat being applied:

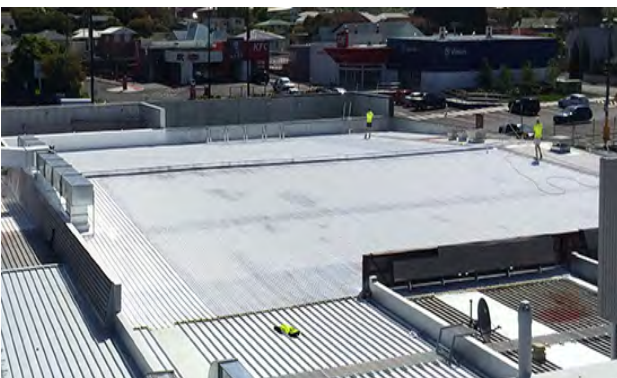
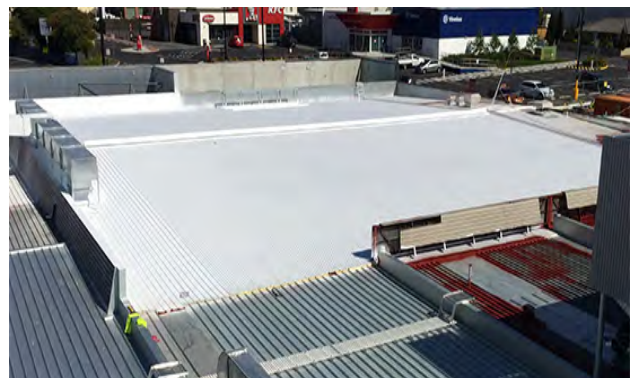
Below is a wider angle photo showing the difference 1st & 2nd coats:

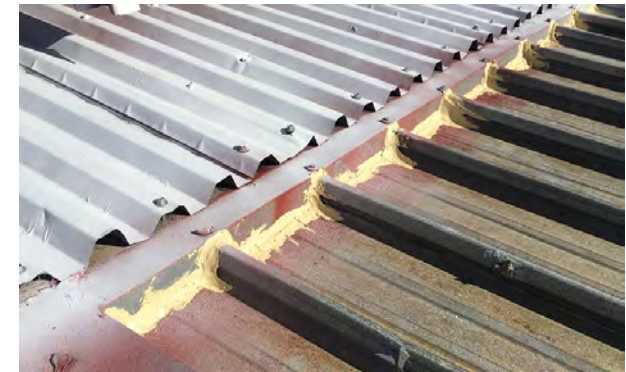
* Caulking flashing / roof sheet joint

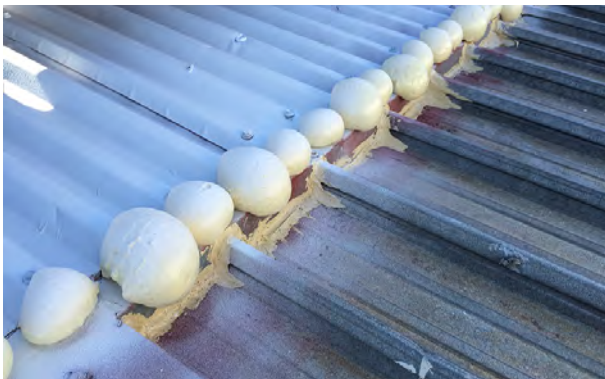
* Expandable foam

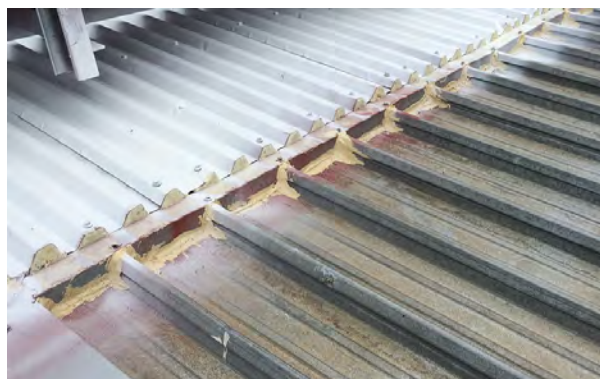
* All external foam cut back off

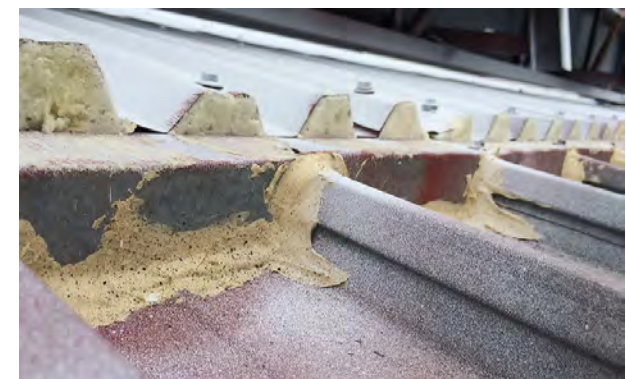
* Closer up view of cut foam

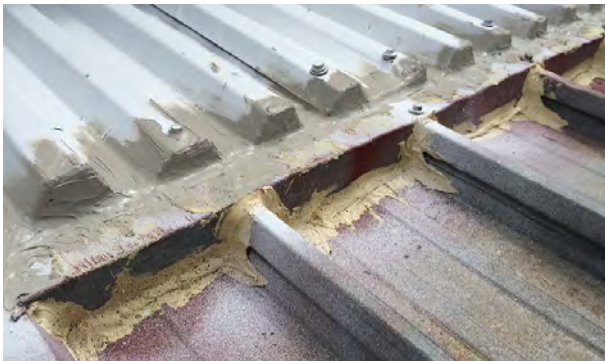
* Silicone applied & carefully smoothed

Often silicone is applied heavily on the sheet join, which causes water to back up & pool. This causes accelerated corrosion & leads to more problems. We apply both on the joint & up onto the sheet then smoothed evenly so that it's almost undetectable & water flows off.

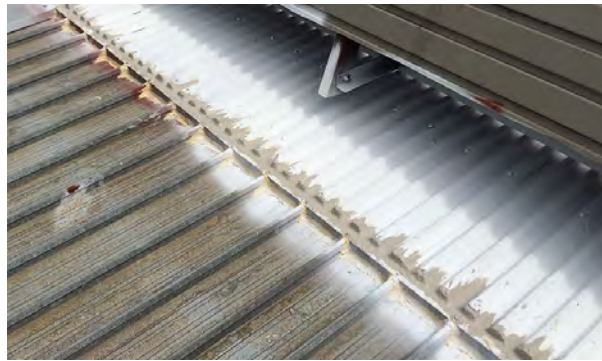
* Silicone on all foam & over joints

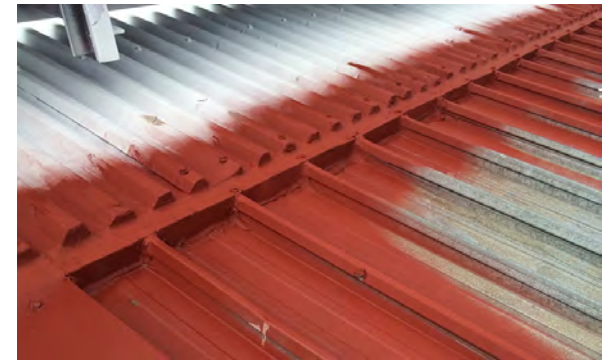
* Etch primer applied over silicone

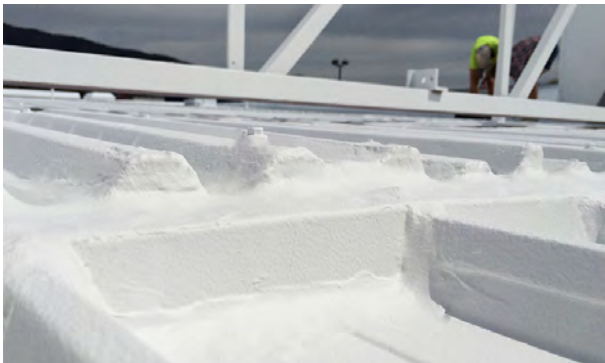
* Silicone 'down slope' & well sealed

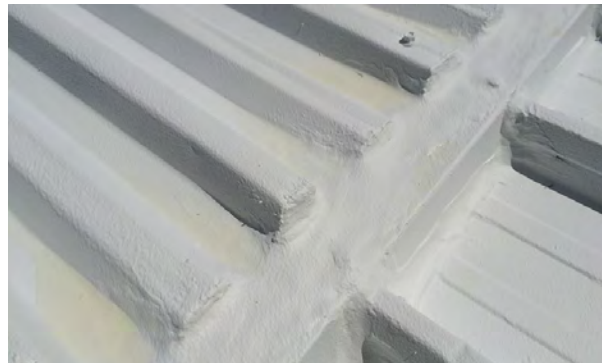
* Silicone so smooth, almost cant see it

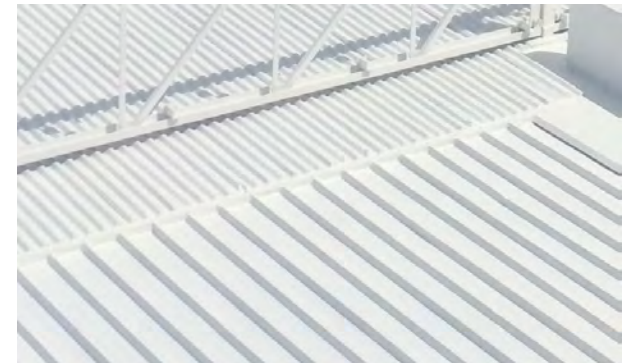
* Wider angle of finished area

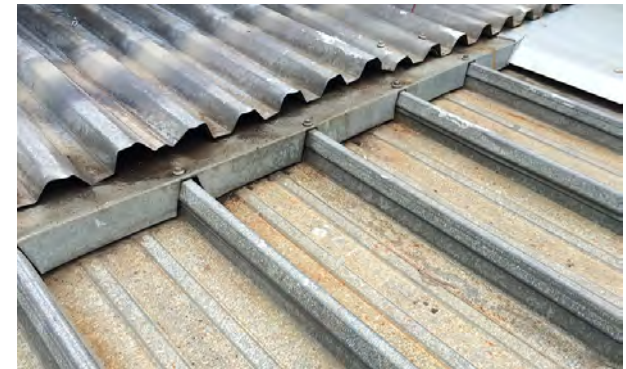
* Caulking flashing / roof sheet joint

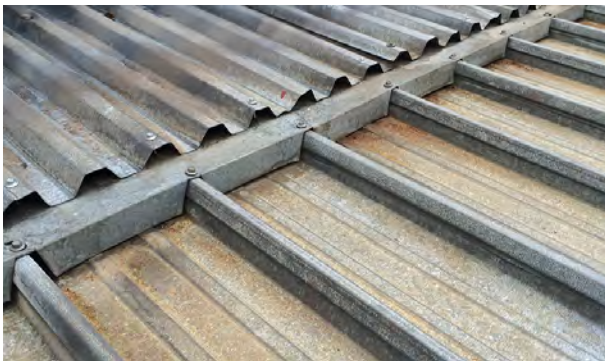
* Silicone 'down slope' & well sealed

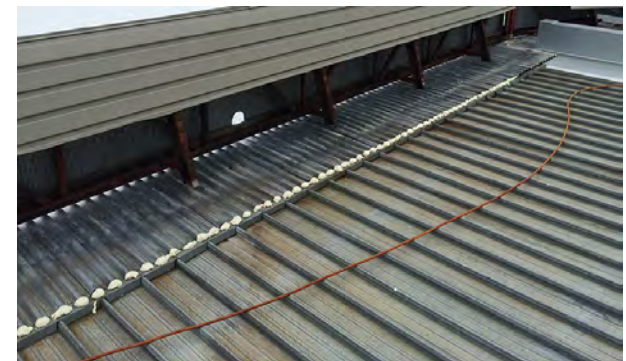
* Wider angle of finished area

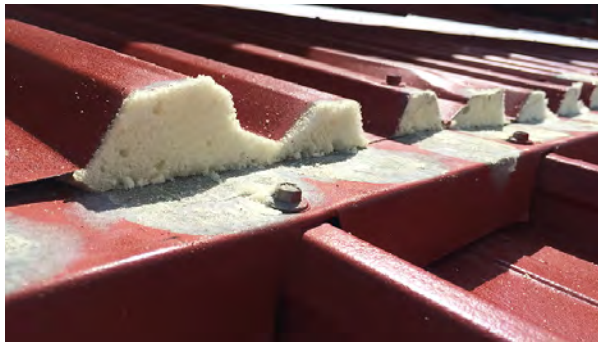
* Silicone on all foam & over joints

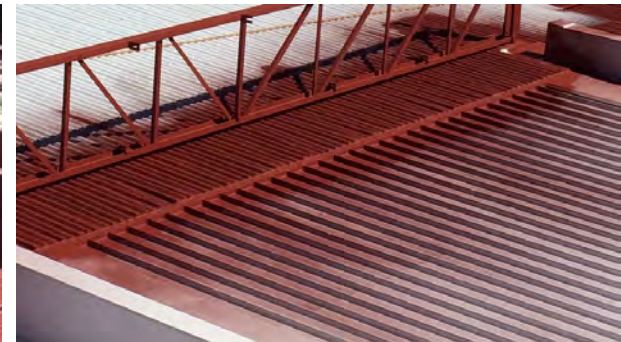
* Etch primer applied over silicone

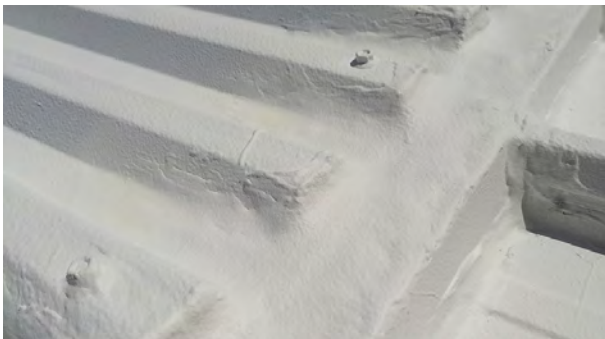
* Silicone 'down slope' & well sealed

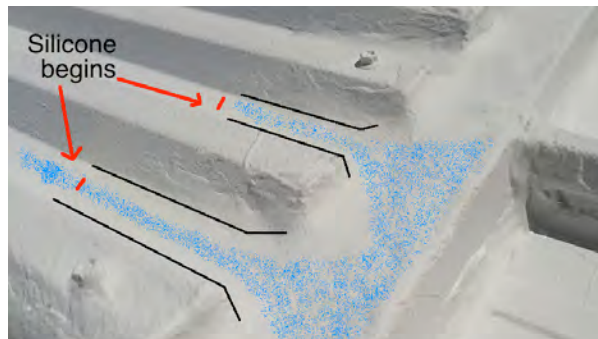
* Silicone so smooth, almost cant see it

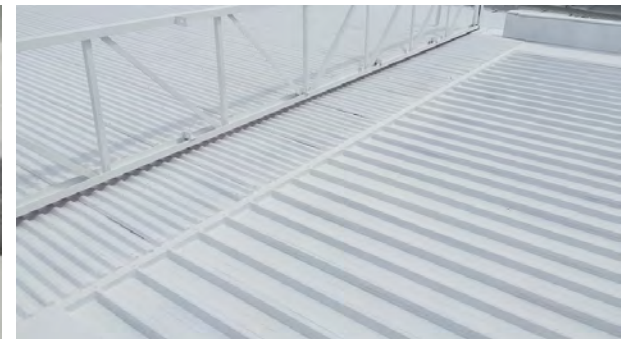
* Wider angle of finished area

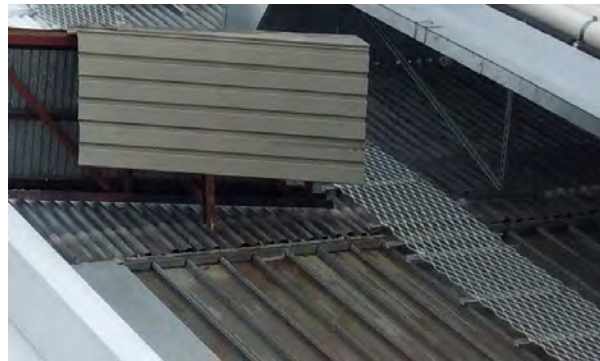
Bay 4 sheet join was also a major source of water ingress with evidence of several 'band aid' repair attempt. Prior to rust conversion & waterproofing measures, additional screws were driven in to better secure the sheets & remove the spongy areas.

* Bay 4 – prior to works

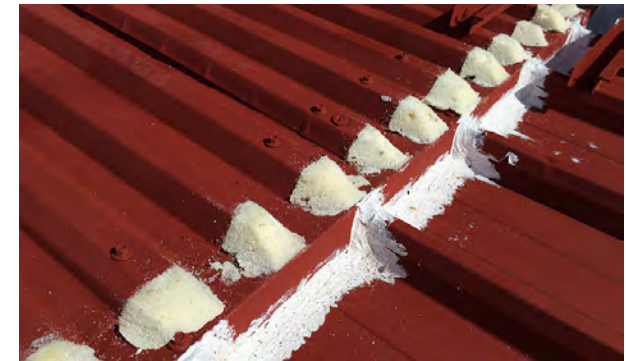
* Expandable foam cut to match profile

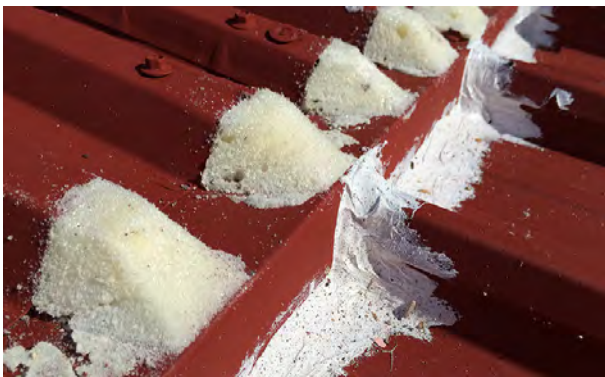
* Foam cut to edge of flashing

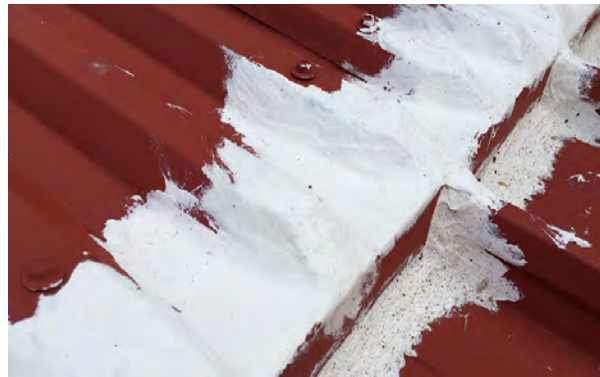
* Silicone applied over join & smoothed

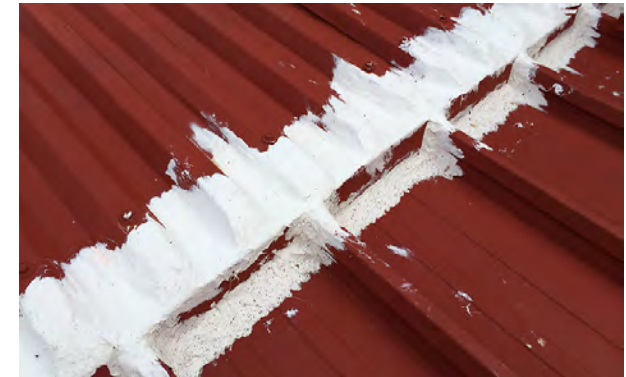
* Silicone far up the sheet, promoting run off

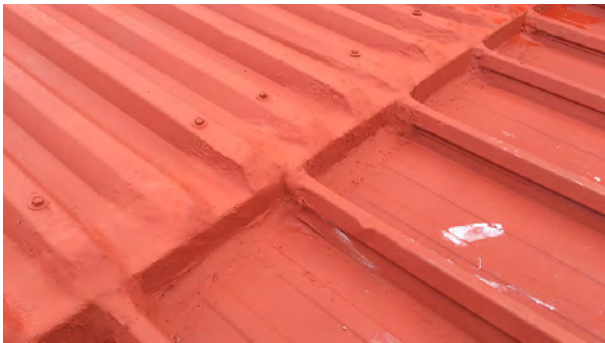
Below photos show the etch priming coat over the silicone. The red etch priming coat demonstrates how smooth the silicone application is by making it all but very difficult to spot in parts. By then coating over the red with a contrasting colour, we are very confidently able to see the protective membrane is able to seal the waterproofing measures beneath.

* Etch primer over silicone

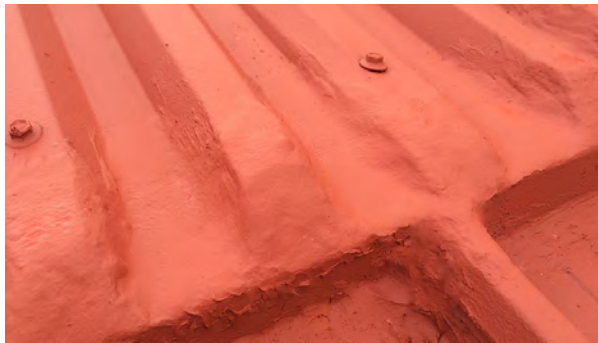
* Close up – silicone well smoothed

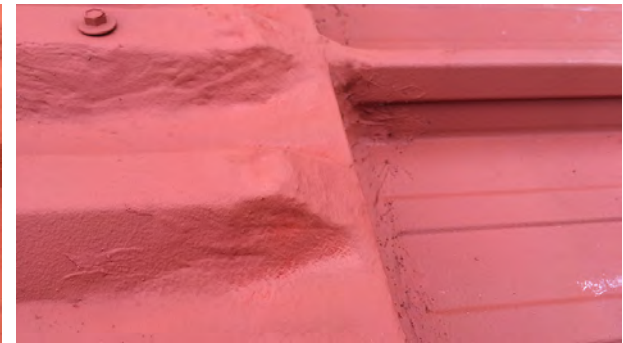
* Water to flow onto lower roof

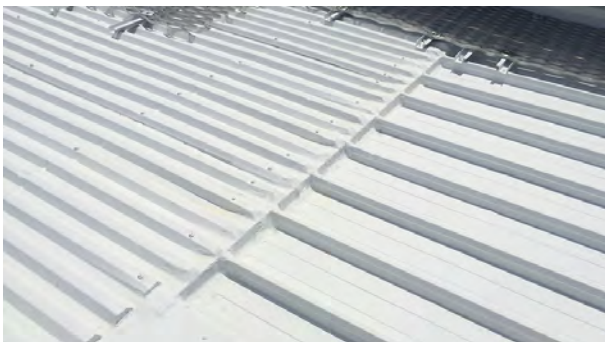
* Finished coat

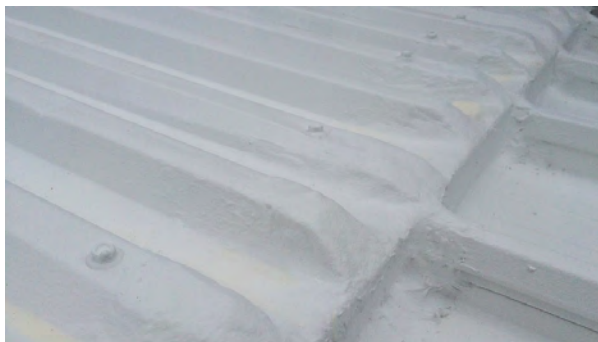
* Silicone almost impossible to spot in areas

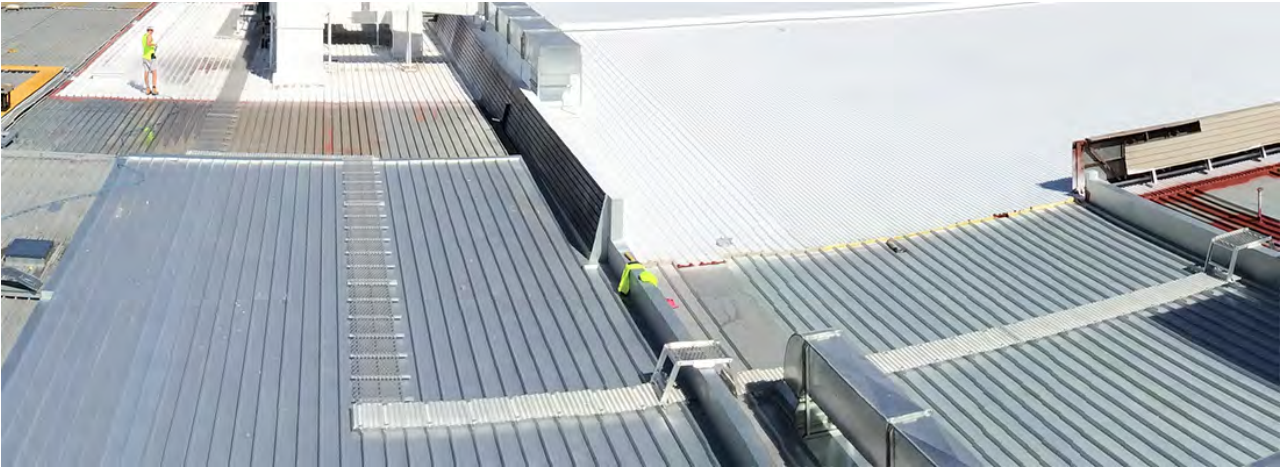
The below new zincalume roofs were installed over [two] of the existing aged roofs:

Brand new zincalume is a more difficult metal to coat than the galvanised steel sheeting. Power washing is required to remove any residue milling oil from manufacturing & a two part water based etch primer is applied to ensure maximum adhesion.

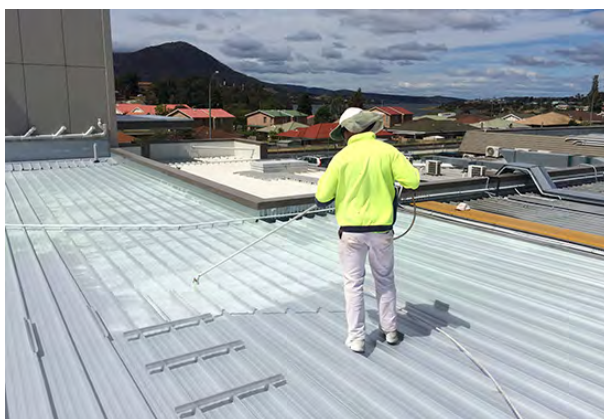
* Etch primer 'misted' on

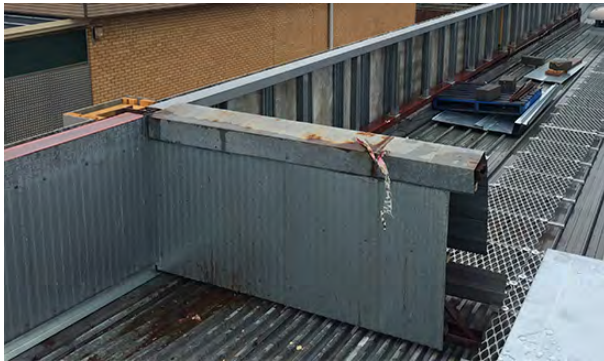
* Section removed

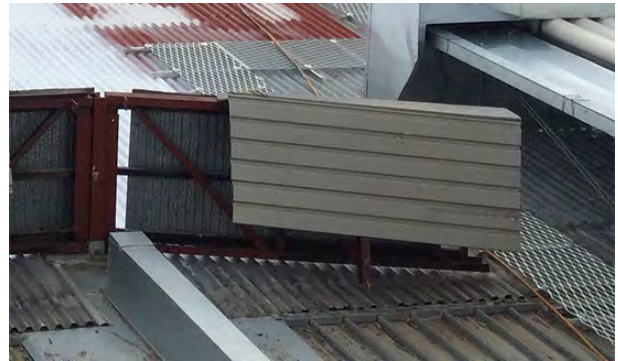
* Section removed

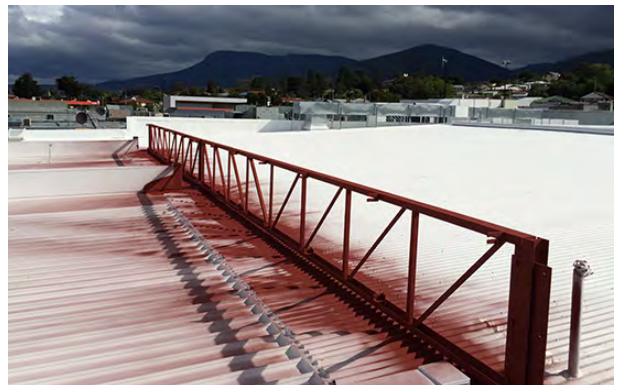
Below photos show the awning frame after it had been power washed, rust converted & etch primed. You can see the overspray onto the 2nd Thermoshield coat, which needed touch-ups.

* Extent of overspray for touch-ups

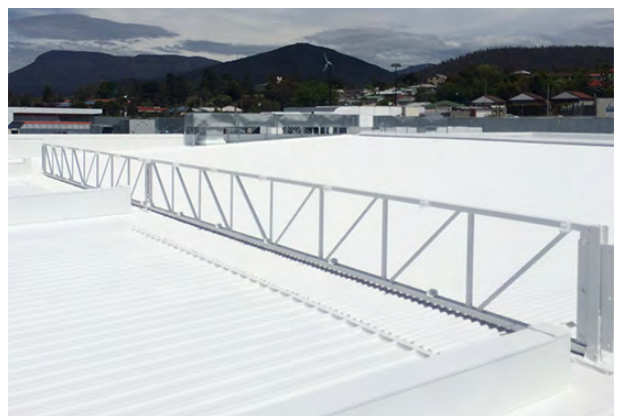
* Finished awning frame

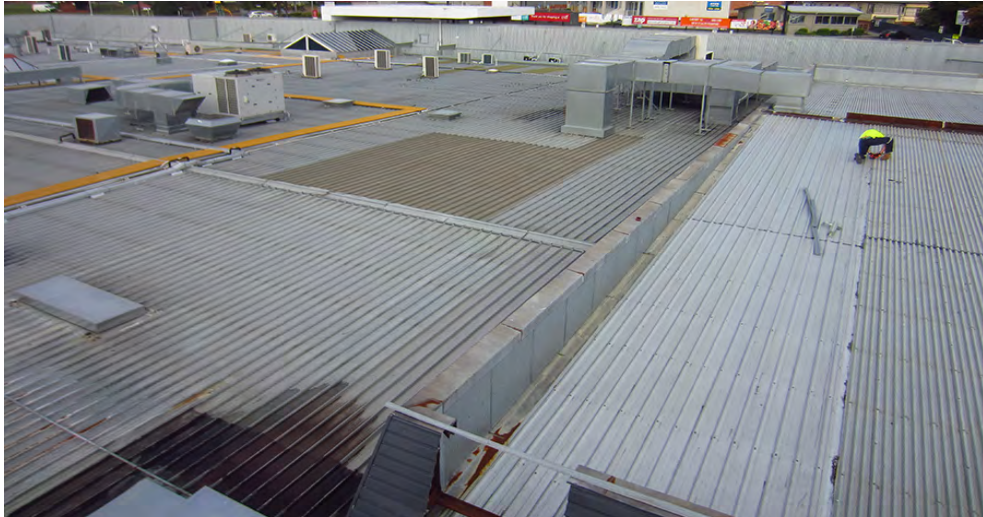
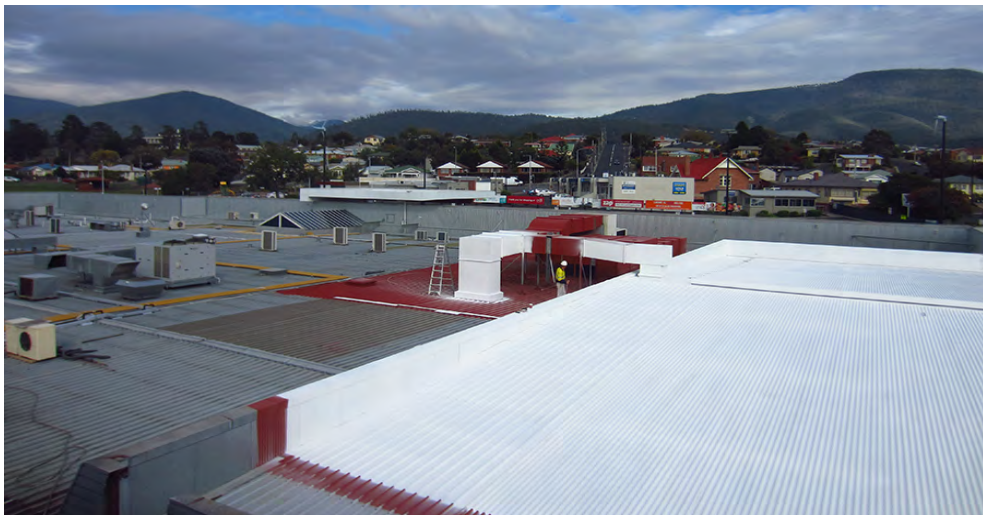
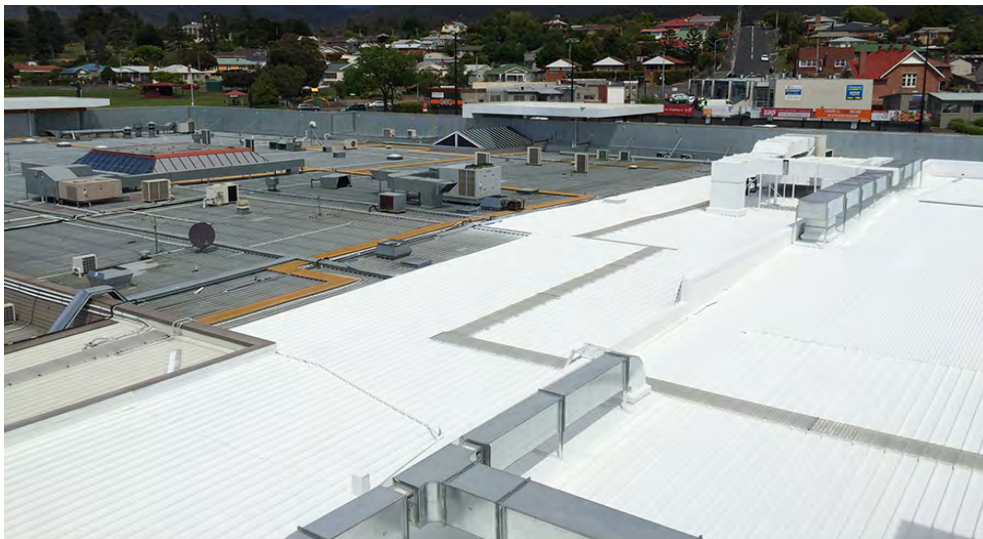
Below series shows a before, during & after shot of where the Woolworths roof meets neighbouring roof:

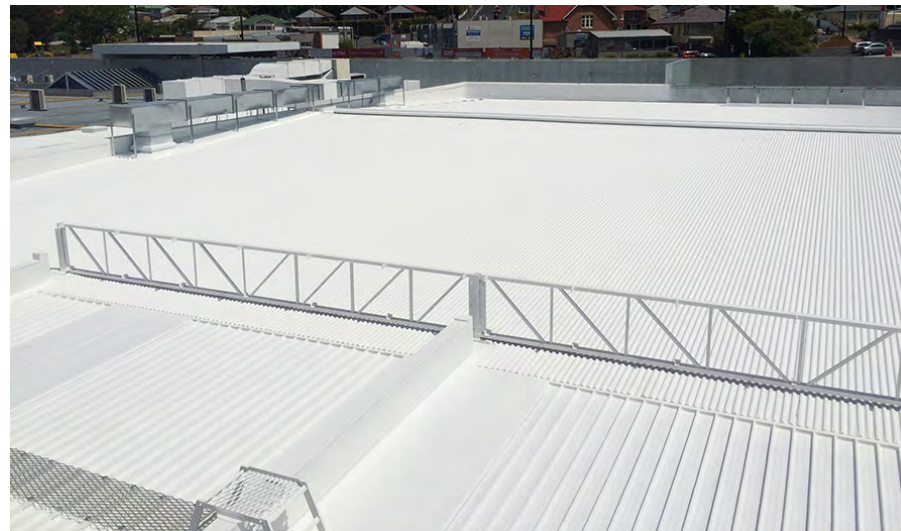
* 'After' – completed coating system:

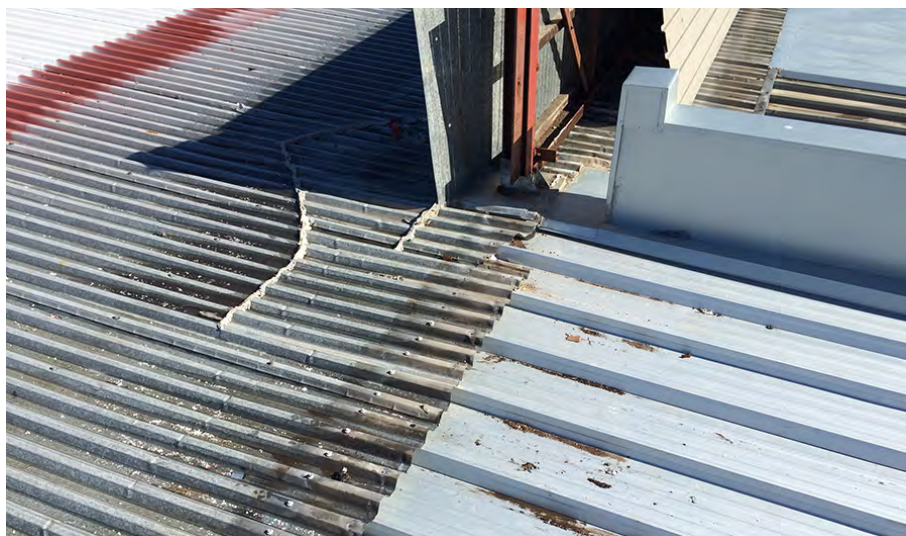
* 'Before' – prior to stage 2 works:

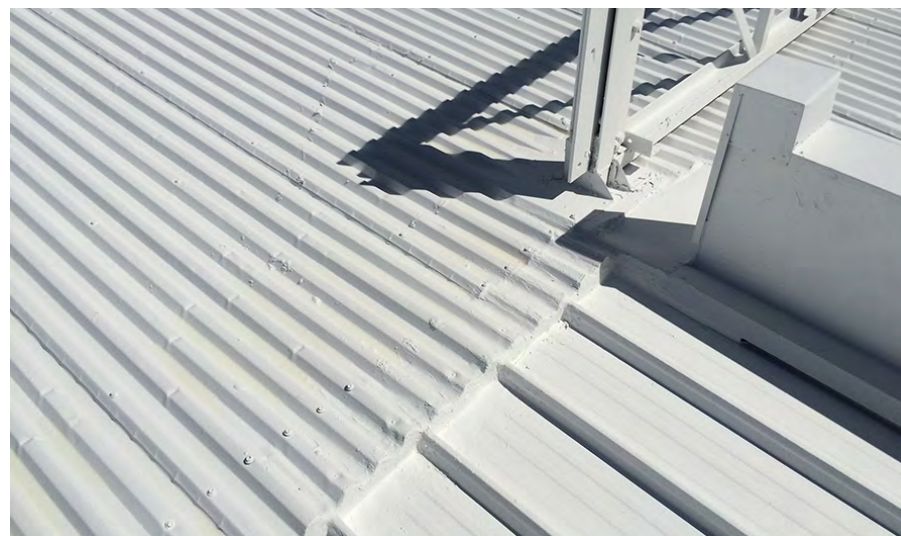
* 'After' – completed coating system:

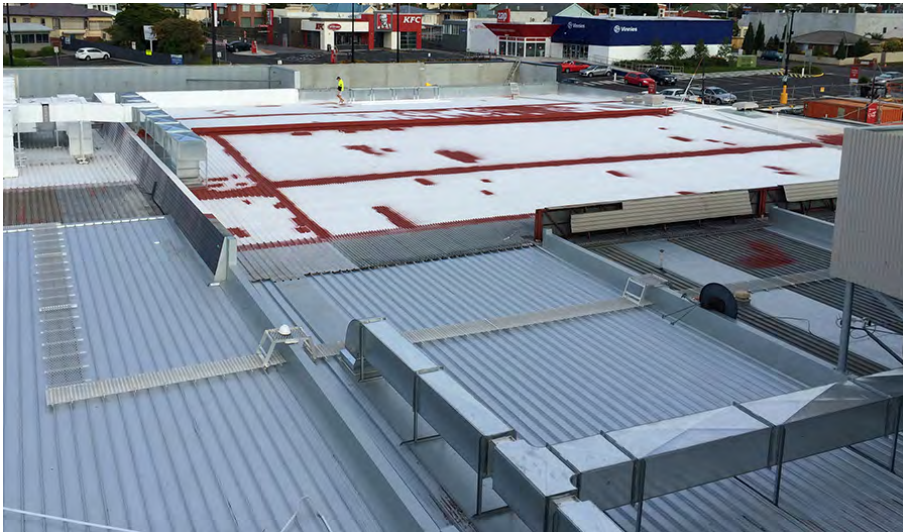
* 'During' – taken during stage 1 touch-ups

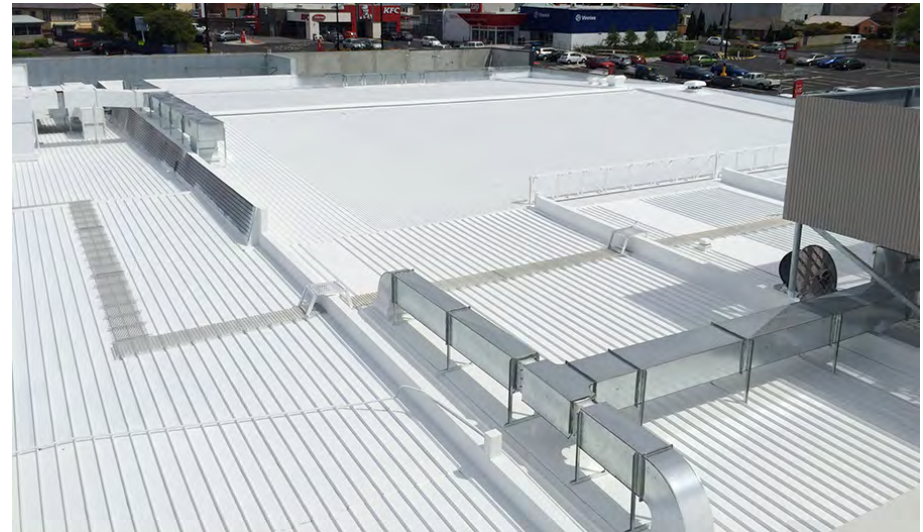
* 'After' – completed coating system:

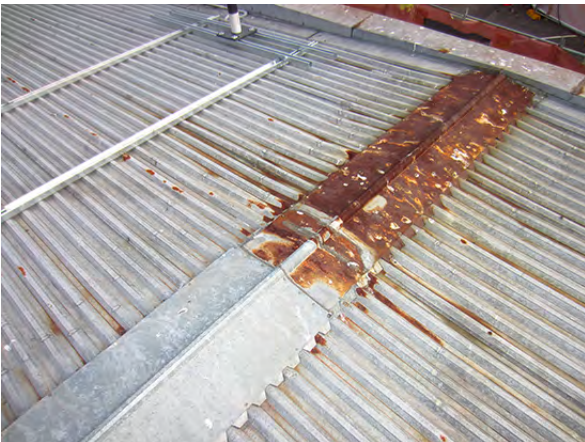
* 'Before' – prior to any work

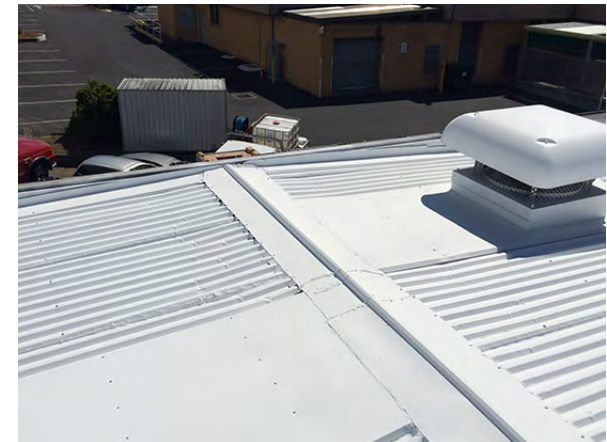
* 'After' – full coating system completed

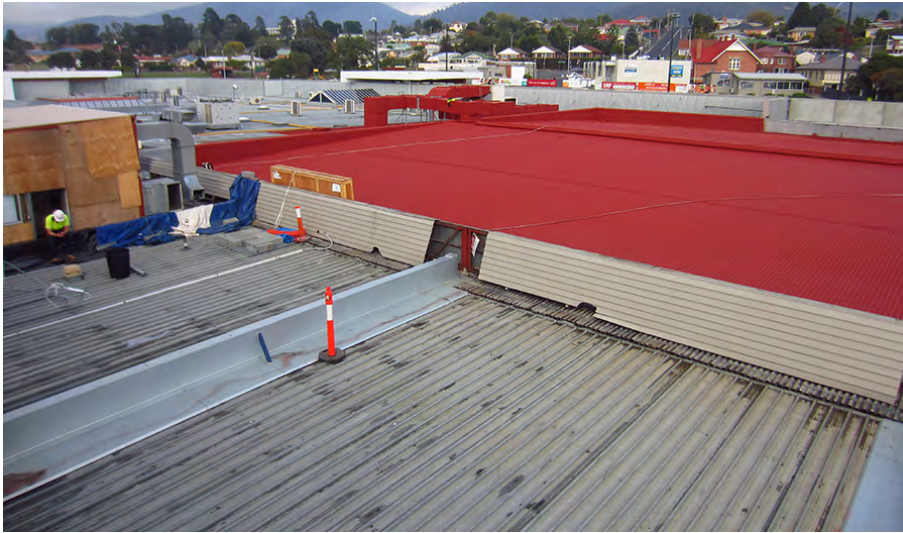
* 'During' – taken during stage 1 rust conversion works

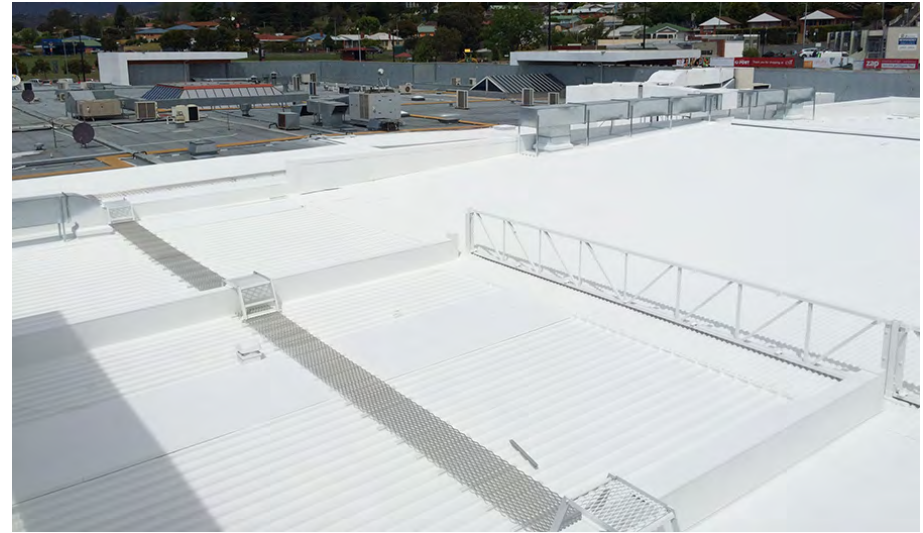
* 'After' – completed coating system:

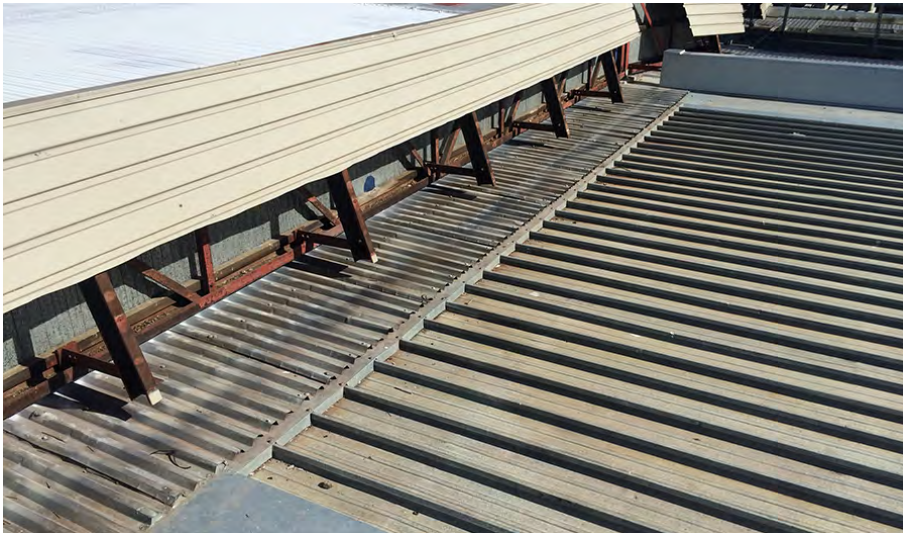
* 'Before' – prior to stage 2 works:

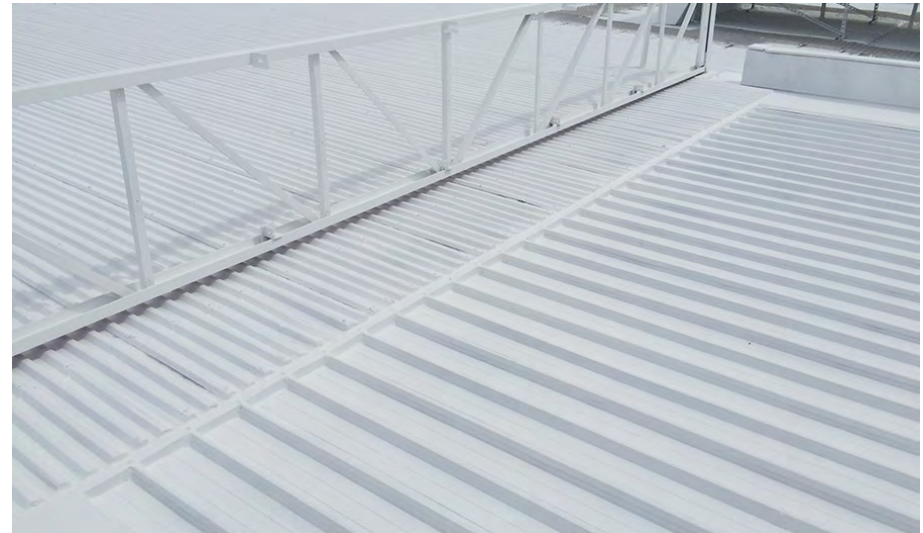
* 'After' – completed waterproofing & coating system:

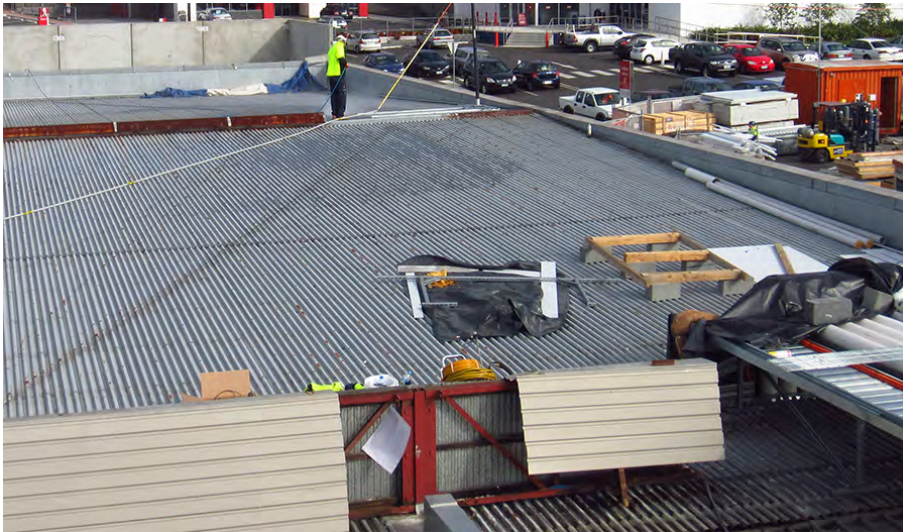
* 'During' – taken during stage 1 power washing

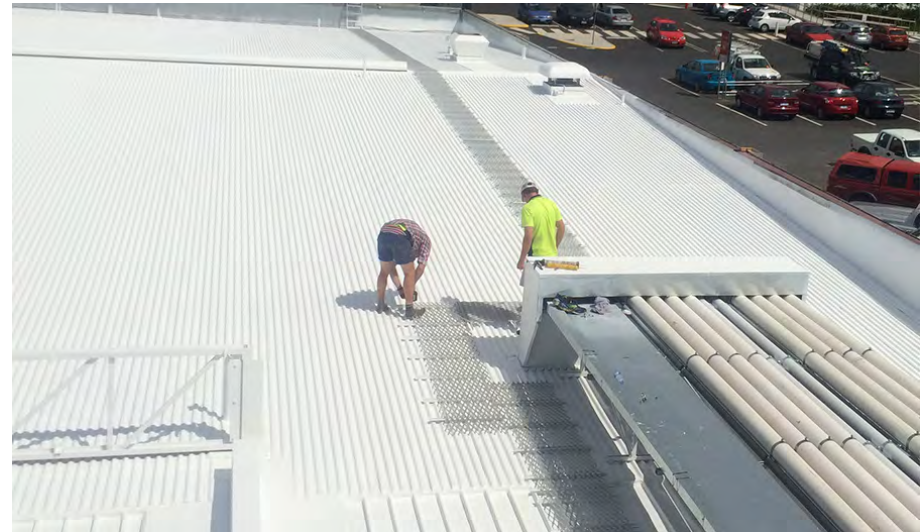
* 'After' – completed coating system:

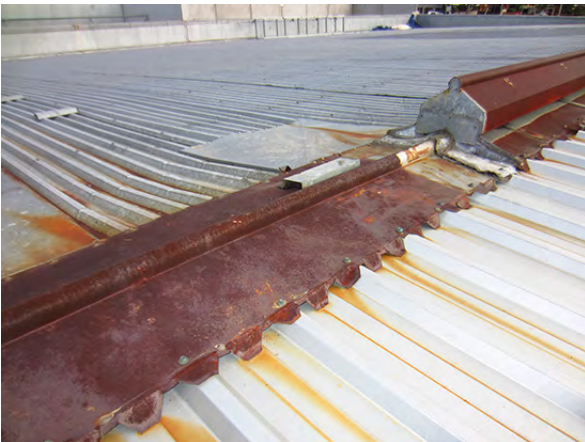
* 'Before' – prior to any work

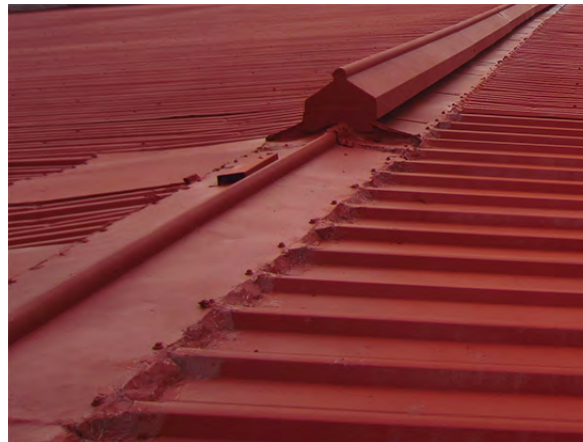
* 'During' – post rust conversion

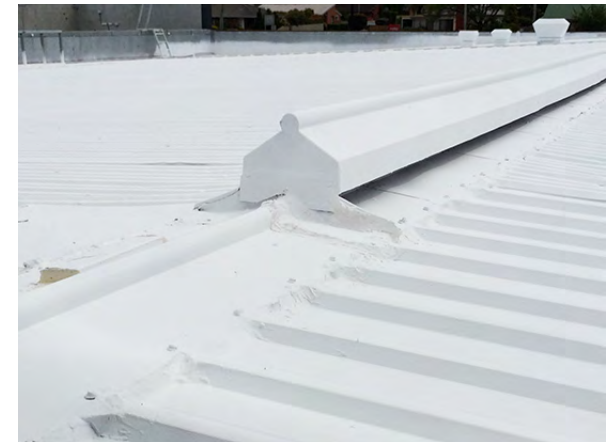
* 'After' – full coating system completed

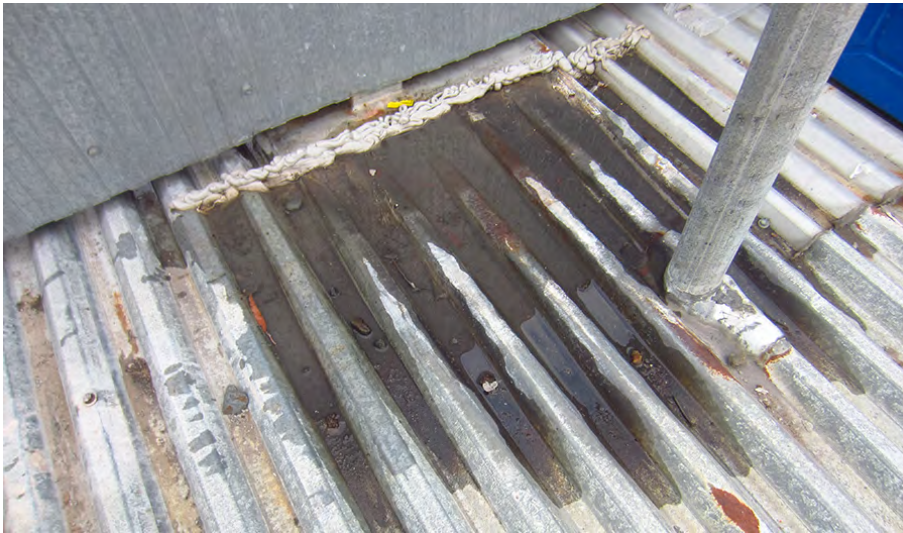
* 'Before' – a horrendous attempt at waterproofing

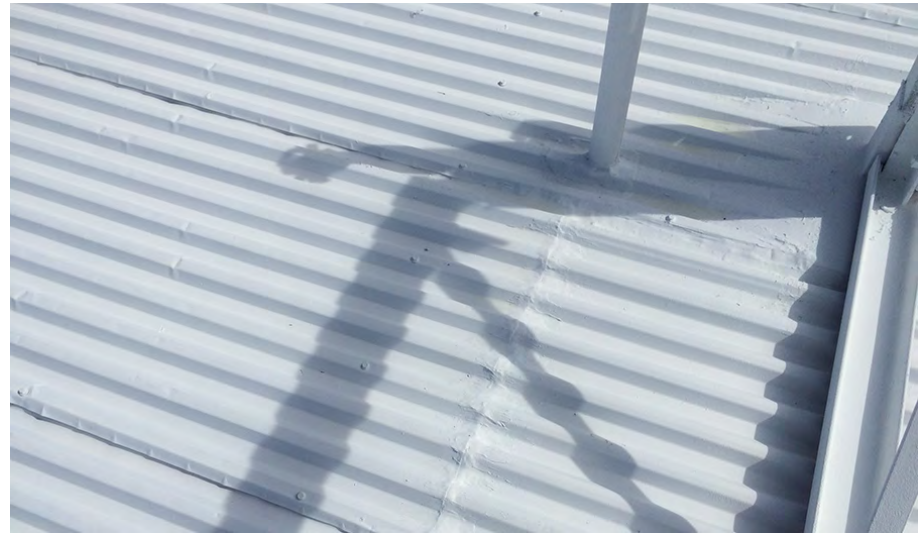
* 'After' – heavily waterproofed, smoothed & sealed

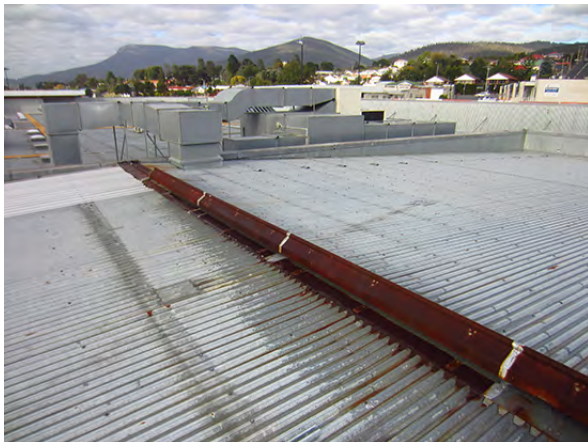
* 'Before' – prior to any work

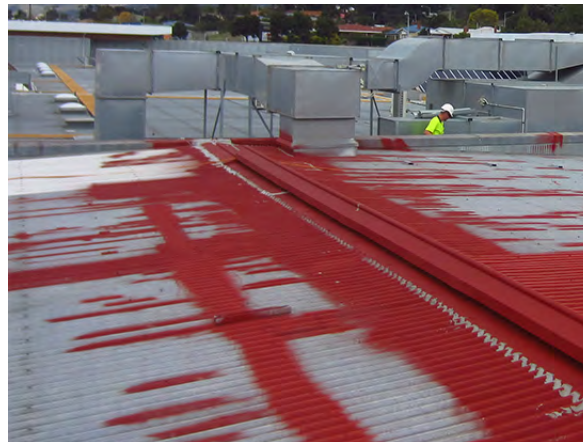
* 'During' – rust conversion

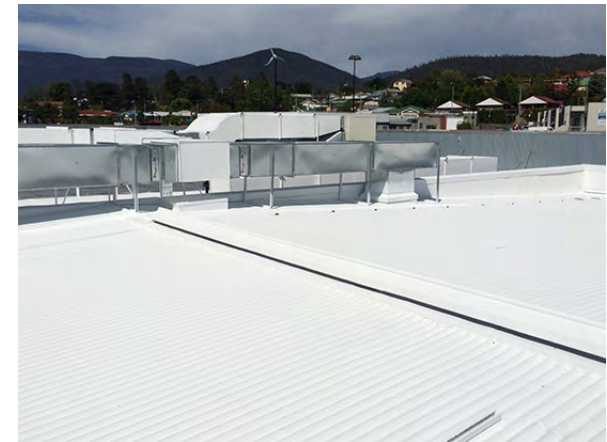
* 'After' – looks like as good as new

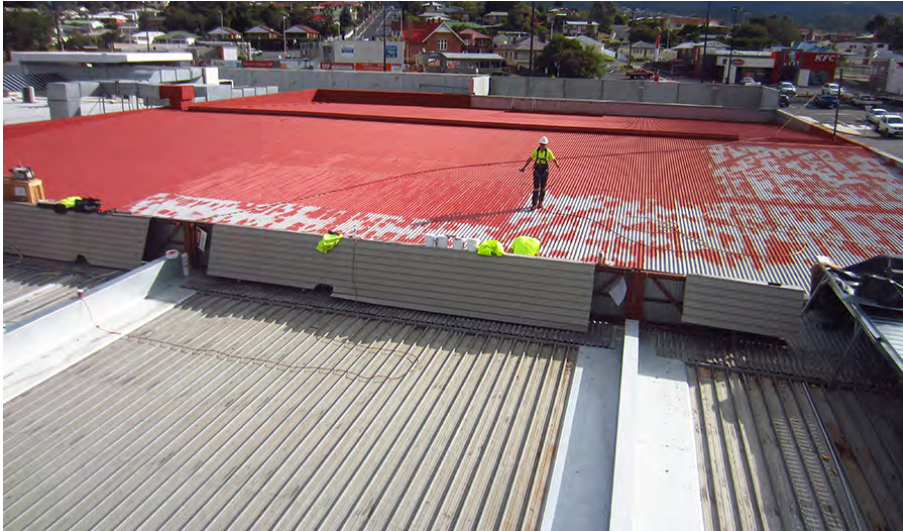
* 'During' – after rust conversion, during rust inhibitor primer

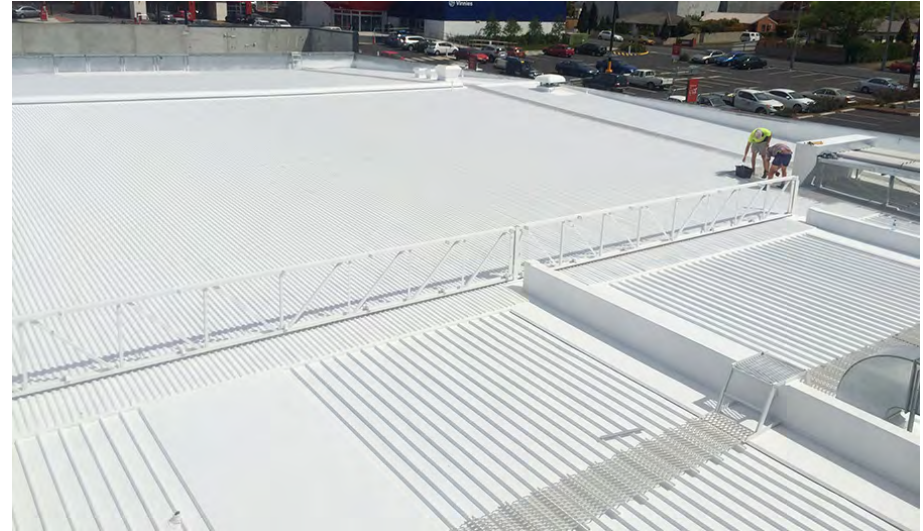
* 'After' – full coating system completed

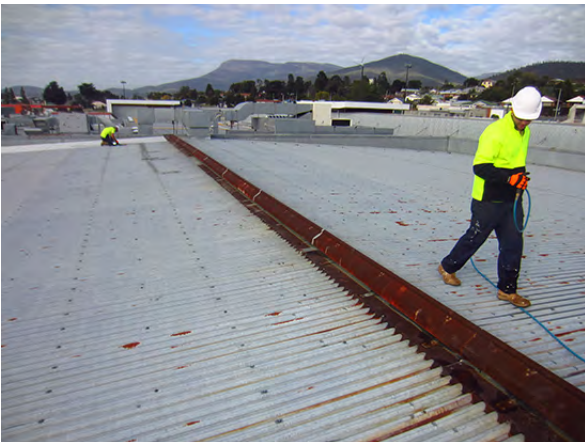
* 'Before' – prior to any work

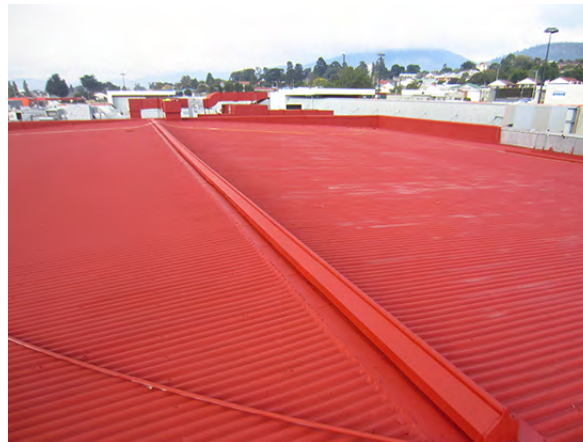
* 'During' – rust conversion & primer coats

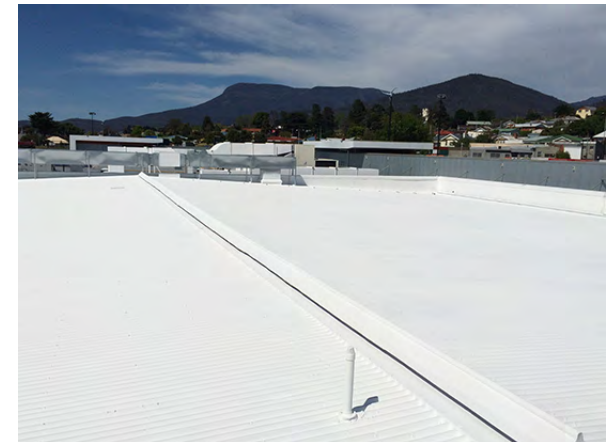
* 'After' – like new appearance
